# Engine – Repair bump stop replaced

## ENGINE BUMP STOP REPLACEMENT

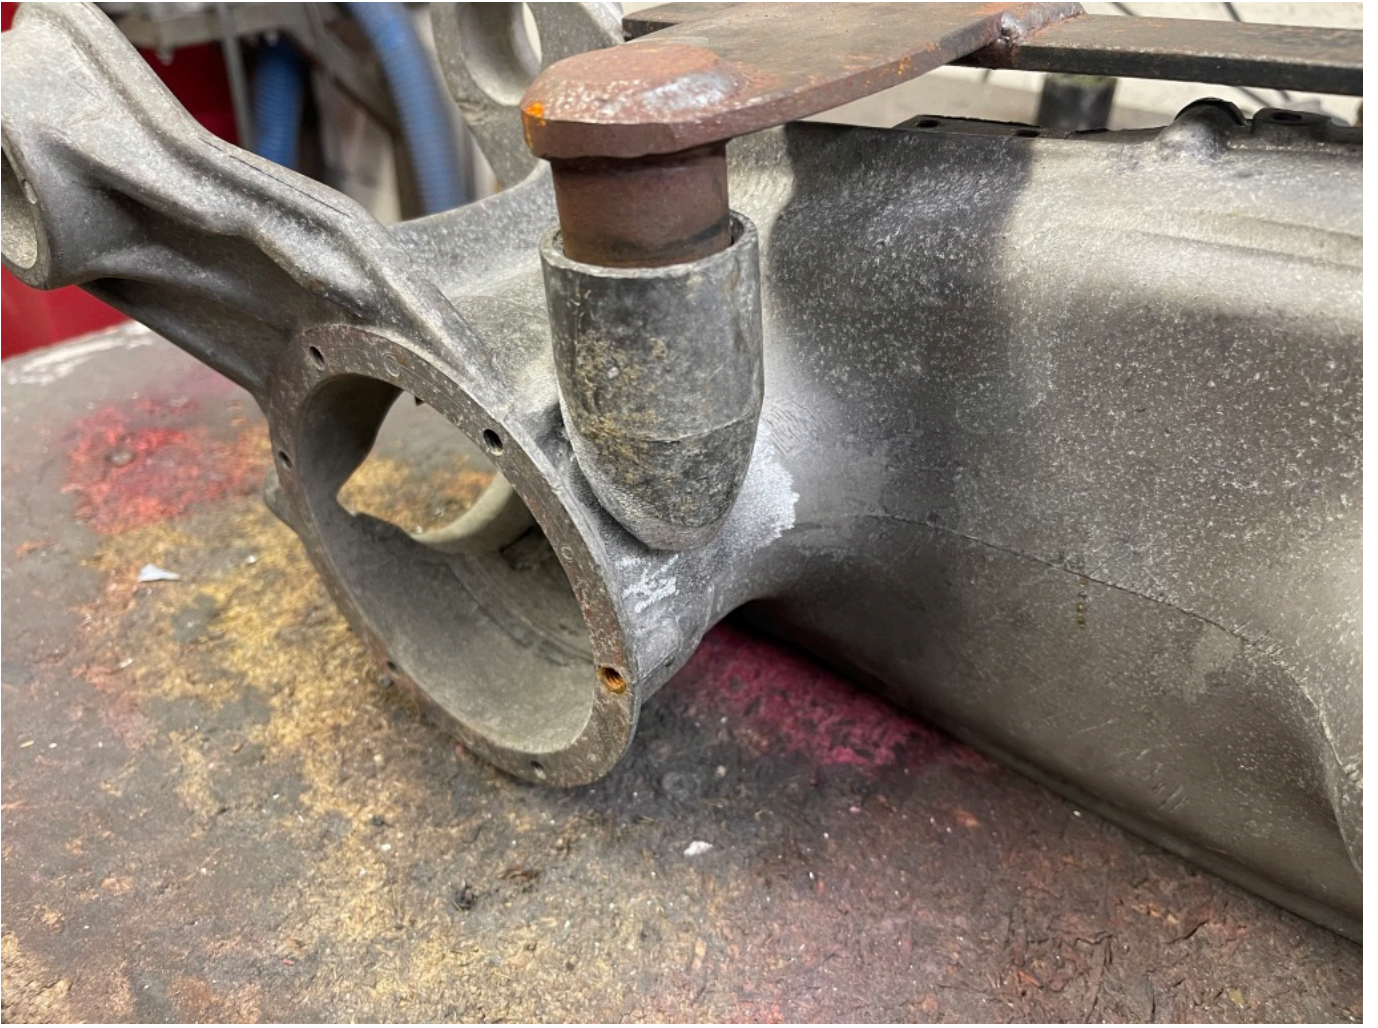
*Donor engine lug fitted with our fixture*

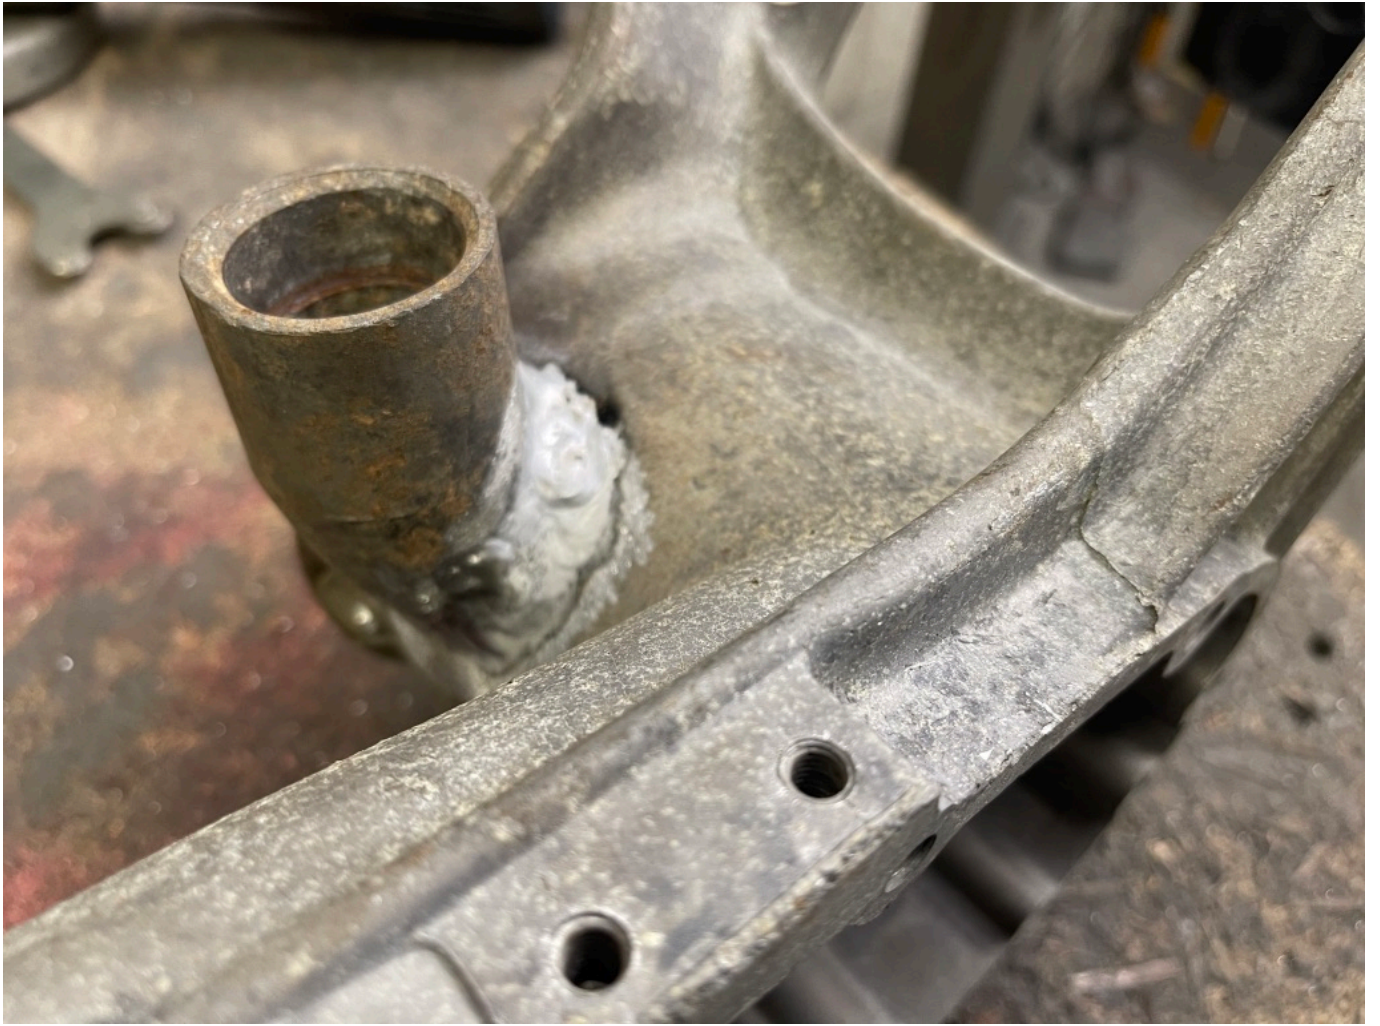
*Not always an easy weld, the back side is a guess to see if its welded correctly*

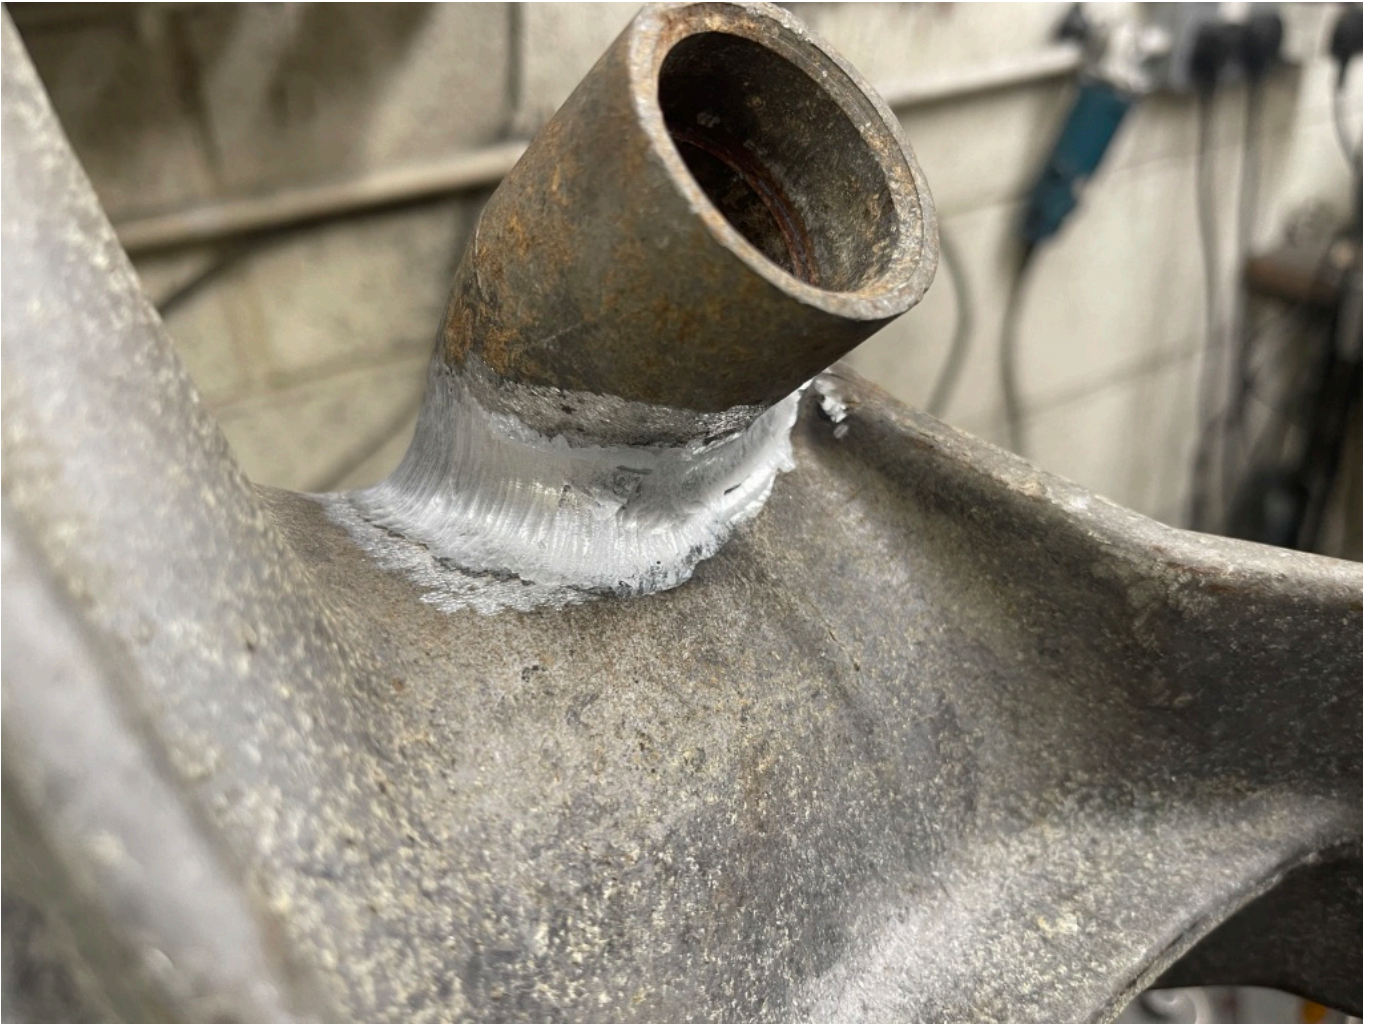
*Once welded and cooled and mag face machined, the welding can be roughly cleaned up*

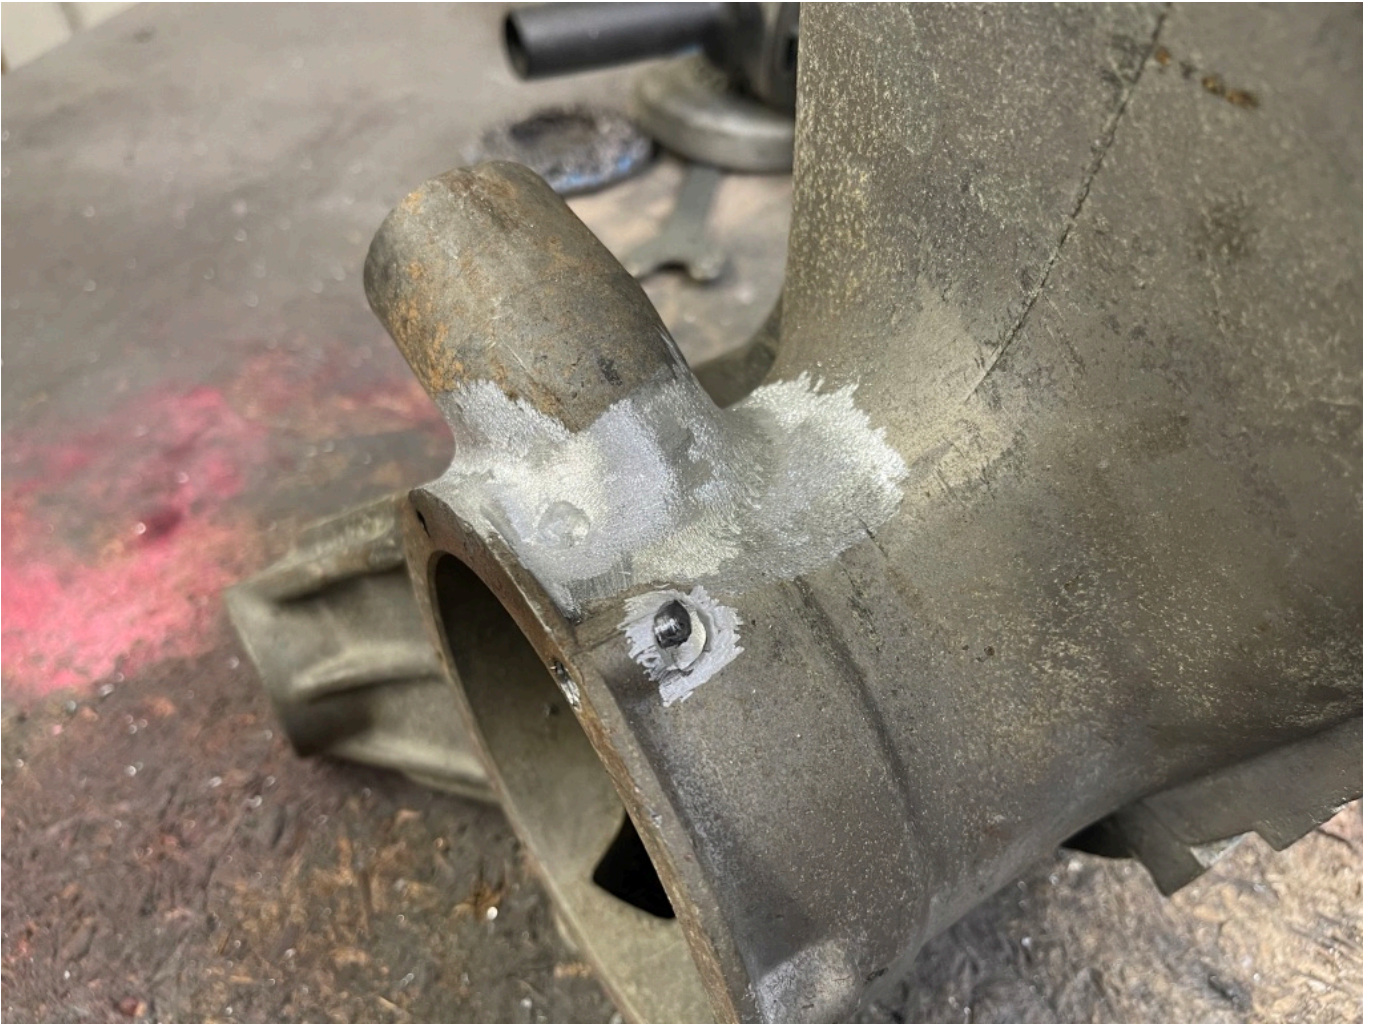
*Roughly grinding away can find some blow holes hidden under the welding, its always best to drill these holes and grind away for more welding*

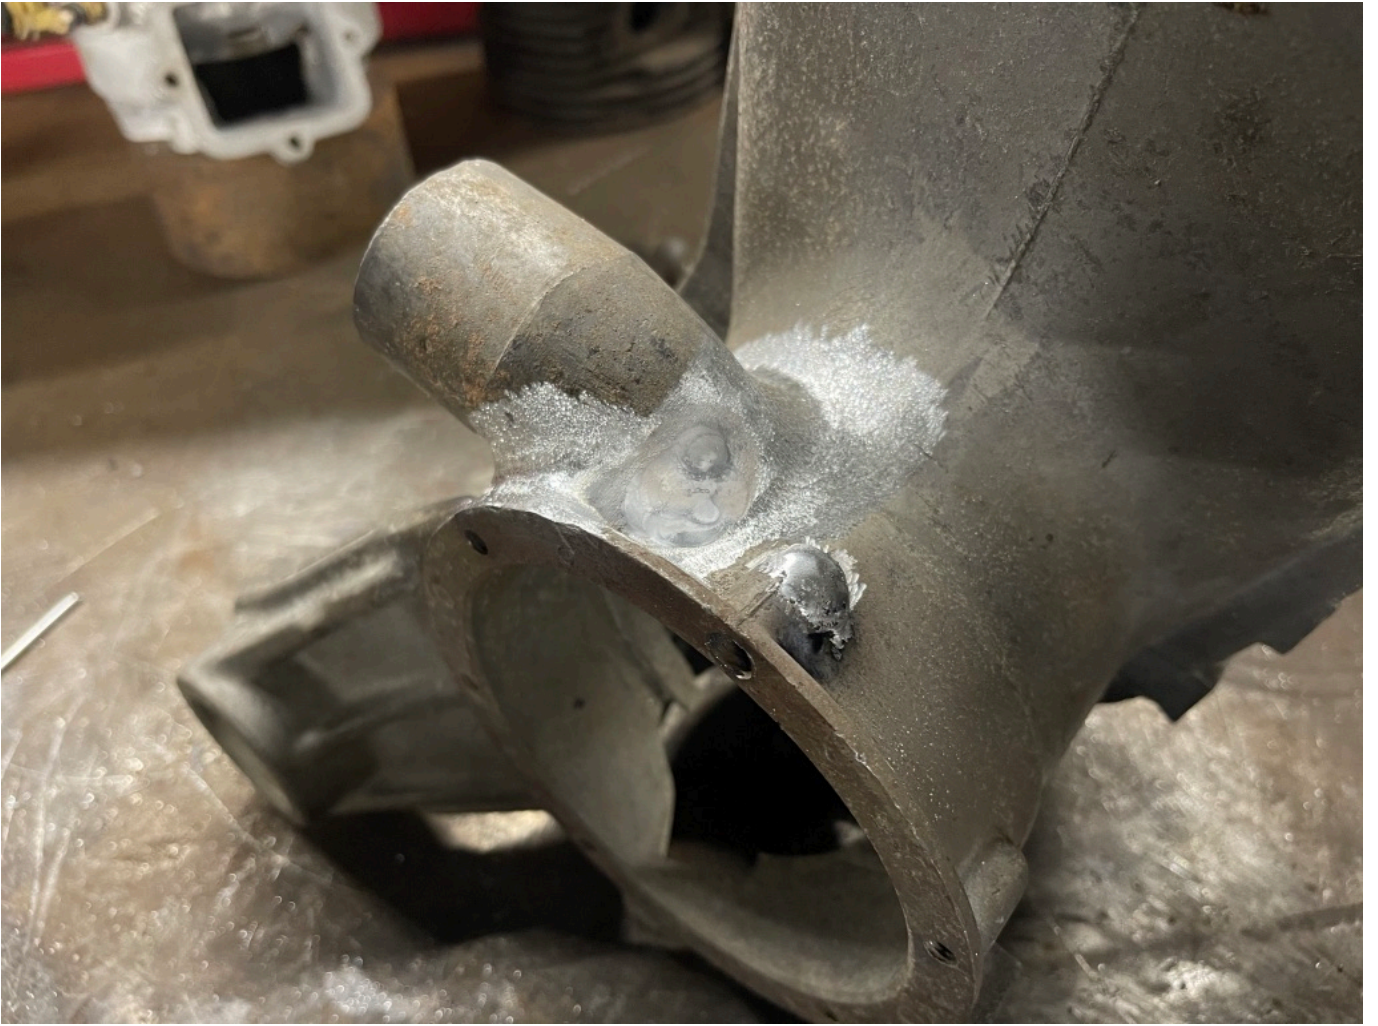
*More welding to fill in any blow holes*

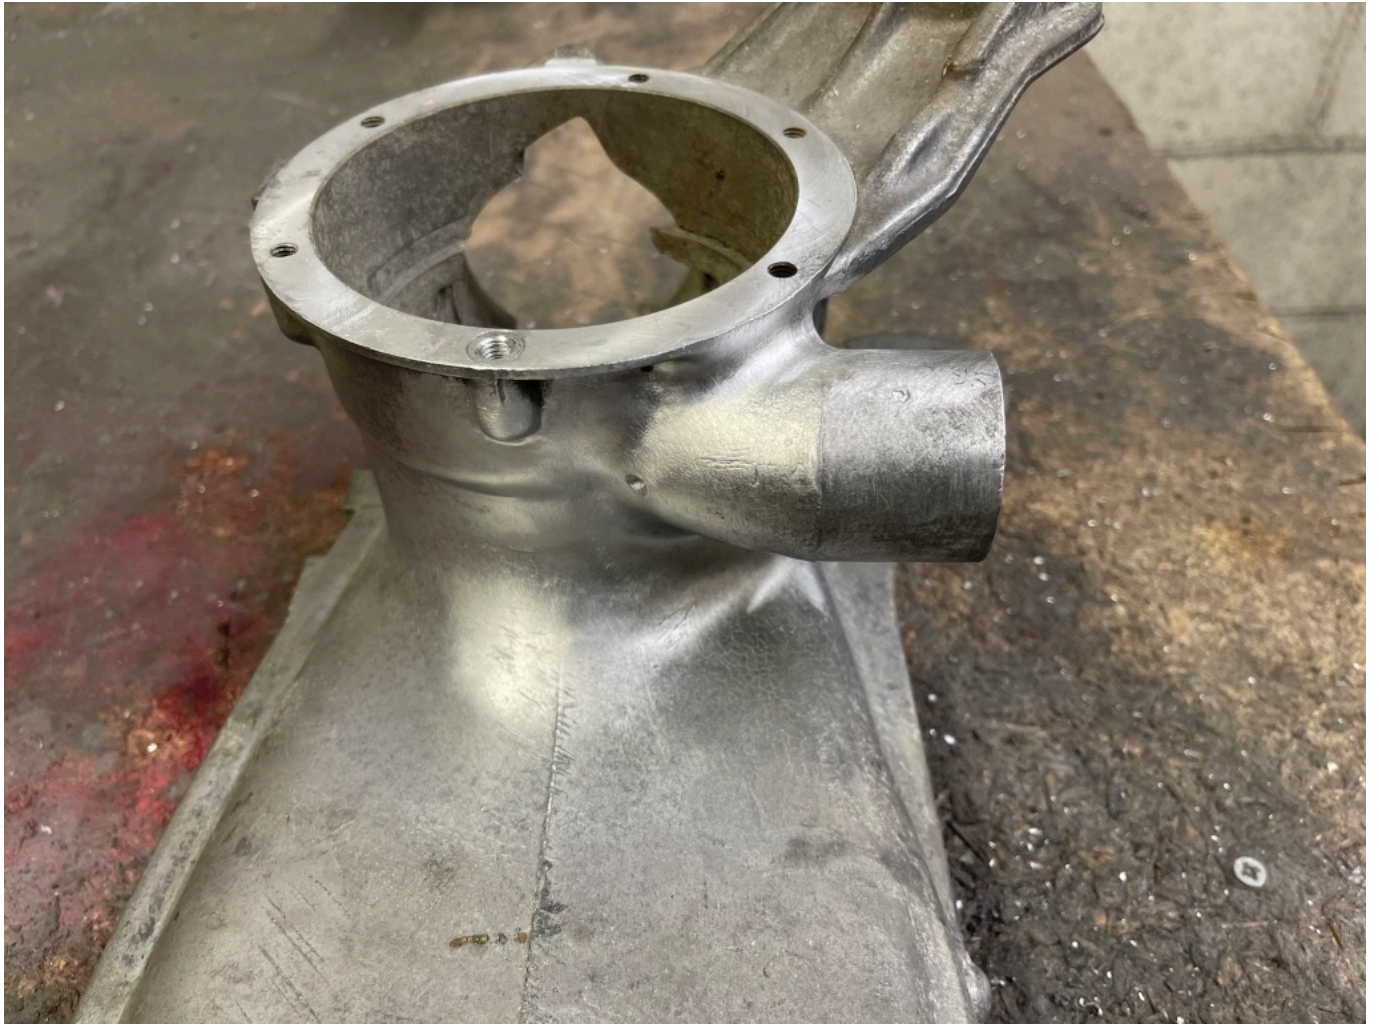
*Once happy that there are no blow holes or that they have been re filled in, you can start to really clean up and fine grind the welding to disguise its been welded*

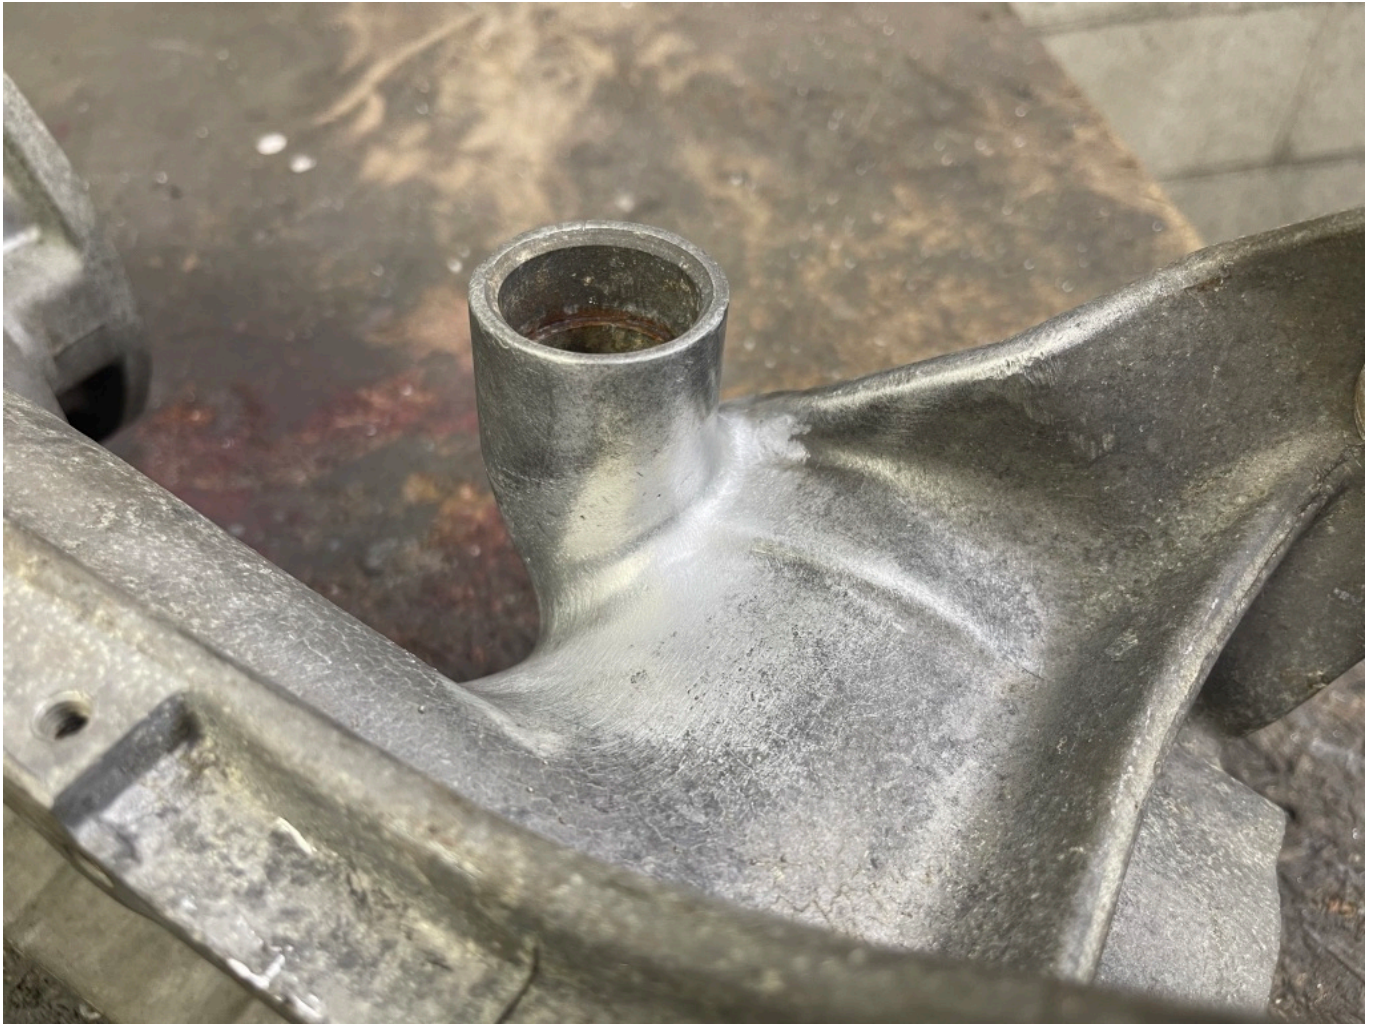
*And done! this customer didnt want the casings bead and aqua blasted, he wanted it to look old*
