Engine – Repair bump stop replaced 2

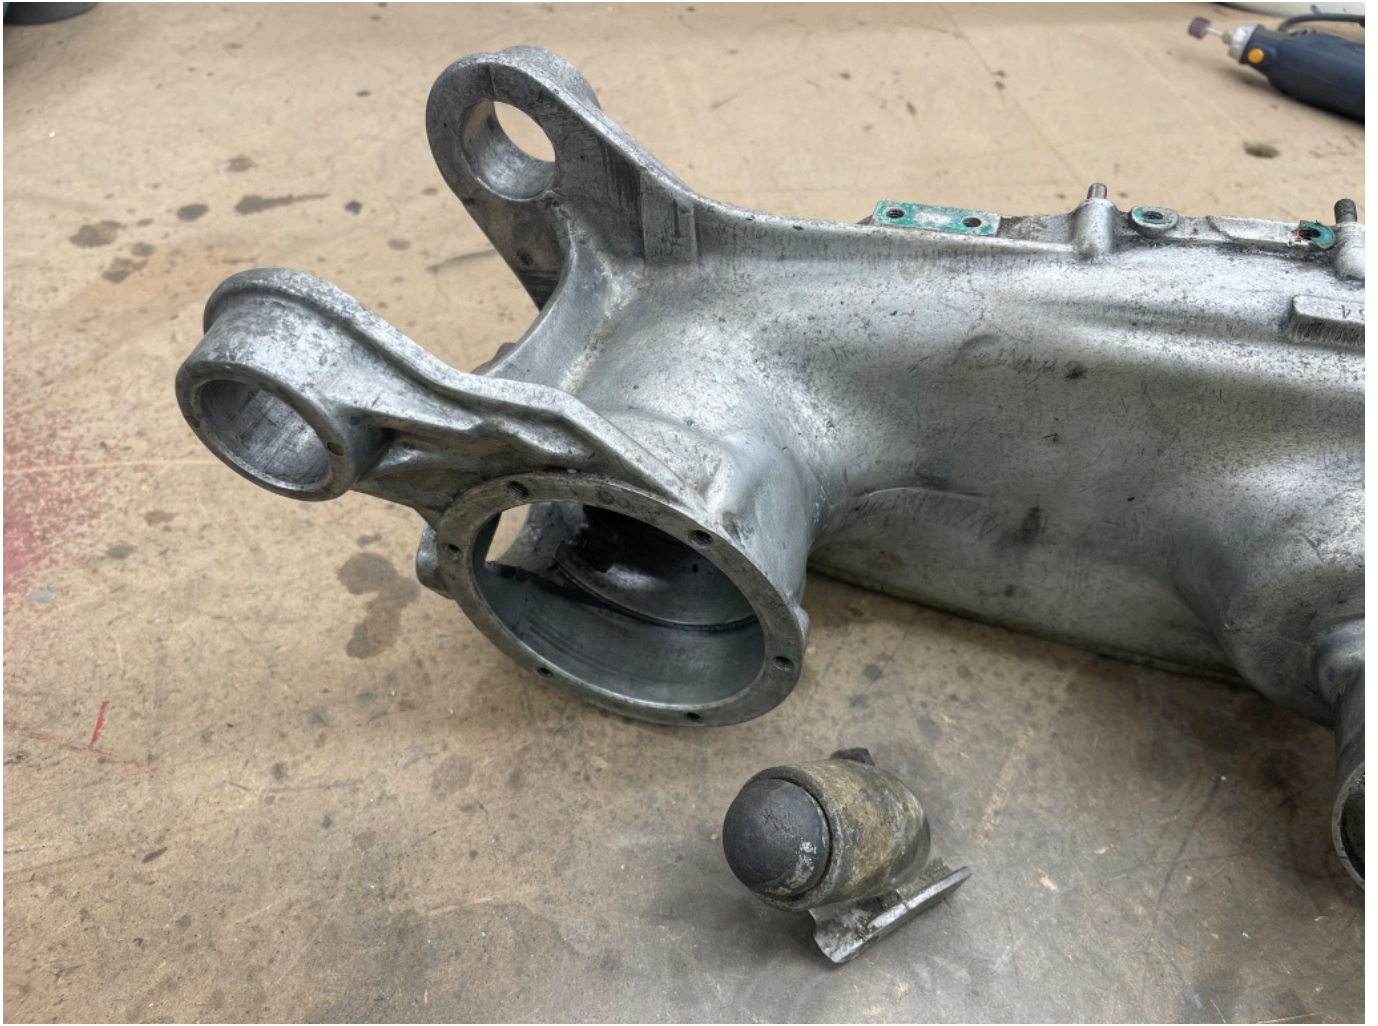
Spare bump stop supplied with a nice clean casing

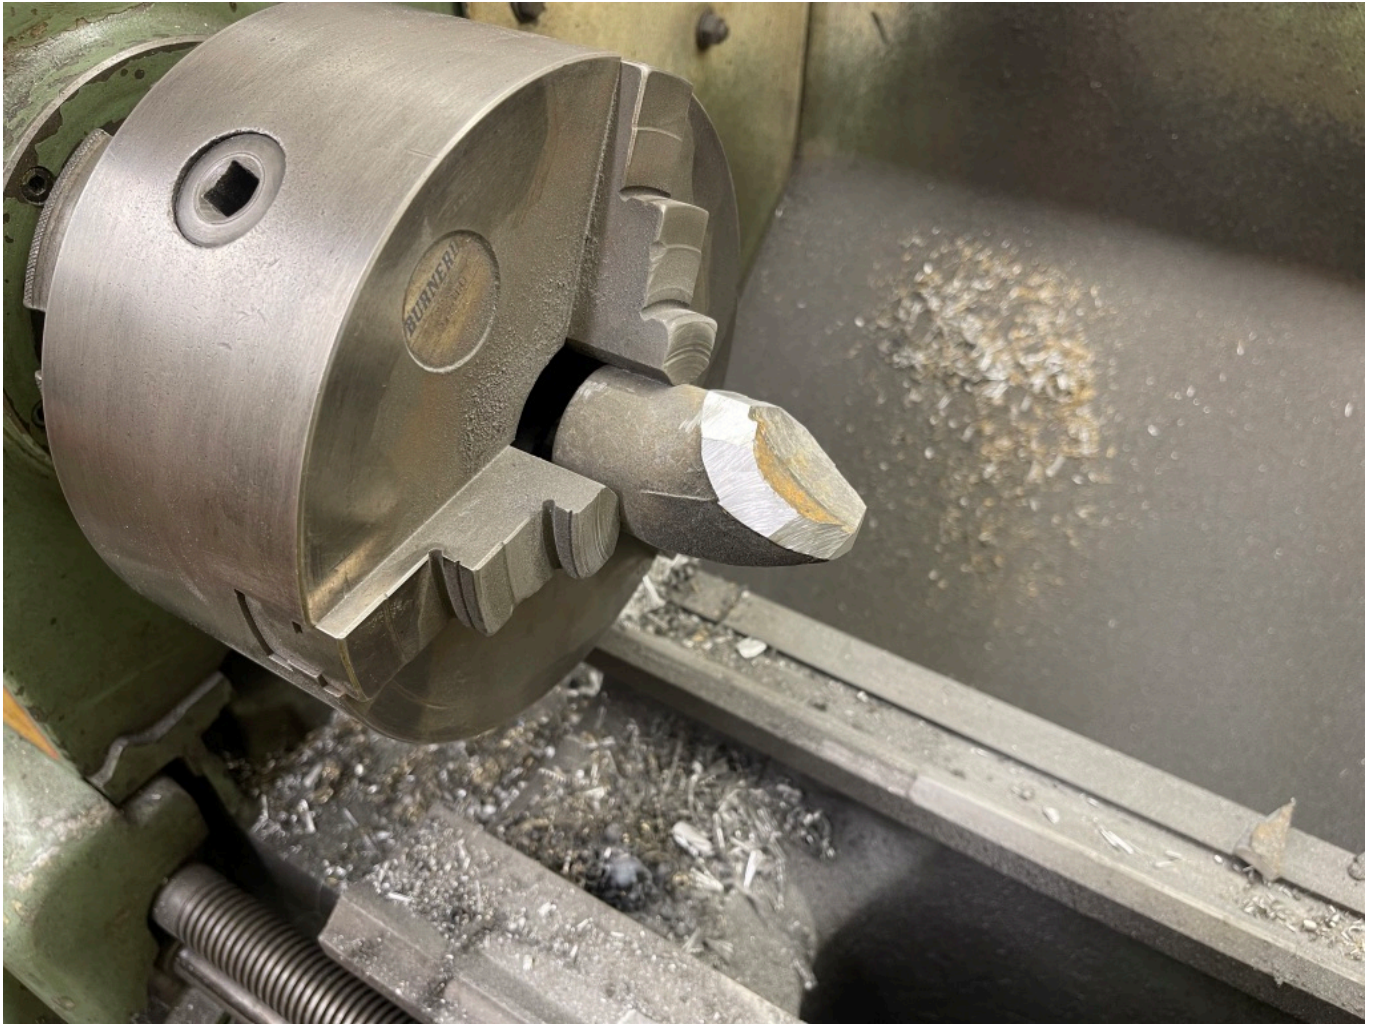
Bump stop is much easier to turn, trim, cut and shape in the lathe

When you get a casing as nice as this, it's easy to cut and clean up the supplied bump stop by spinning it in our lathe, which is ground to fit the best you can. I made a fixture years ago to hold the stops in place. This fixture holds the loose bump stop in as you pre warm the casing and weld the stop in place.

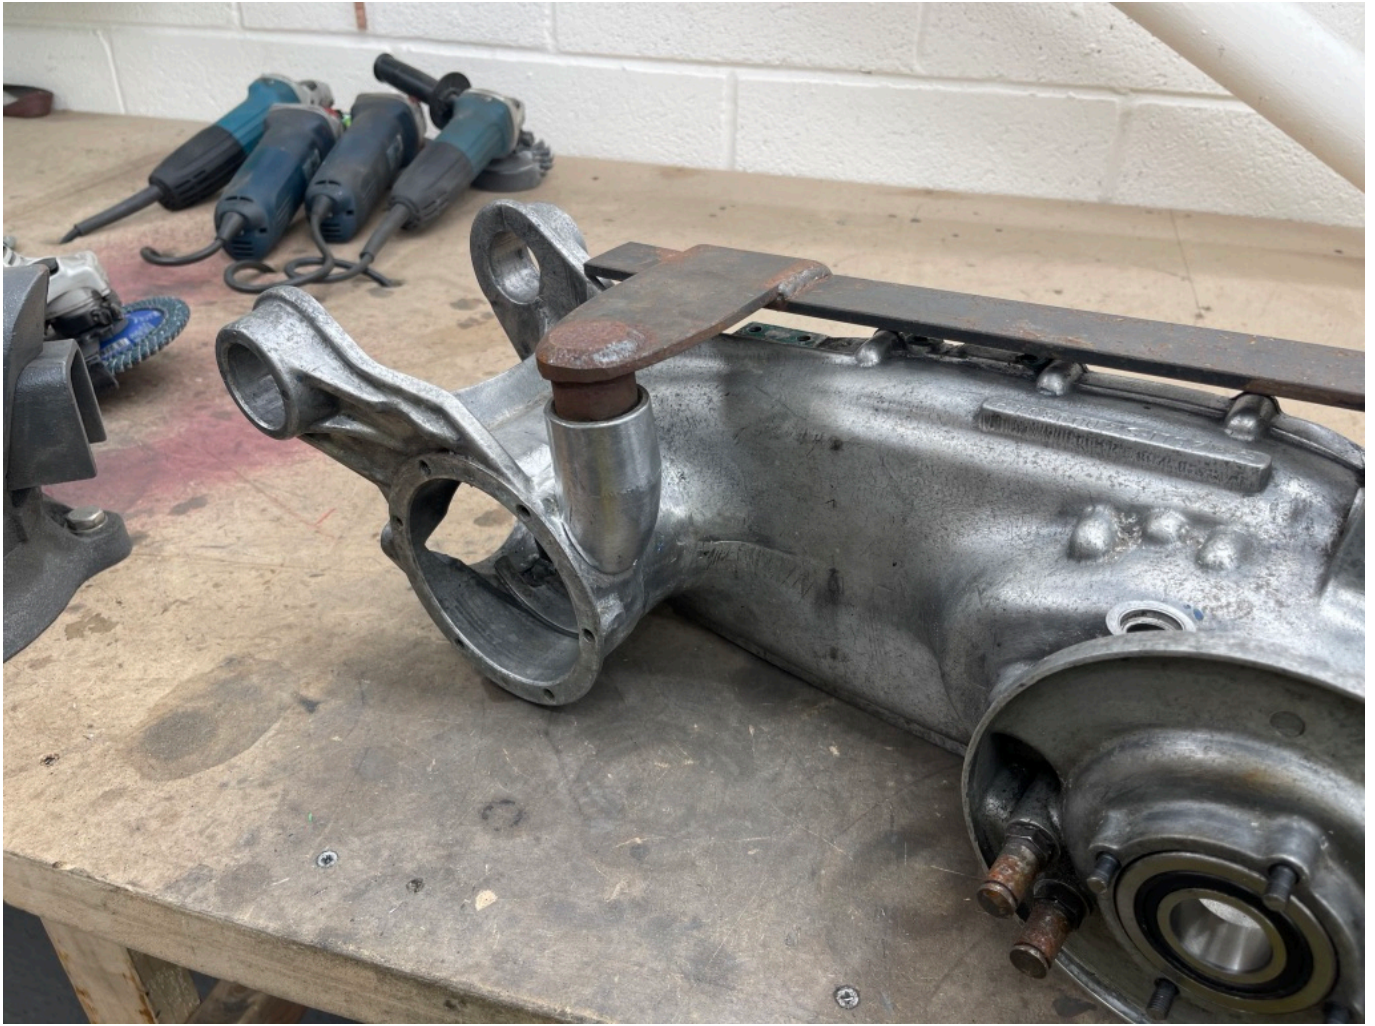
Bump stop finely ground to shape and offered up in the fixture jig to position it

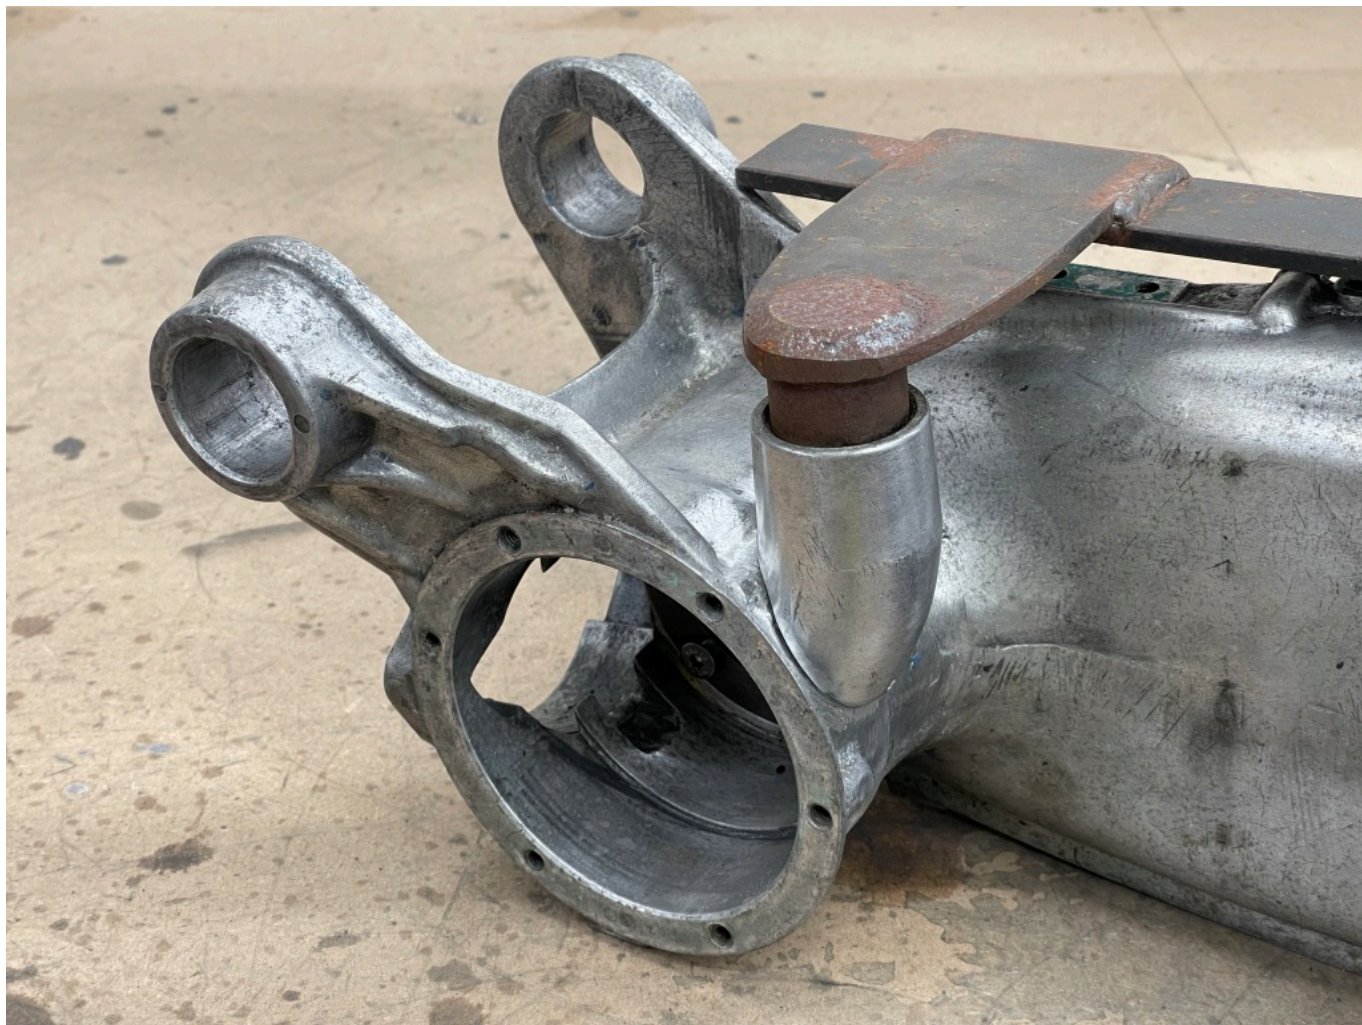
All high spots removed to get the stop to fit

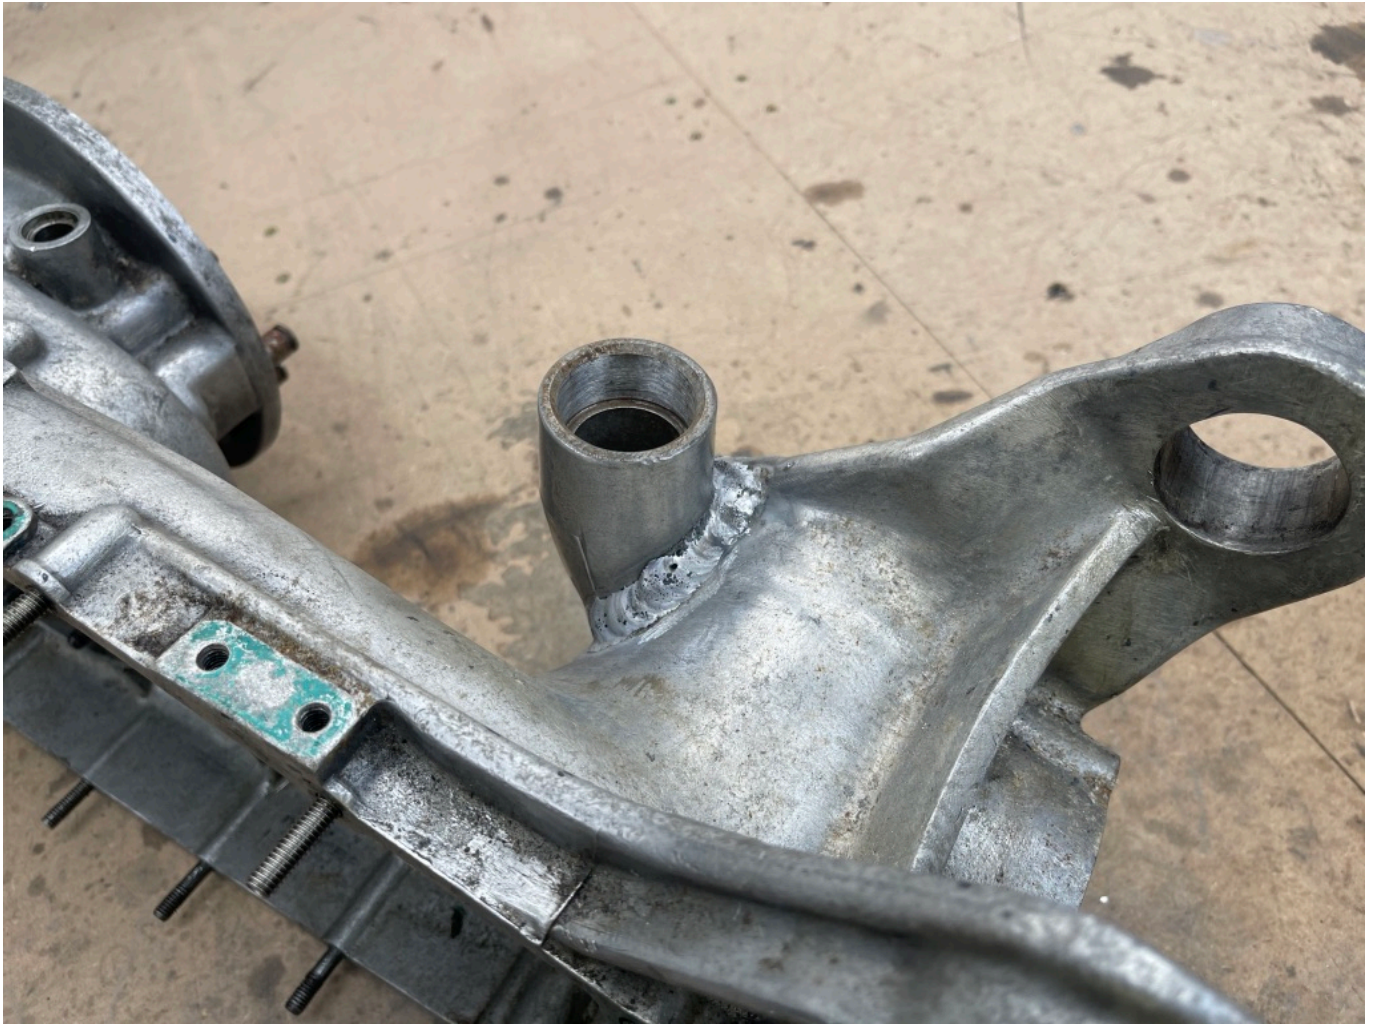
Bump stop tacked in shape, jig removed and welded up

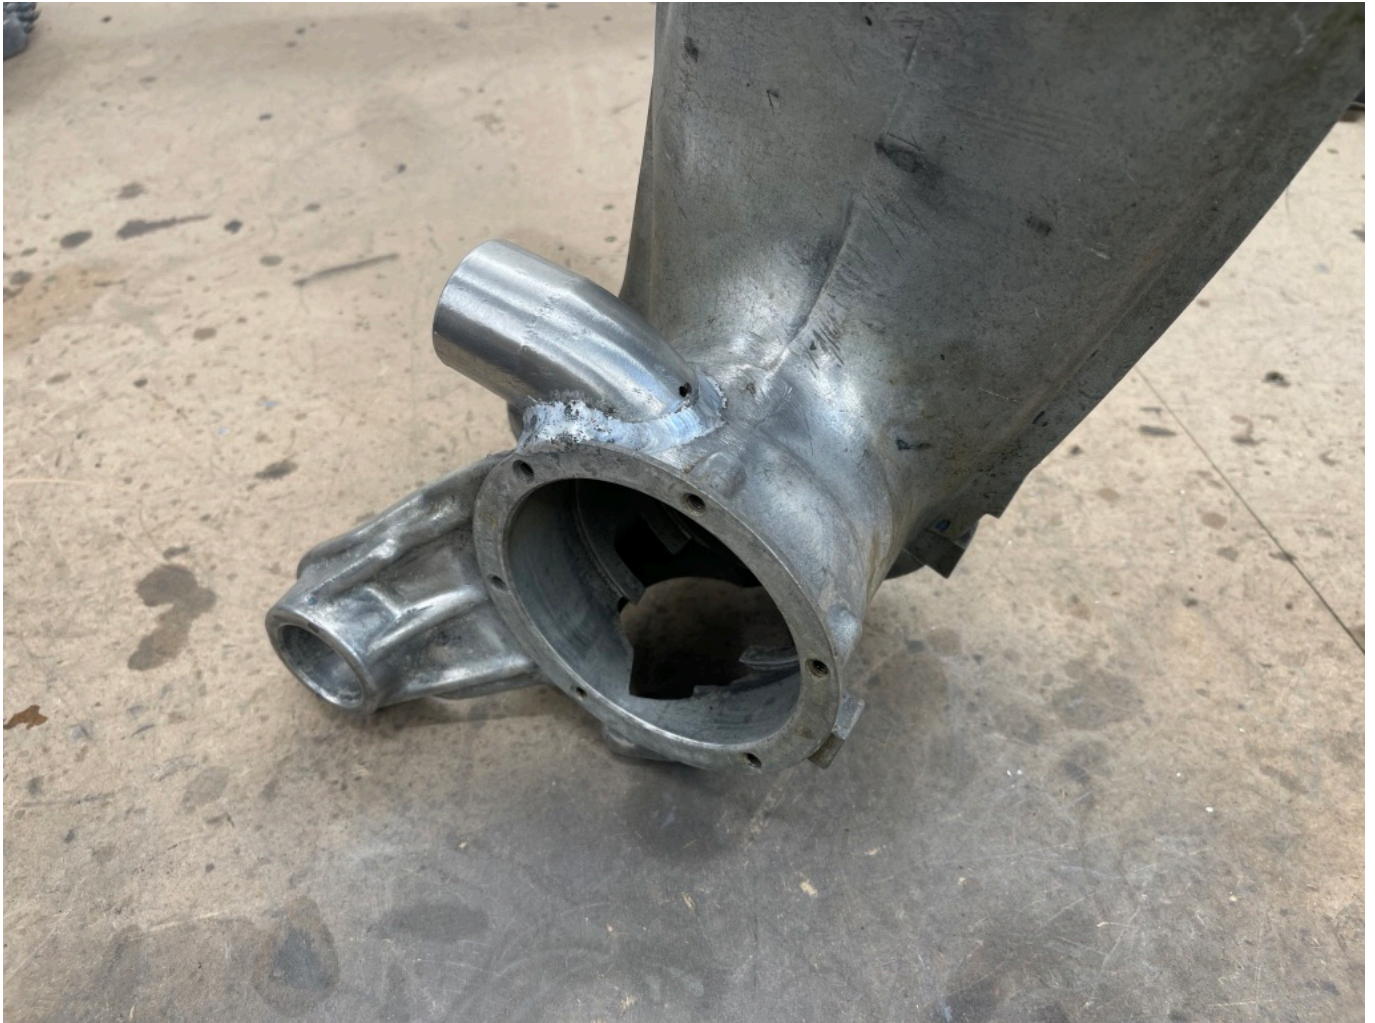
Plenty of penetration all the way around, but you have to be careful near the mag housing so you don't melt it away

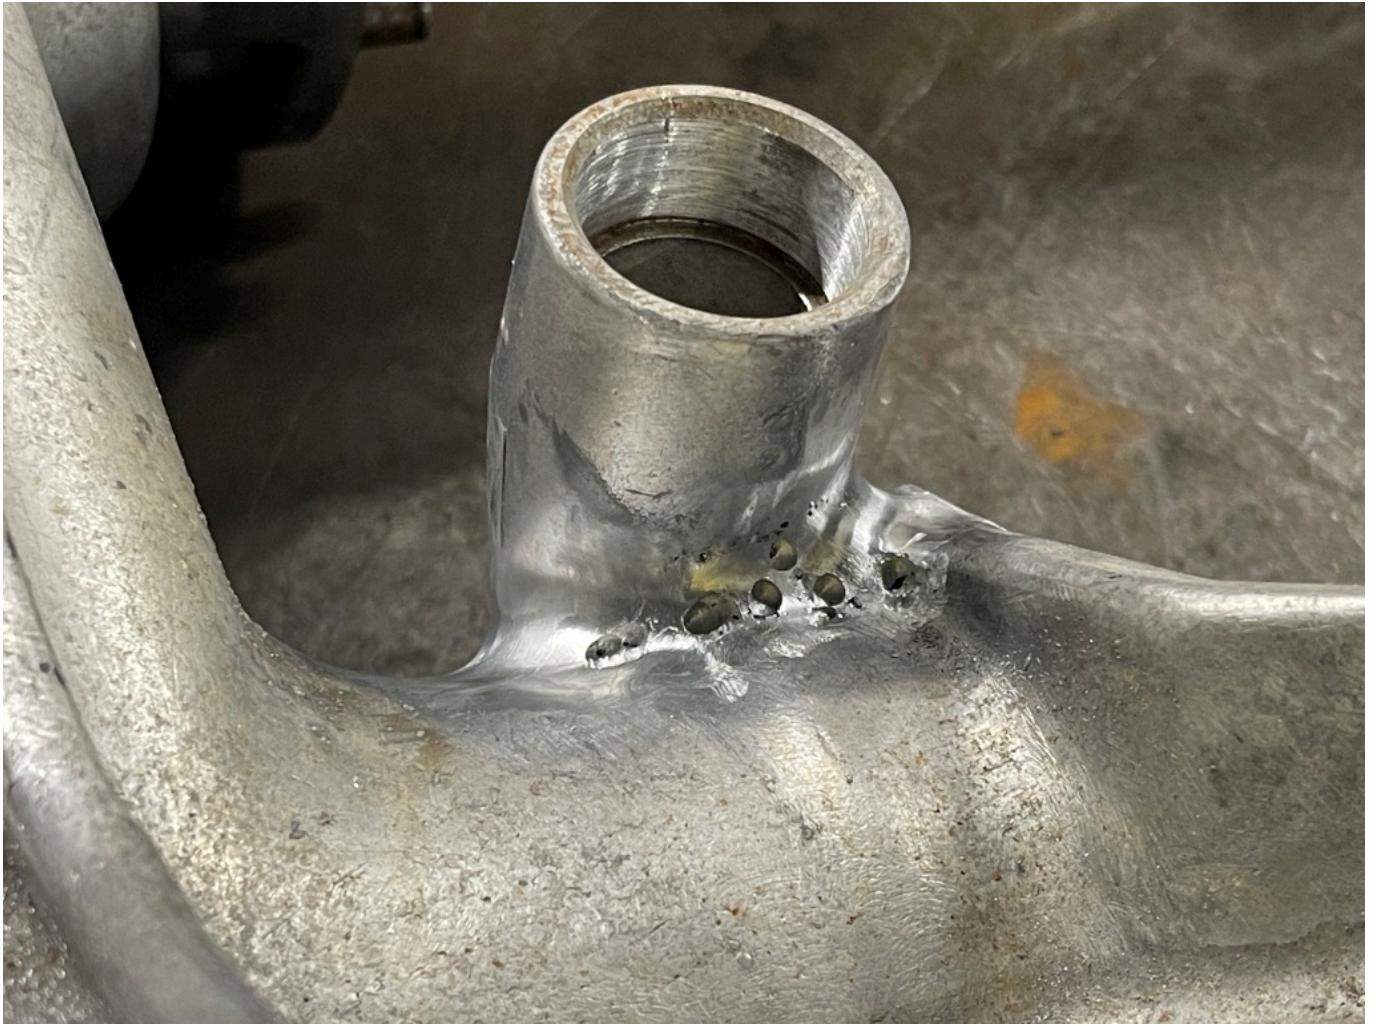
When grinding away sometimes holes appear, these need drilling or grinding away and rewelding

After that, its a case of grind away the welding to shape it back to original looks and if you're unlucky you had some holes in the casing under the weld, these need drilling out and redoing over with weld and grind back again until perfect.

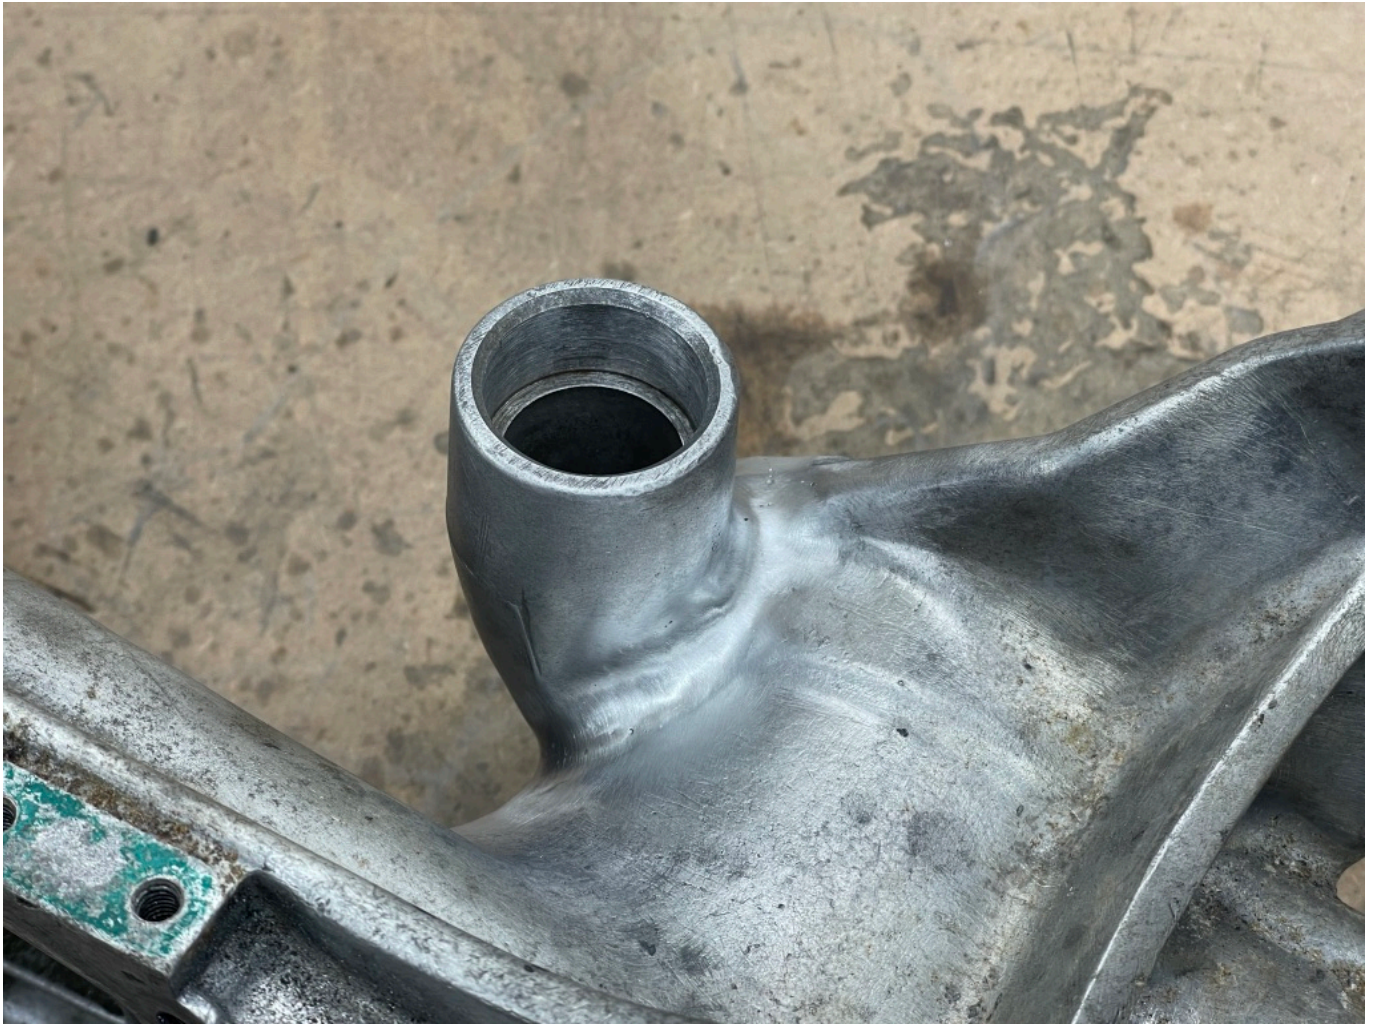
Once finally welded, it needs grinding to shape, flowing and smoothing and blending so its not obvious it been welded

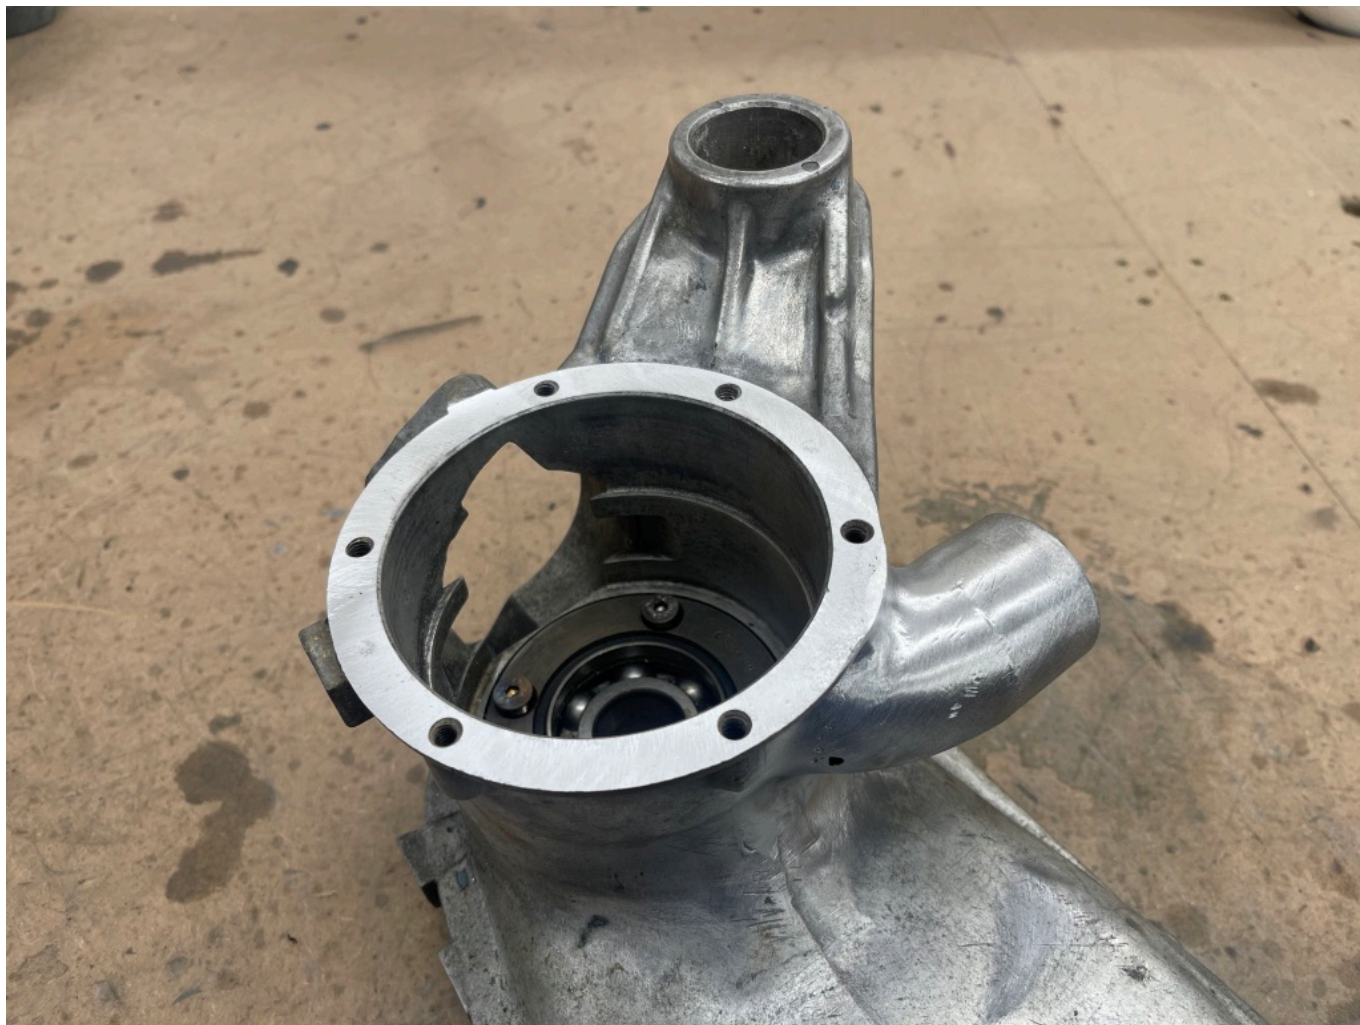
Nice cleanly welded and machine casing back to new
