Engine – Repair drive bolt damage

SIDE CASING REPAIR AGAIN

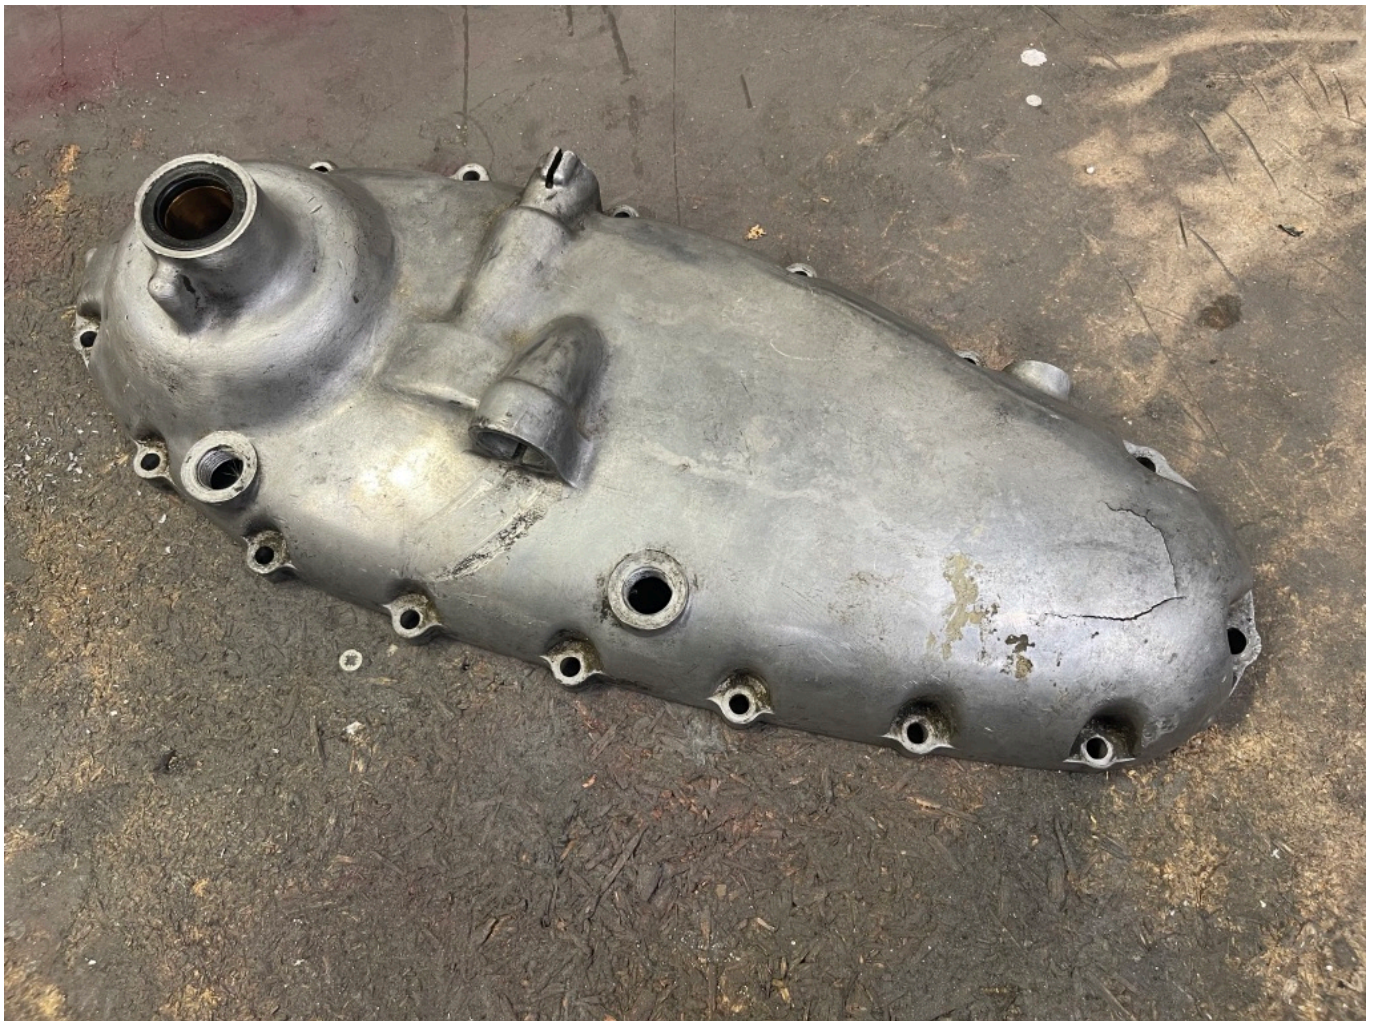
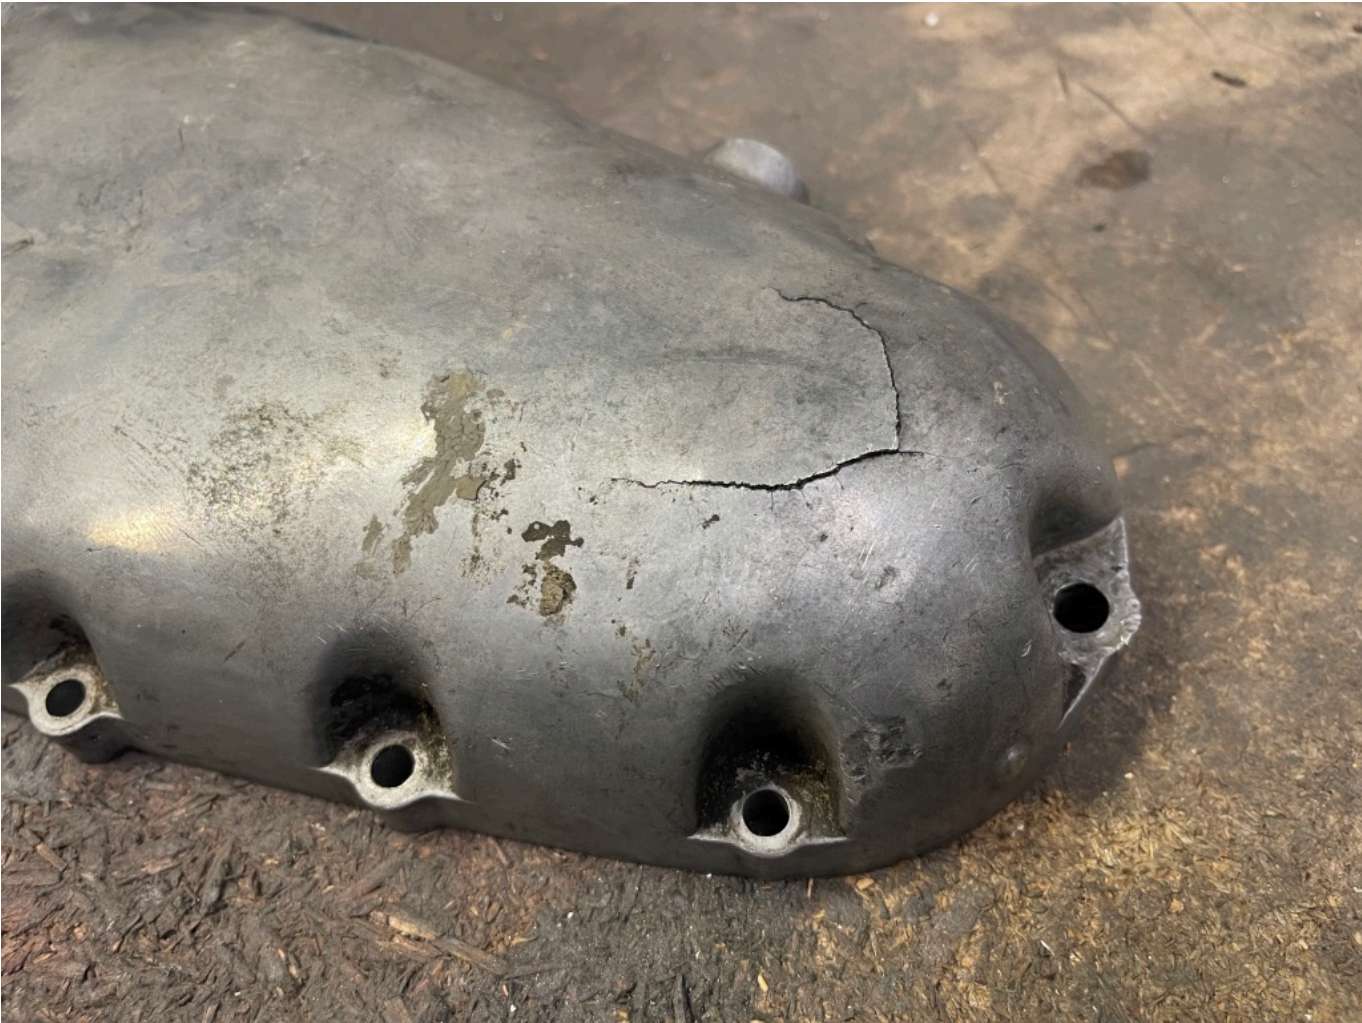
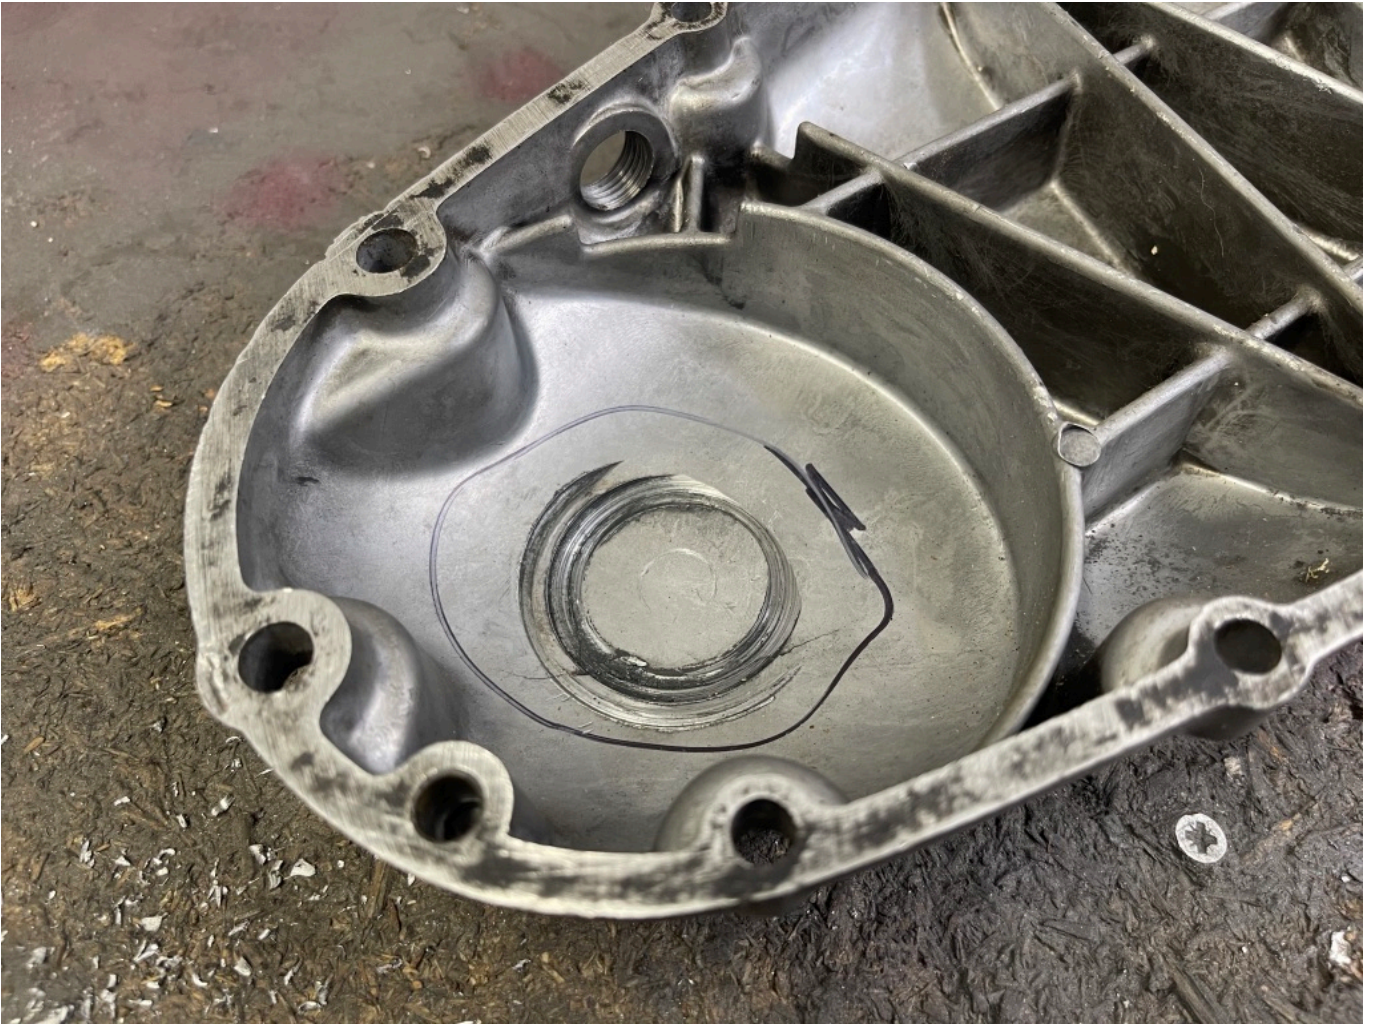
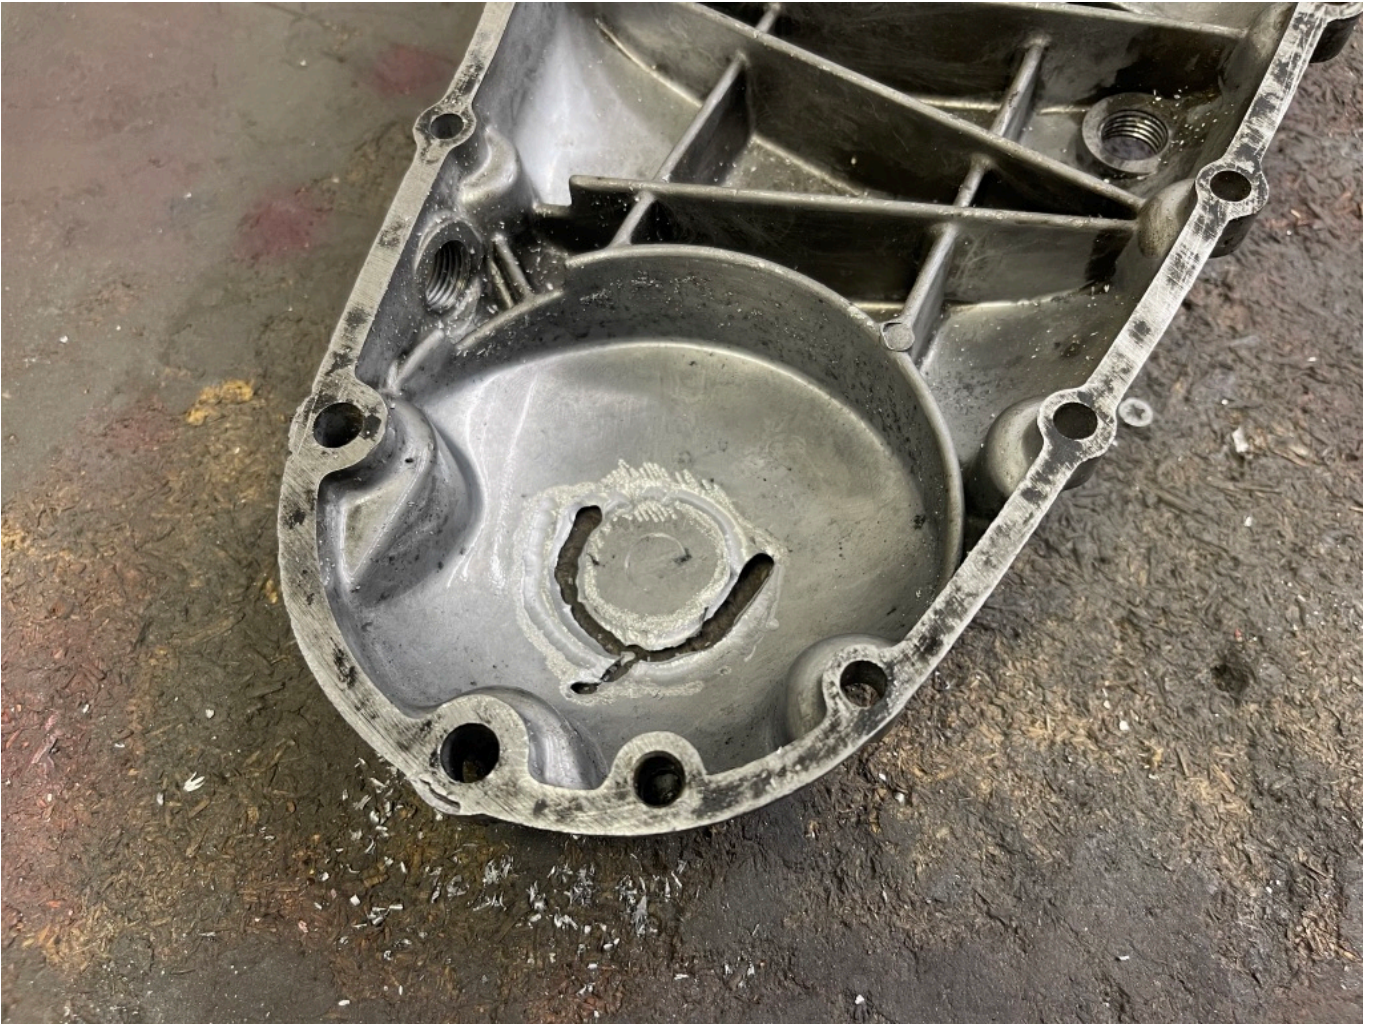
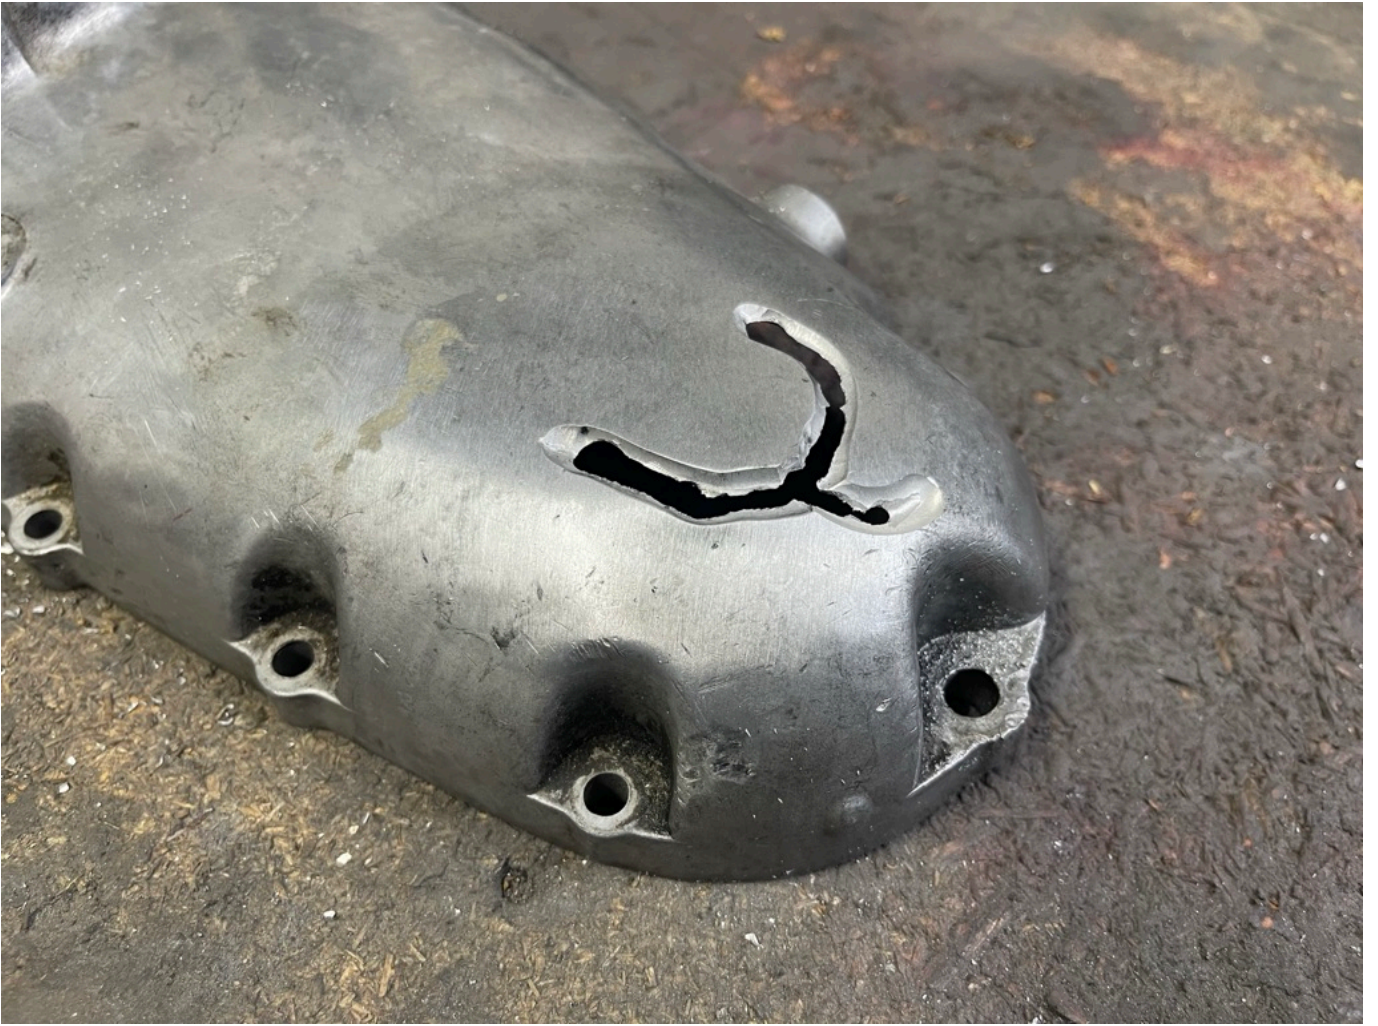
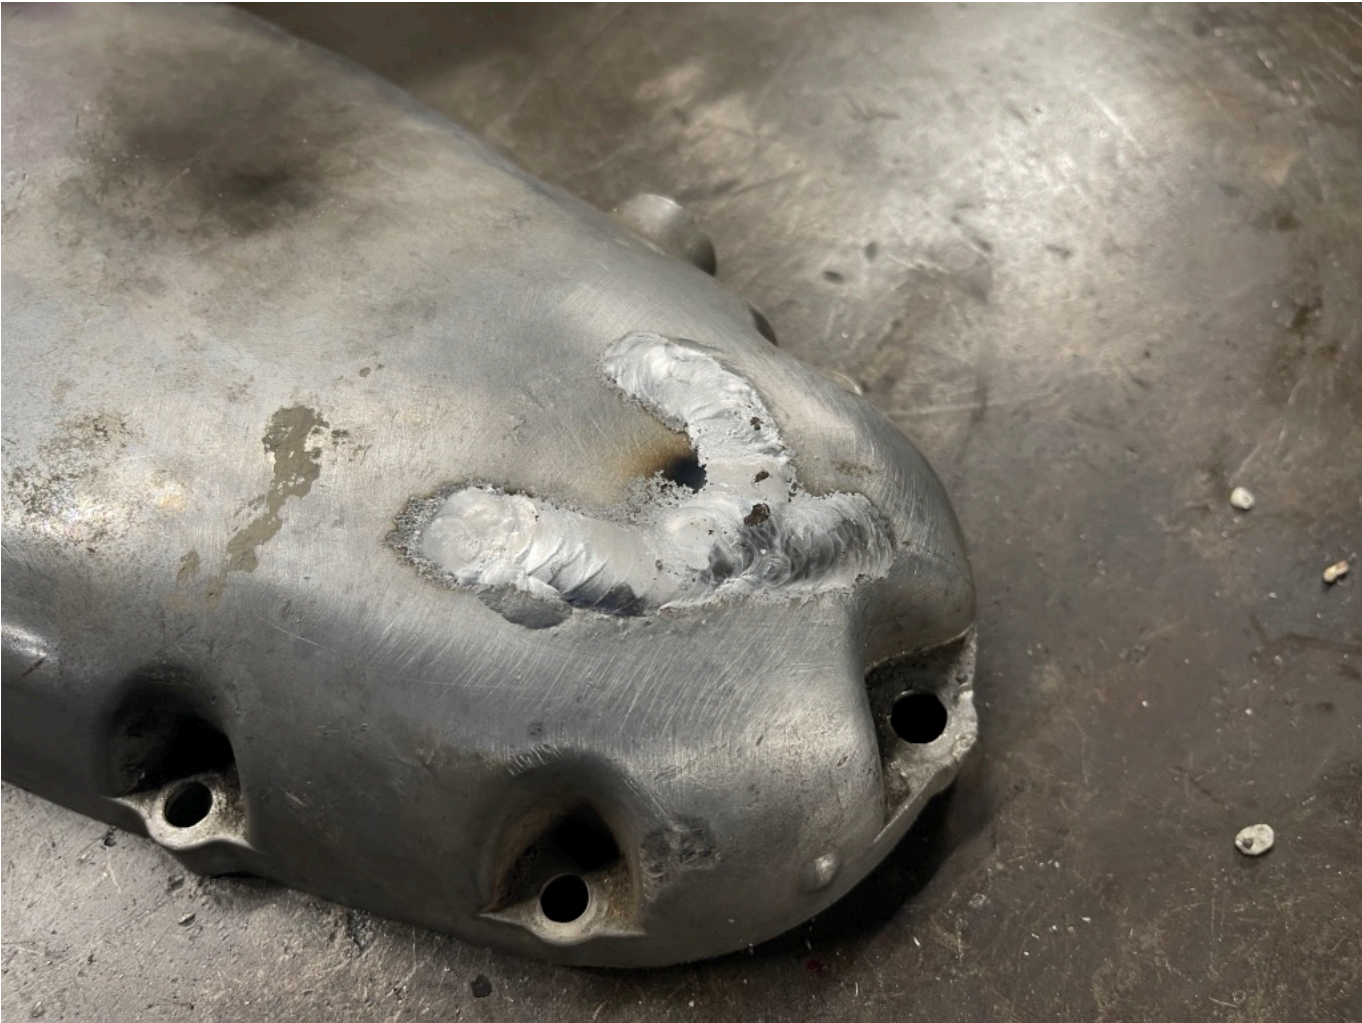
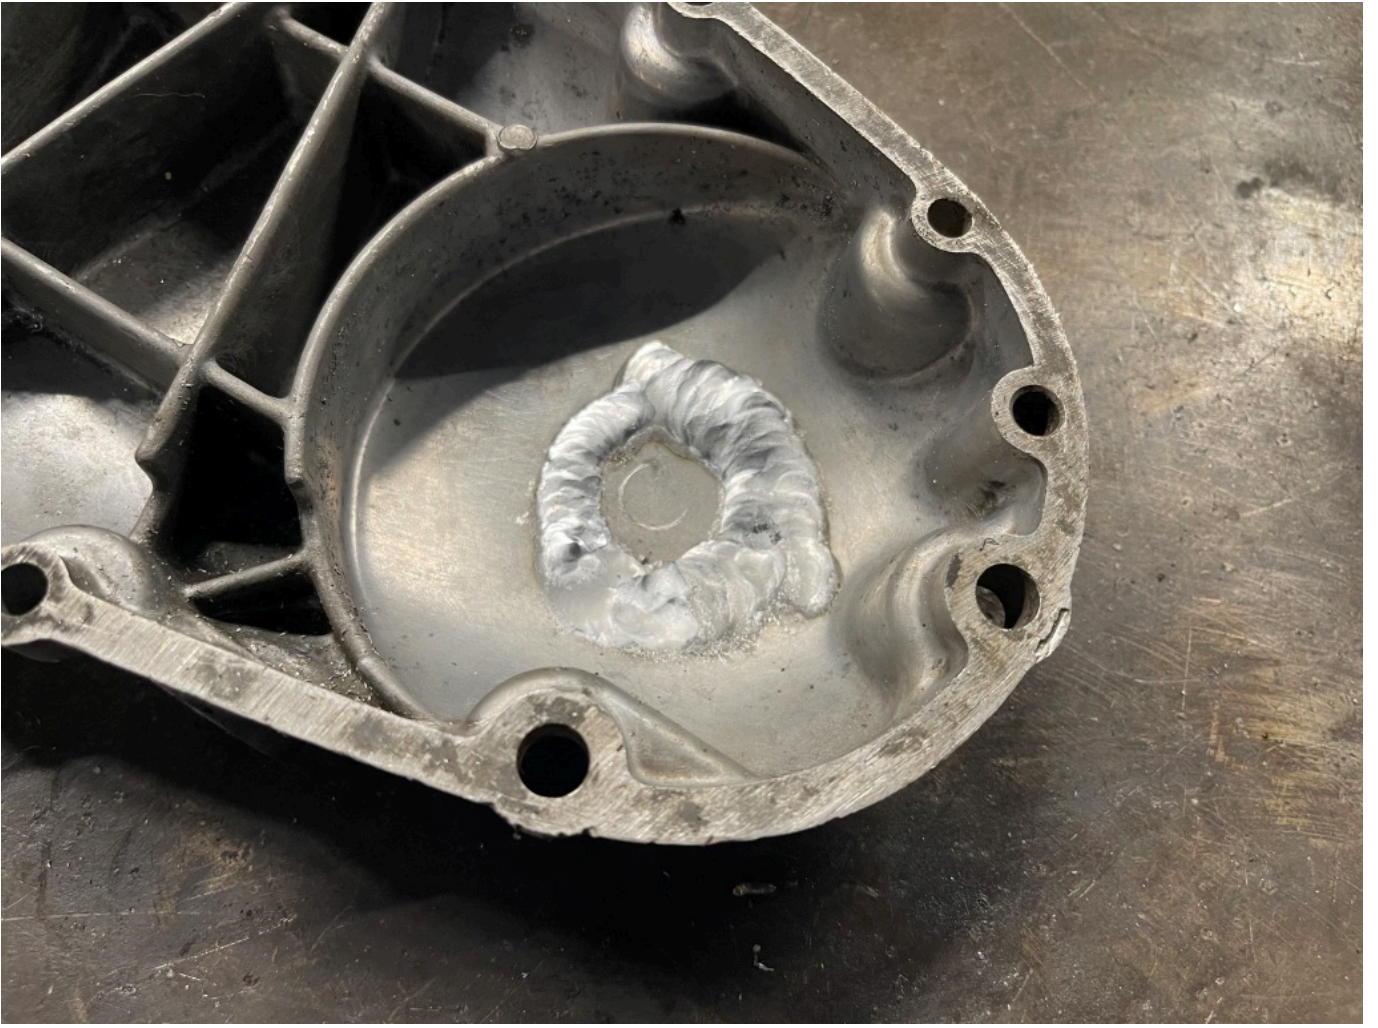
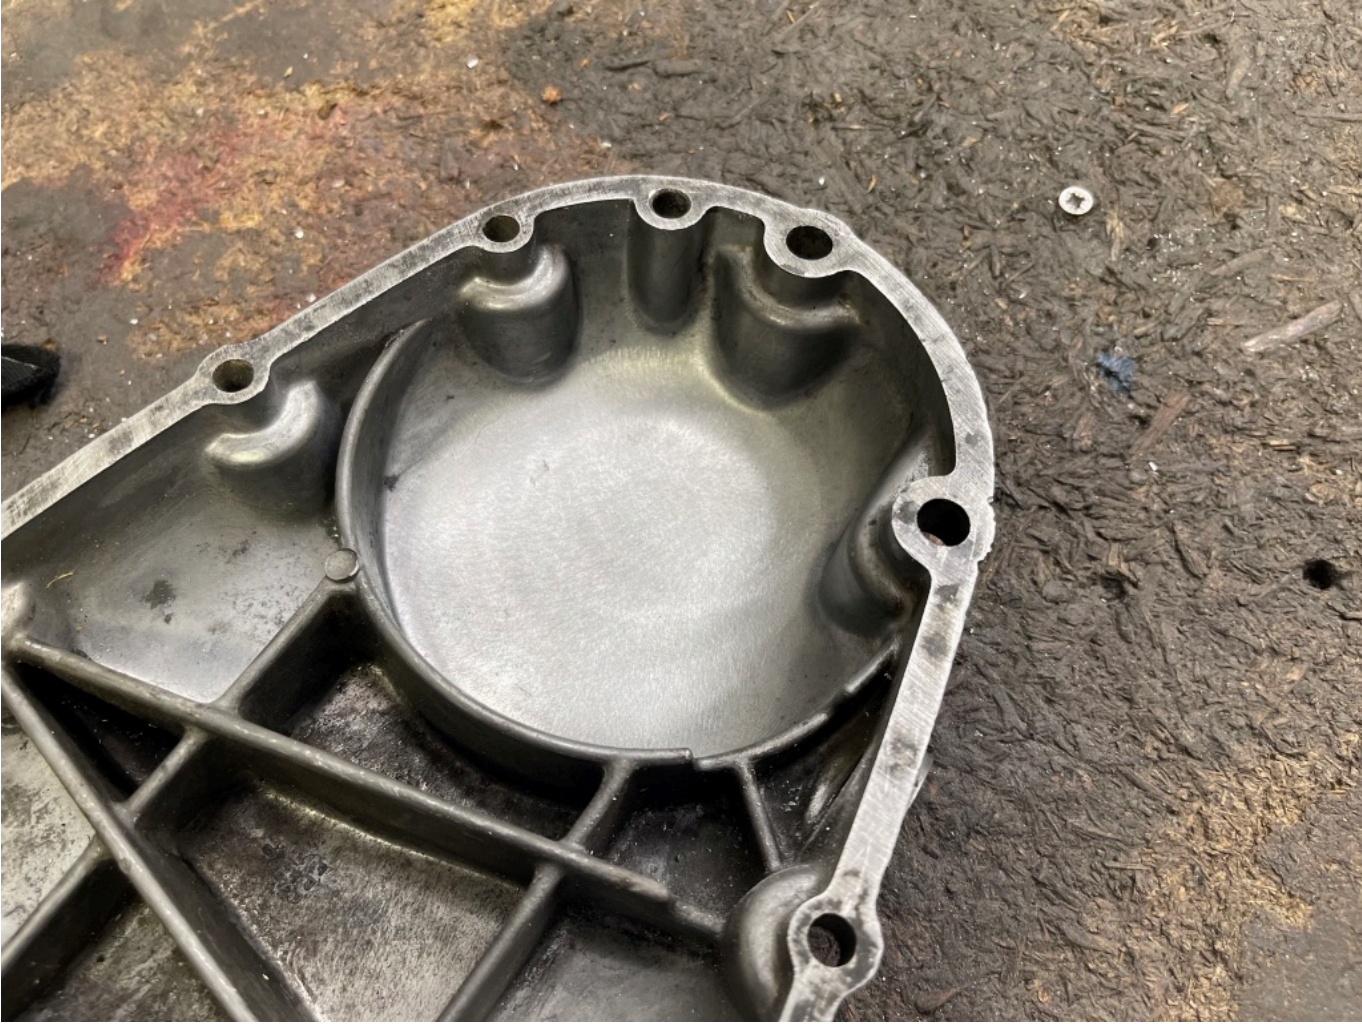
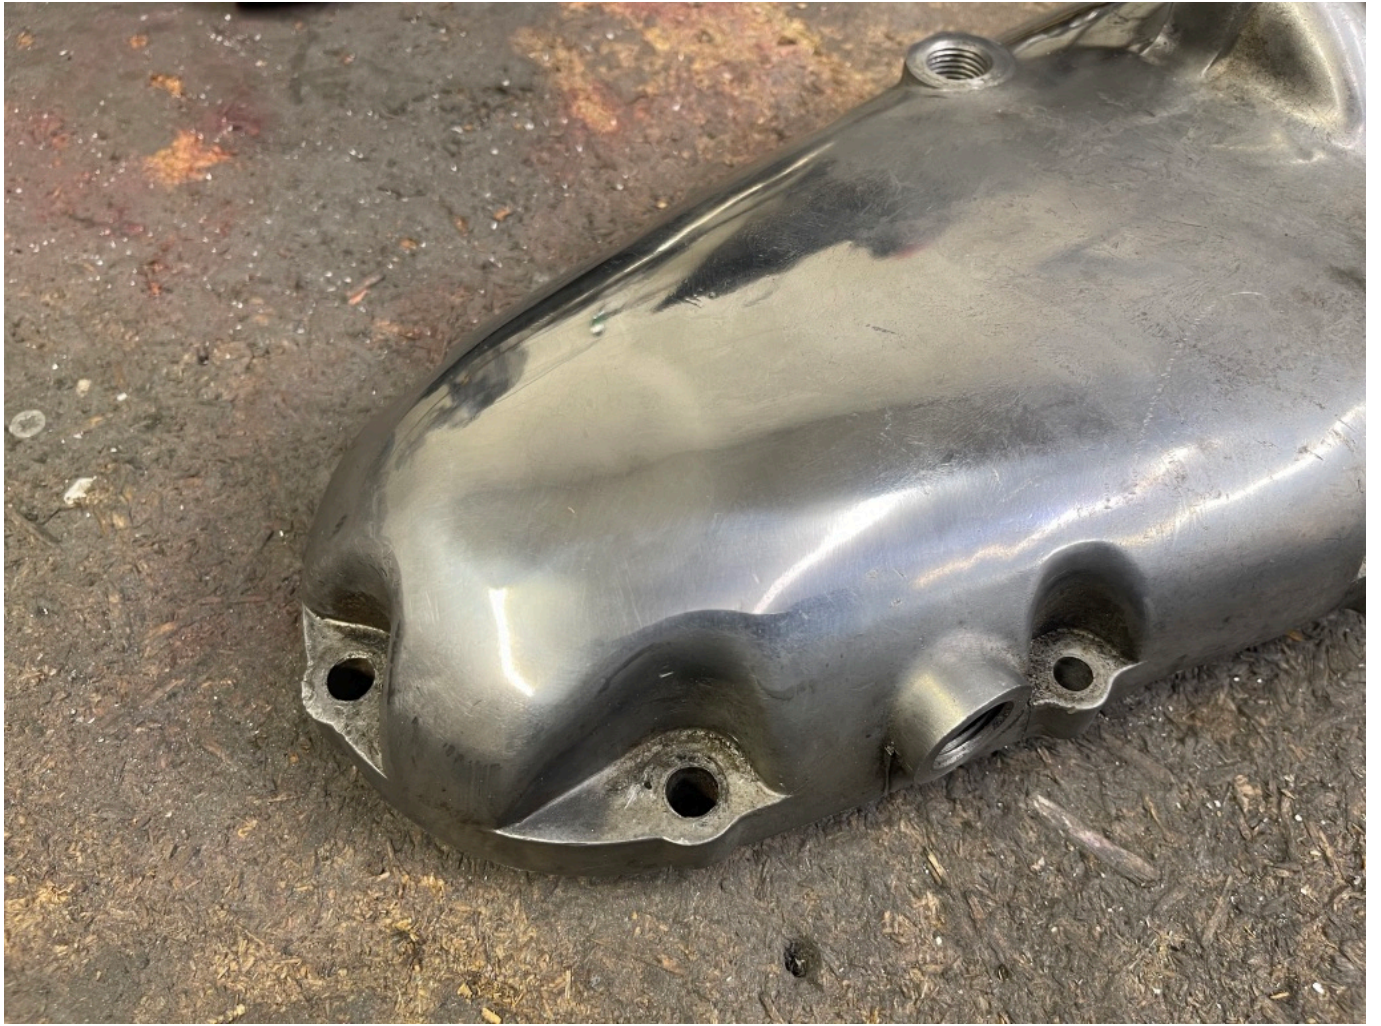
For some reason this is unbelievably common – the drive bolt coming loose and coming through the side cover!

Side covers for some reason are usually hard to weld, as soon as the torch goes near the casing holes appear, even with all the prep work needed to make a good job. Even when it welds you usually see little holes at the side of the weld. This happens even with new casings, so it's not the oil soaked up over time in old casings.

Here's a Series 2 type side cover, which has been ground away, welded, fettled and polished up to look original.

Those drive bolts need to be tightened correctly and always use a new spring if not sure how old it is!
