# Engine – Repair split casing

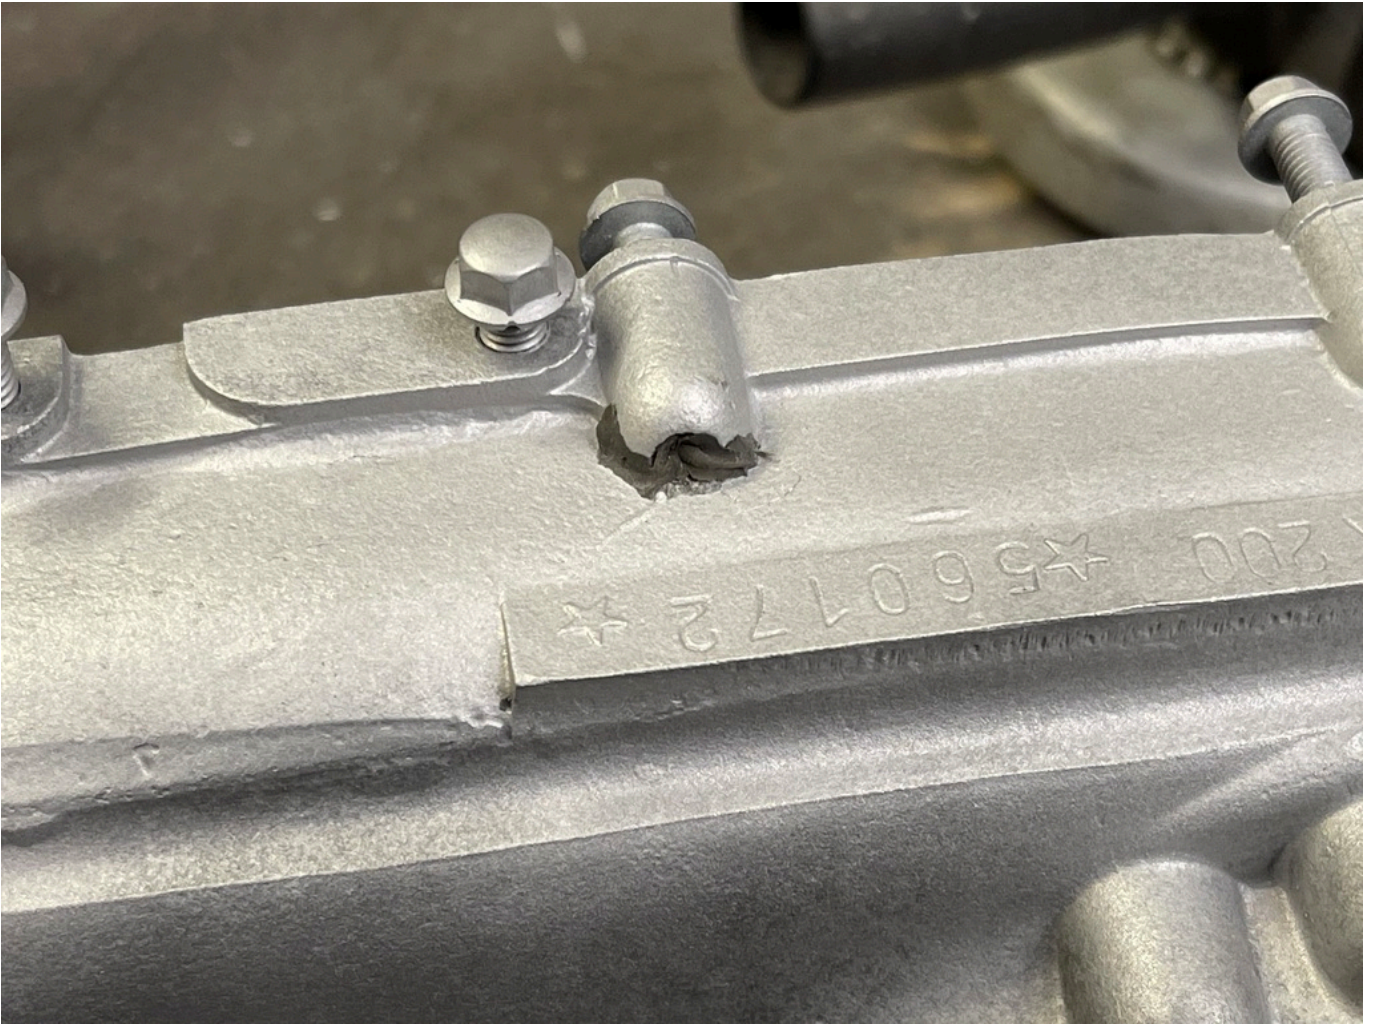
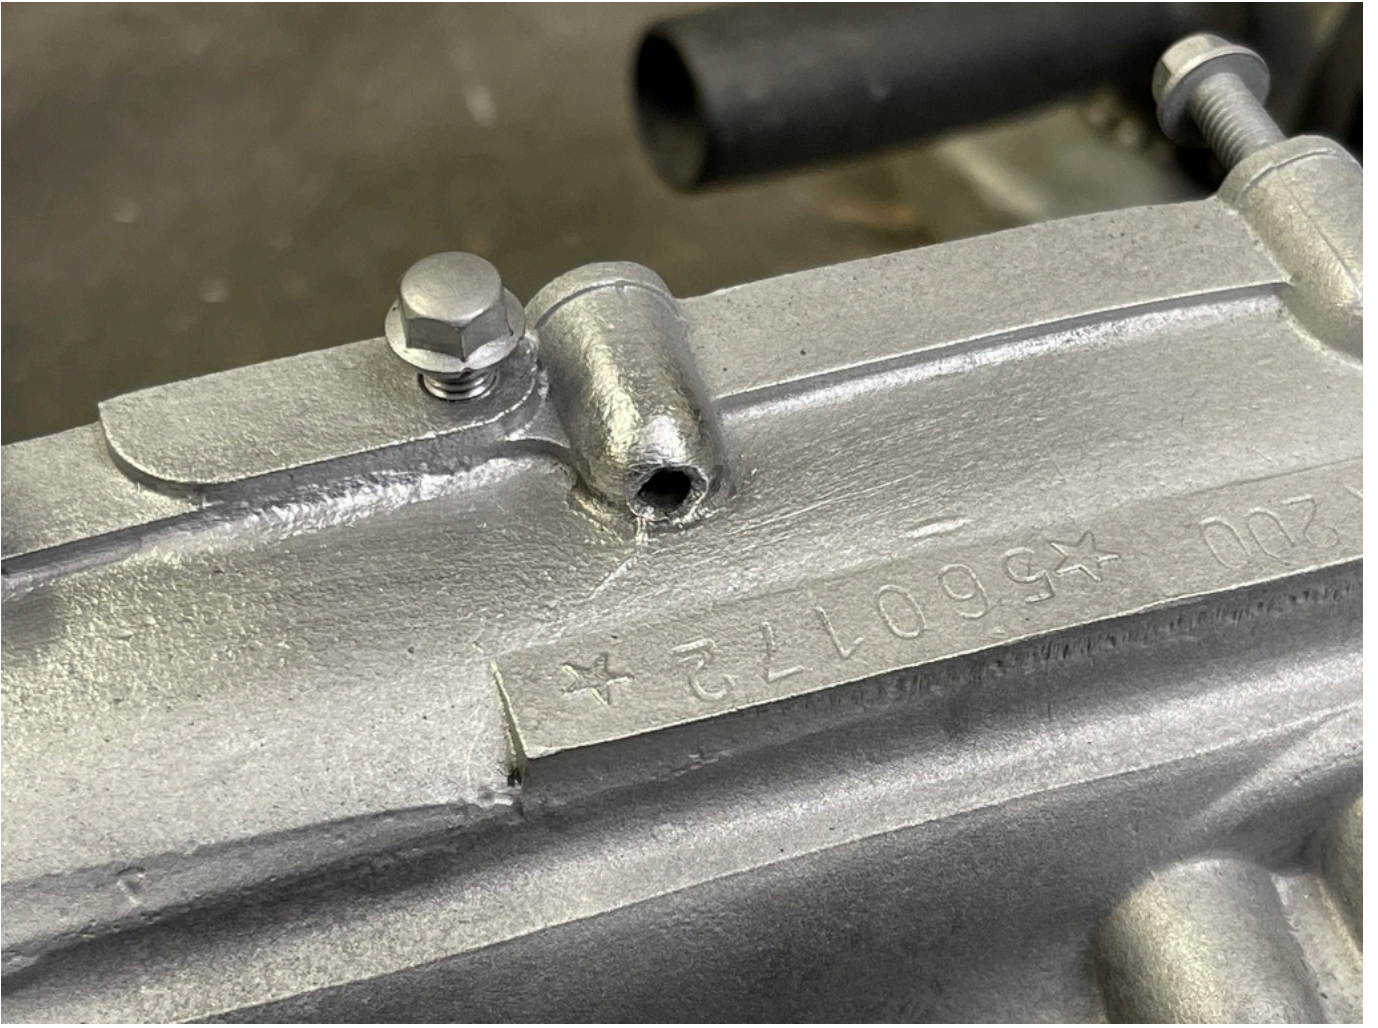
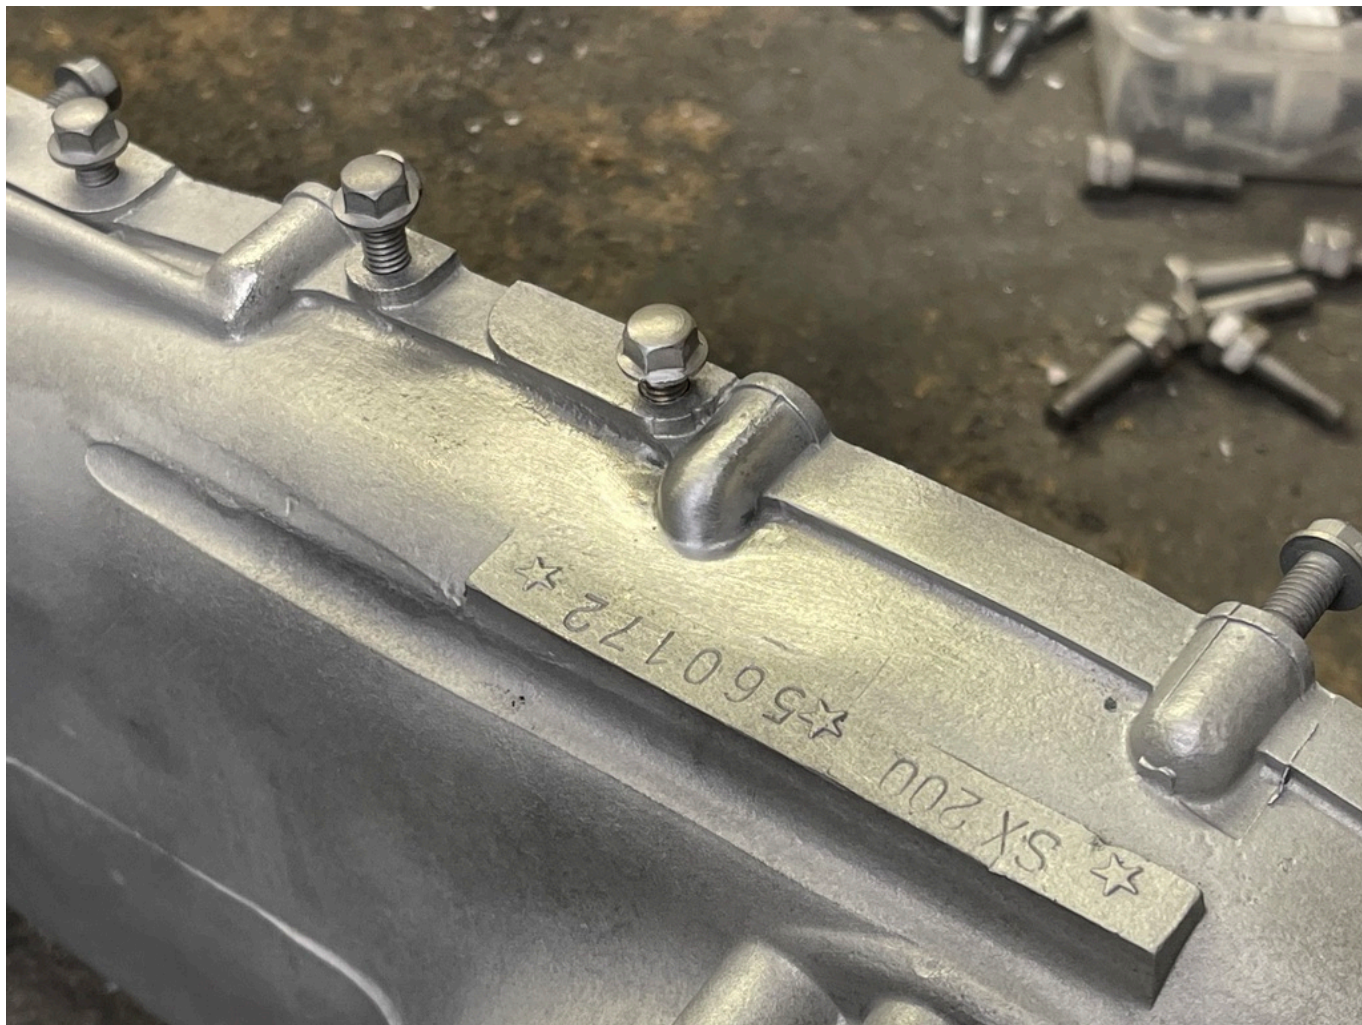
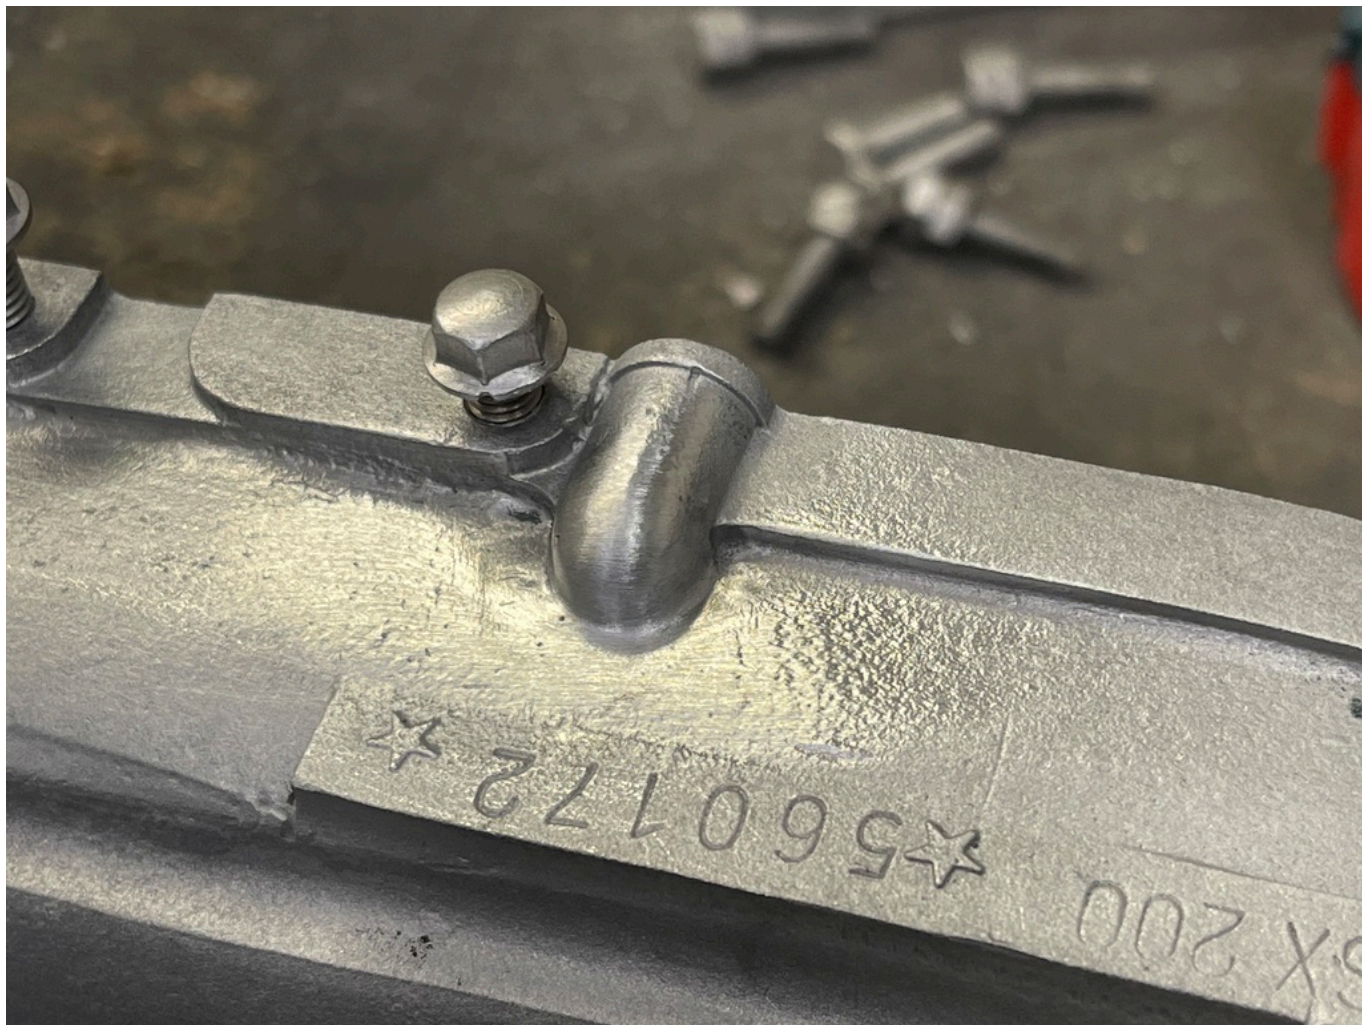
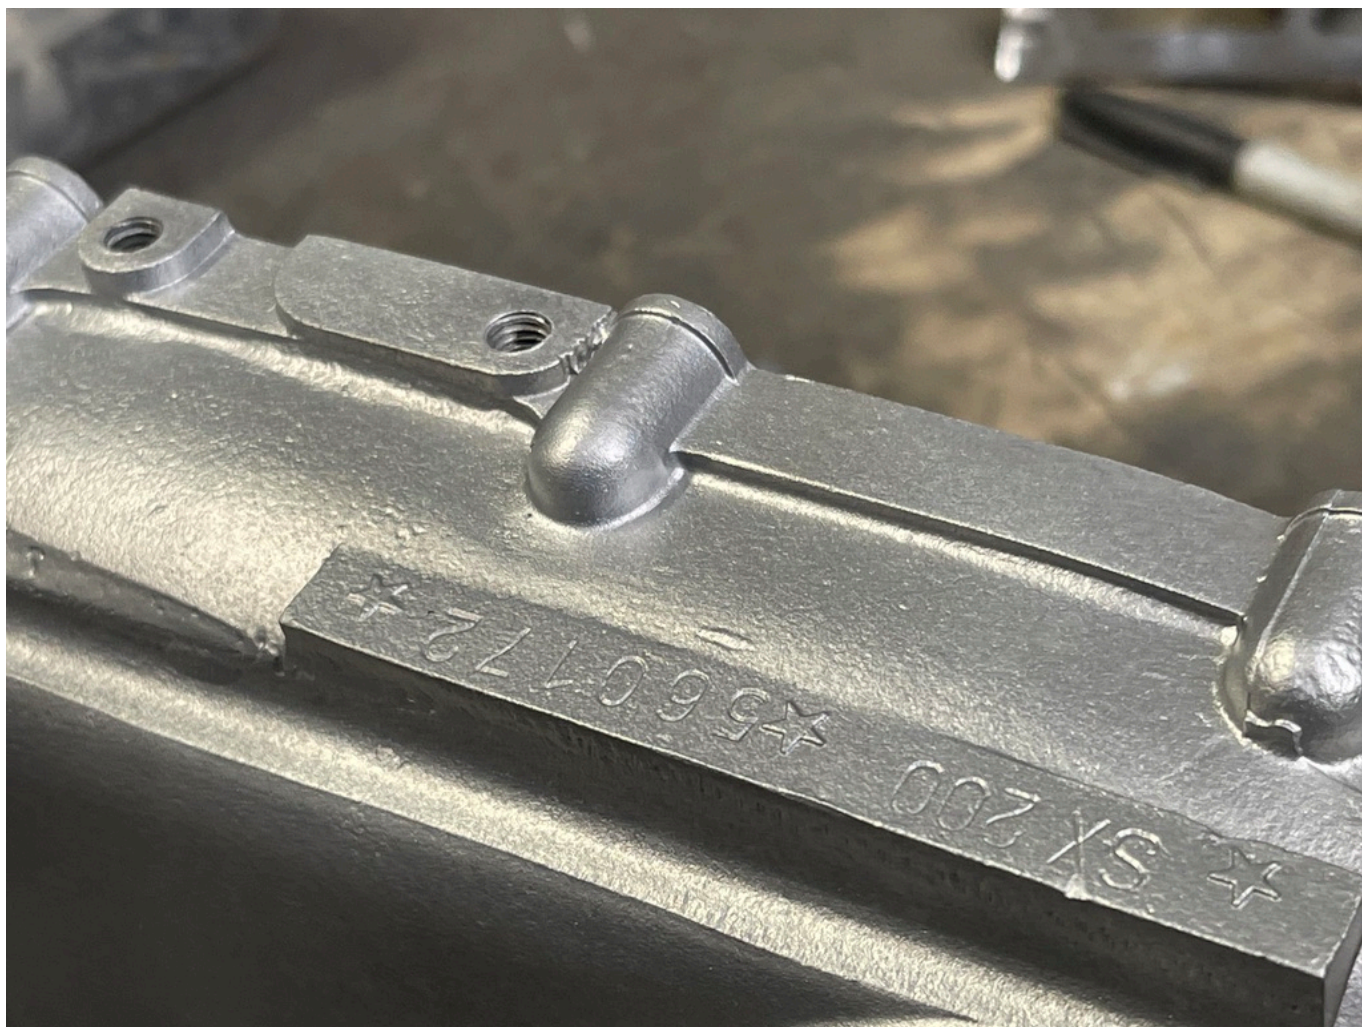
This is when you fit a stud, screw or bolt in a casing where too much grease, oil, loctite or sealer has been fitted in the thread first. You screw in whatever – once the fluids have stopped coming out of the threads they start to compress, at a point pressure is building up and sometimes to a point it is so great it pops out the back of the casing. Some are really easy to do as the casing design is so bad. Others like a cylinder stud can pop out a casing inside where the cylinder spigot goes – leading to a big repair.

Here we have a casing blown out, which was hidden by silicone sealer, it didn't show up with ultra sonic cleaning, or heating and welding – it only showed up when it was bead blasted. What looked like some burnt on stubborn grime just wouldn't blast away as the beads bounce off the silicone!

So out of the blasting cabinet to have a good look and poke about and get ridden of the silicone to see a hole – arghh just as I thought the job was done!

The thread needed cleaning and tapping out, the area where the hole is needs grinding to bare metal so you can weld it up.

Thats the easy bit – its always the same – the hardest bit is grinding and fettling to make it look standard factory after the bead blasting and aqua blasting is done again!

Thats the trick, do it so good that you can not tell theres a repair!
