Engine – Repair Tv200

WELL YOU DON'T SEE THIS EVERY DAY

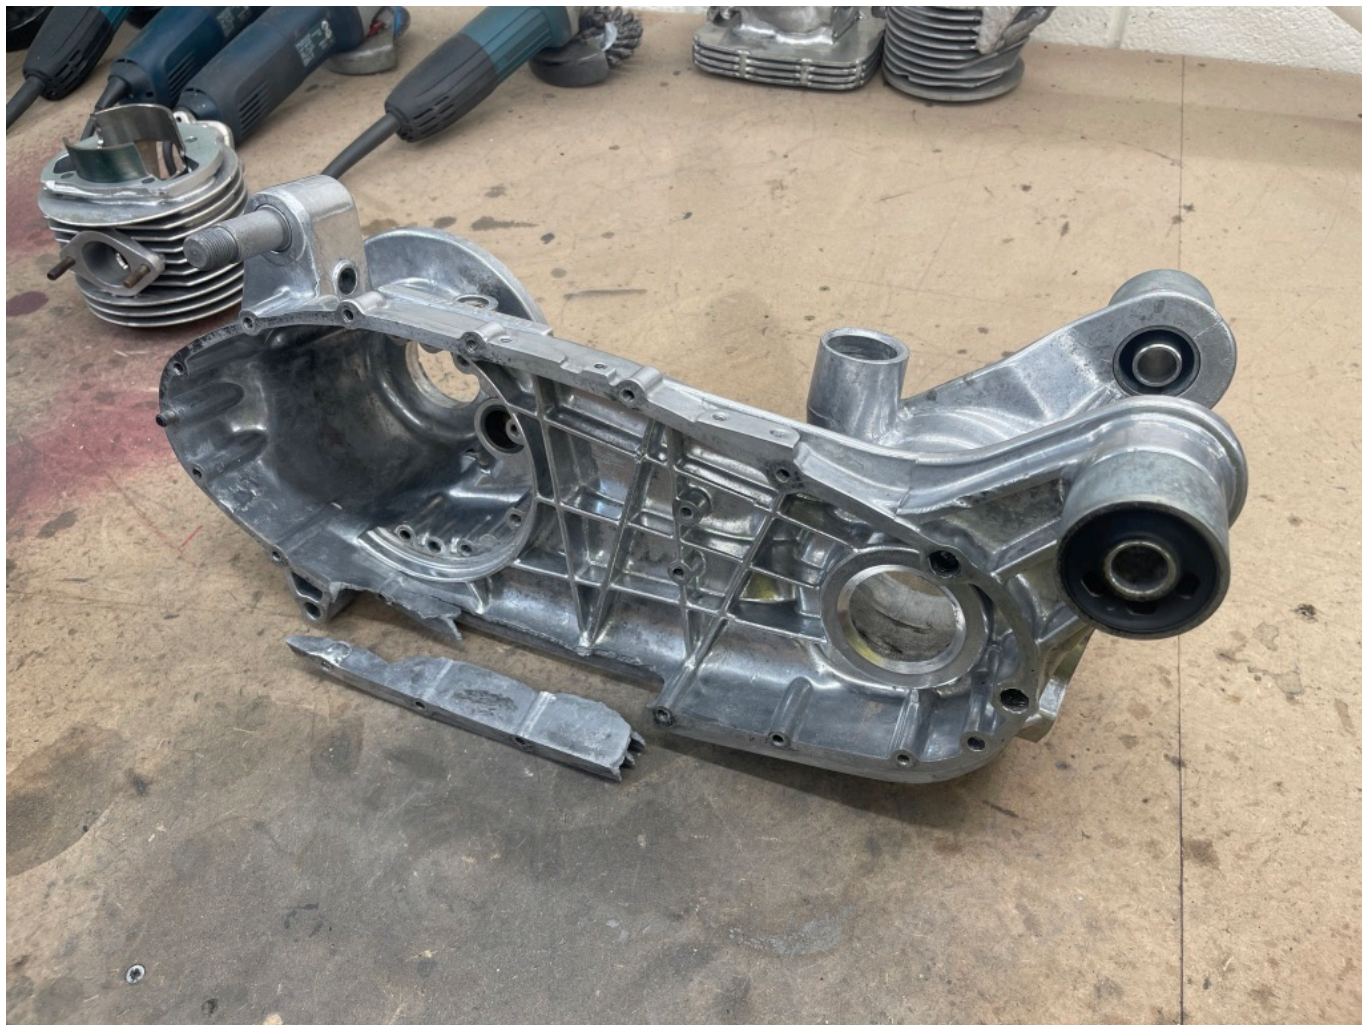
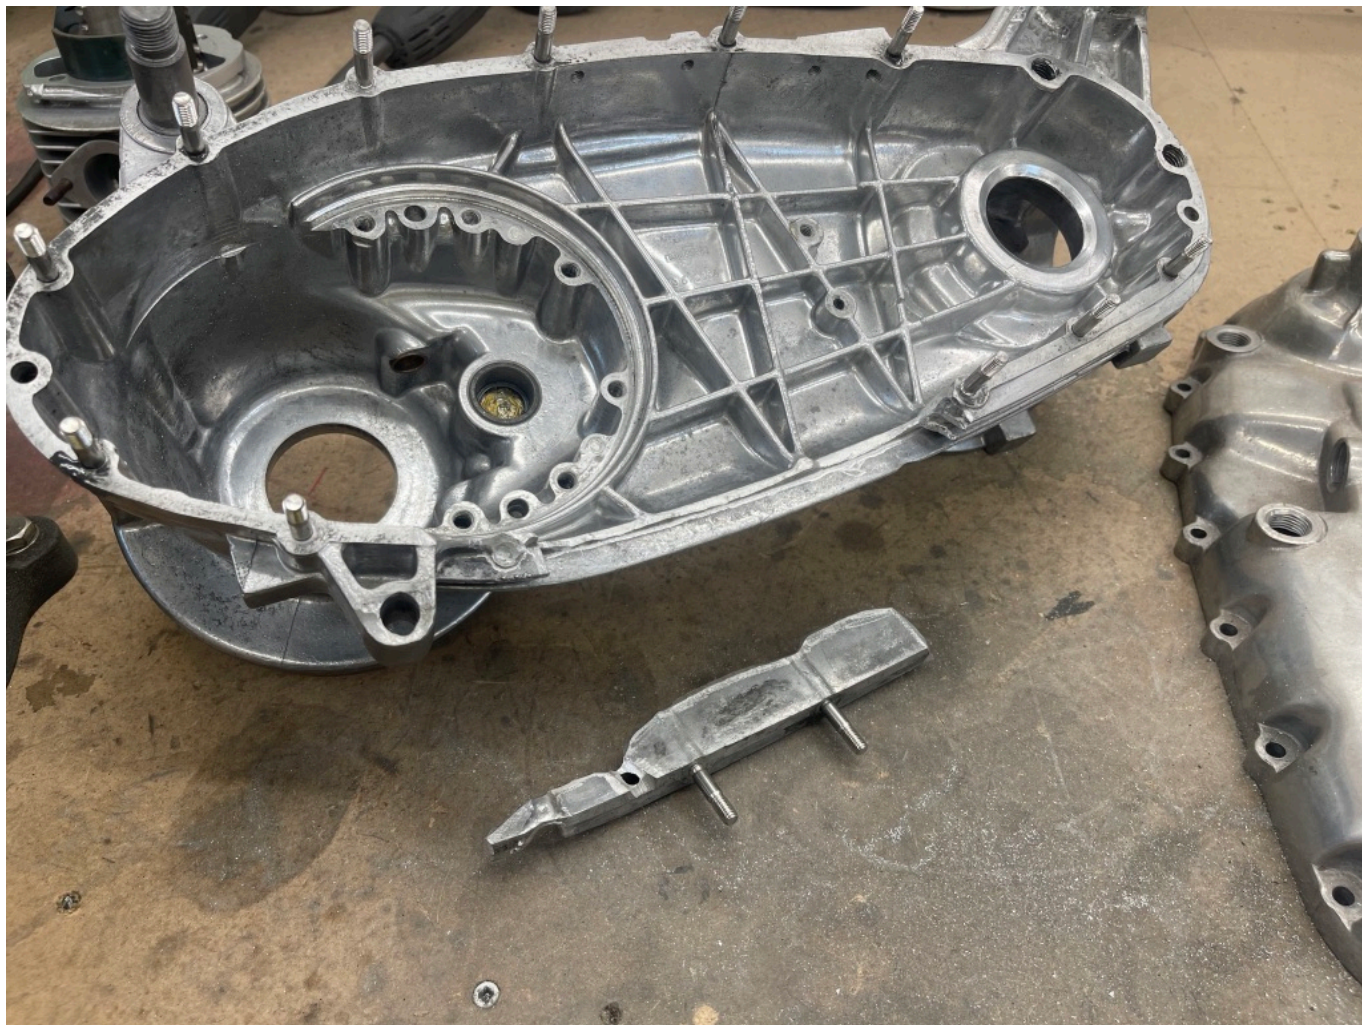
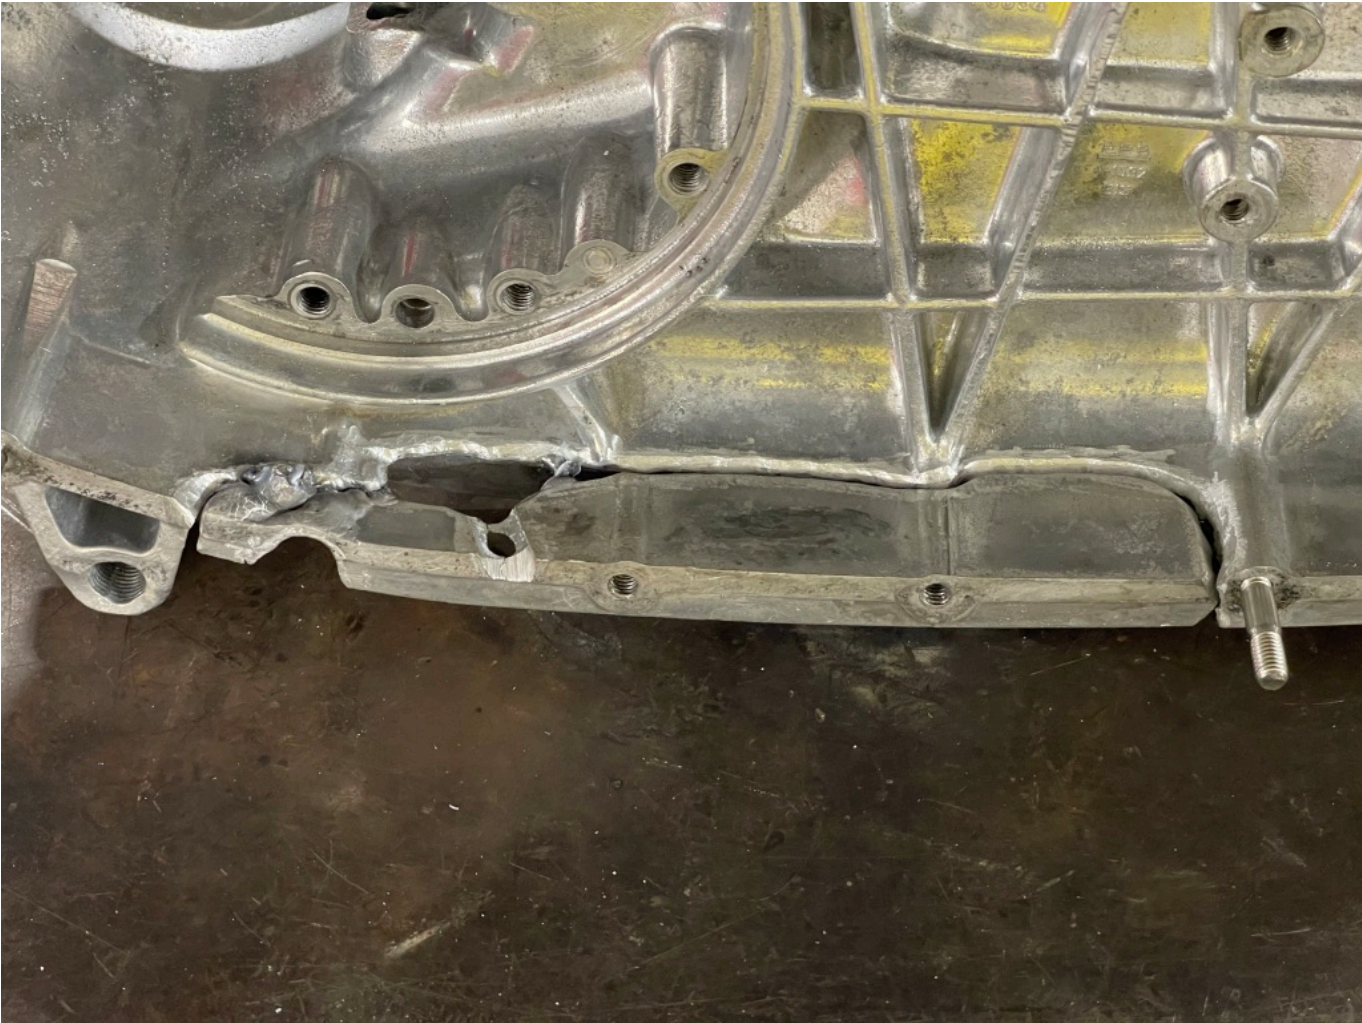
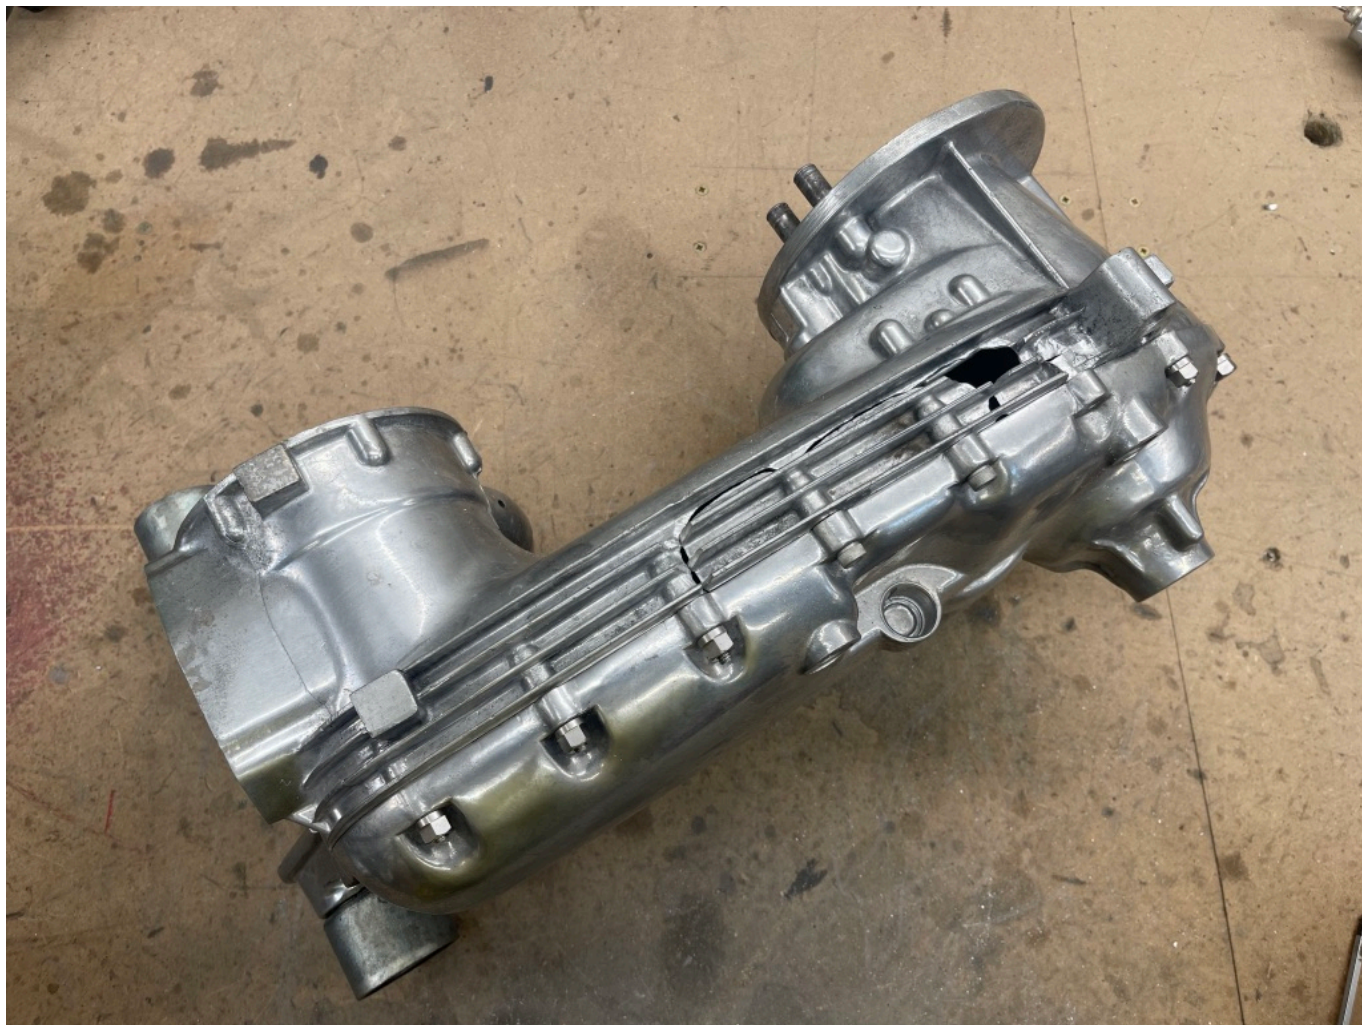
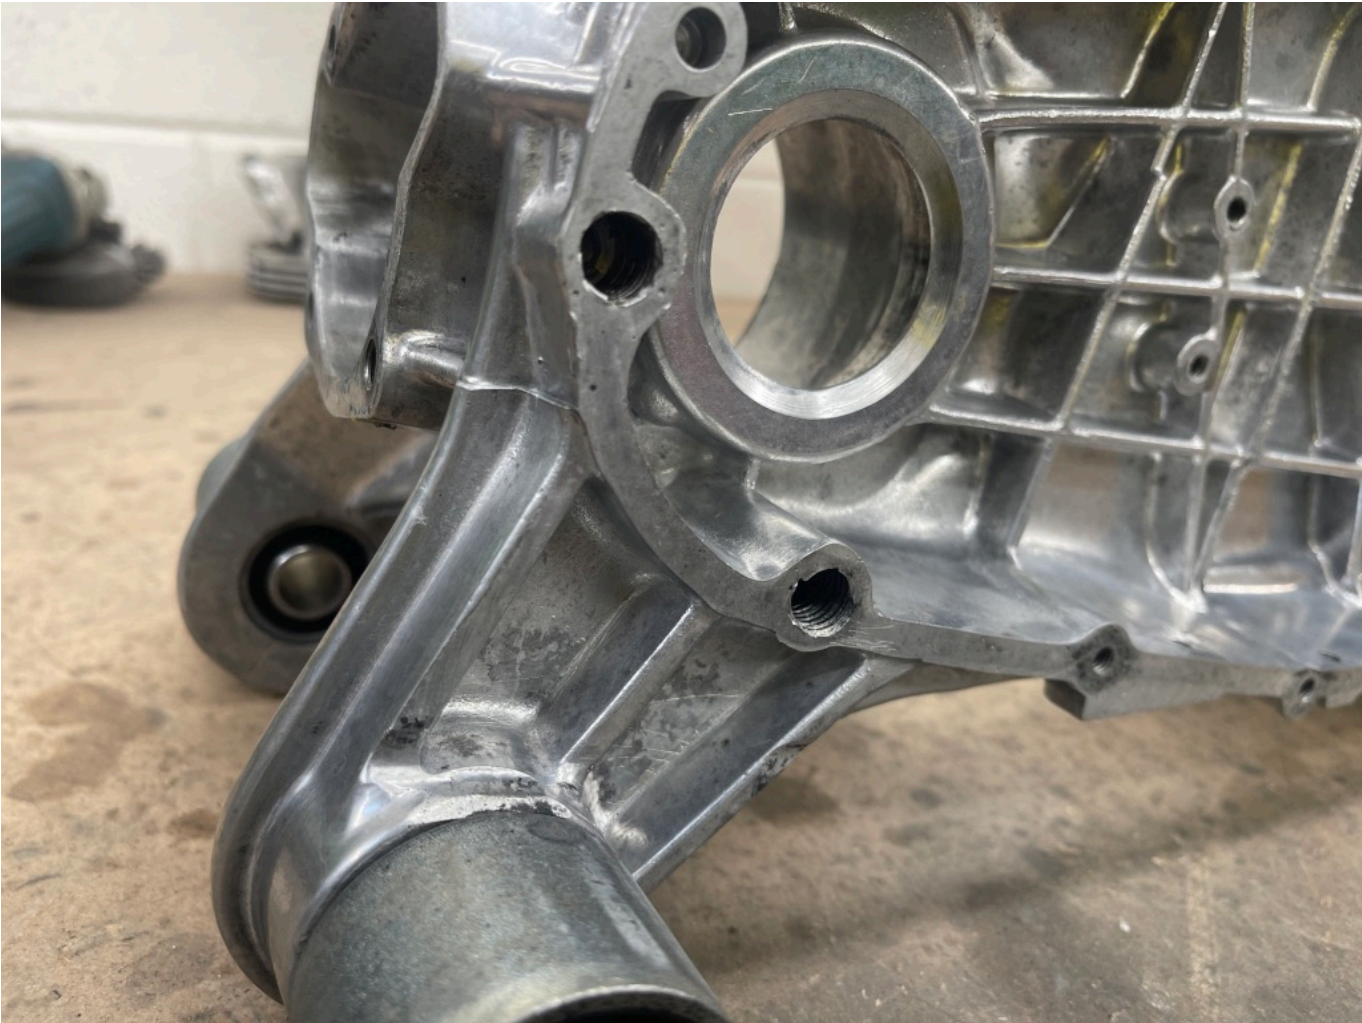
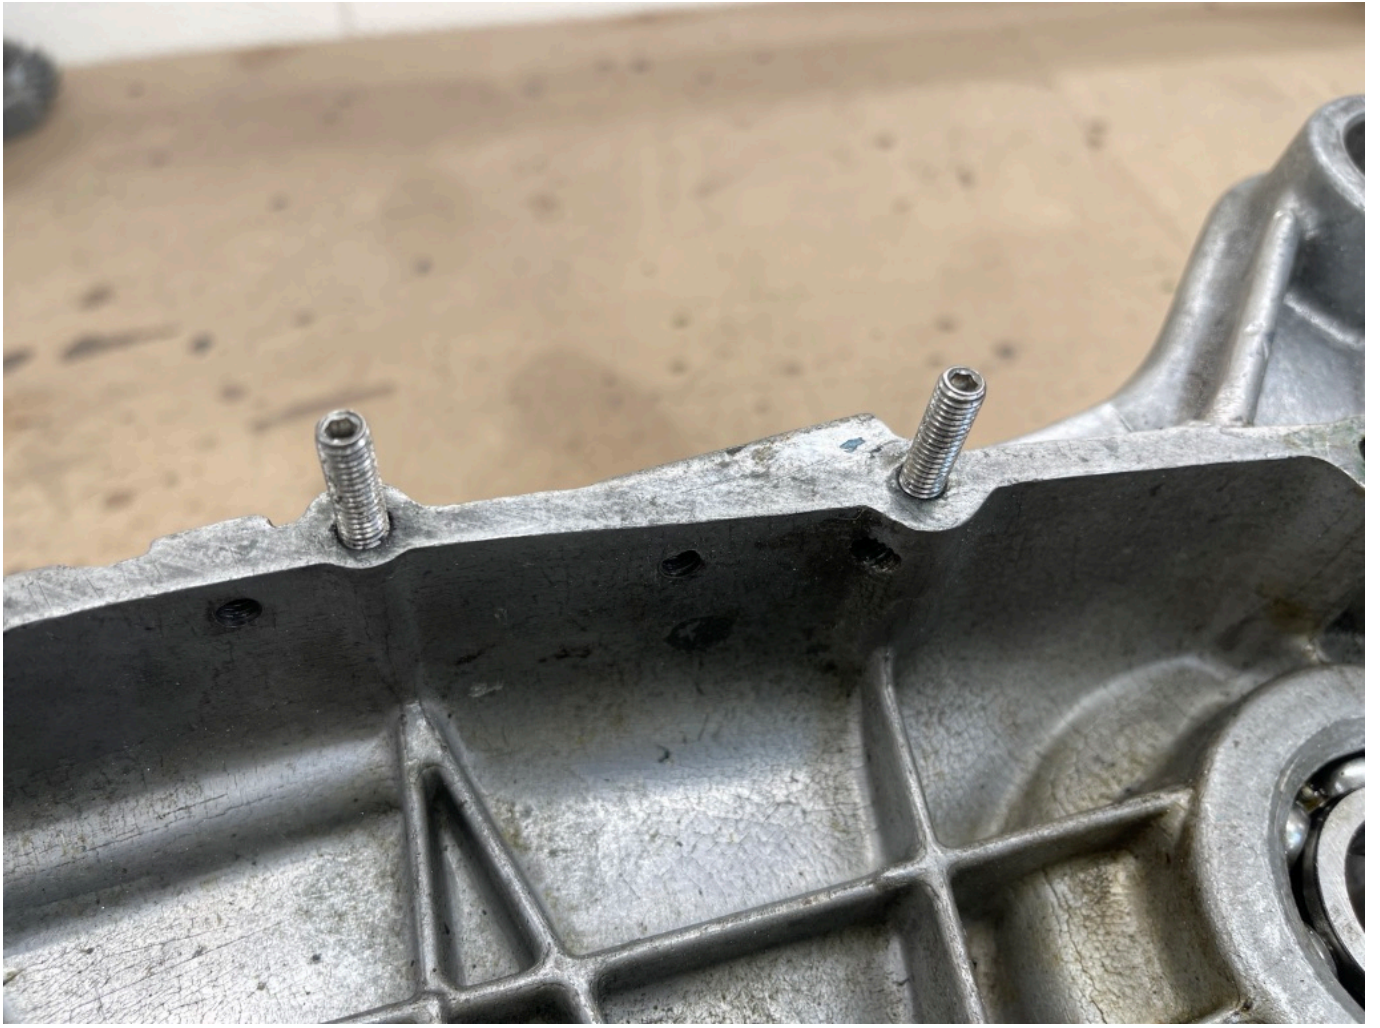
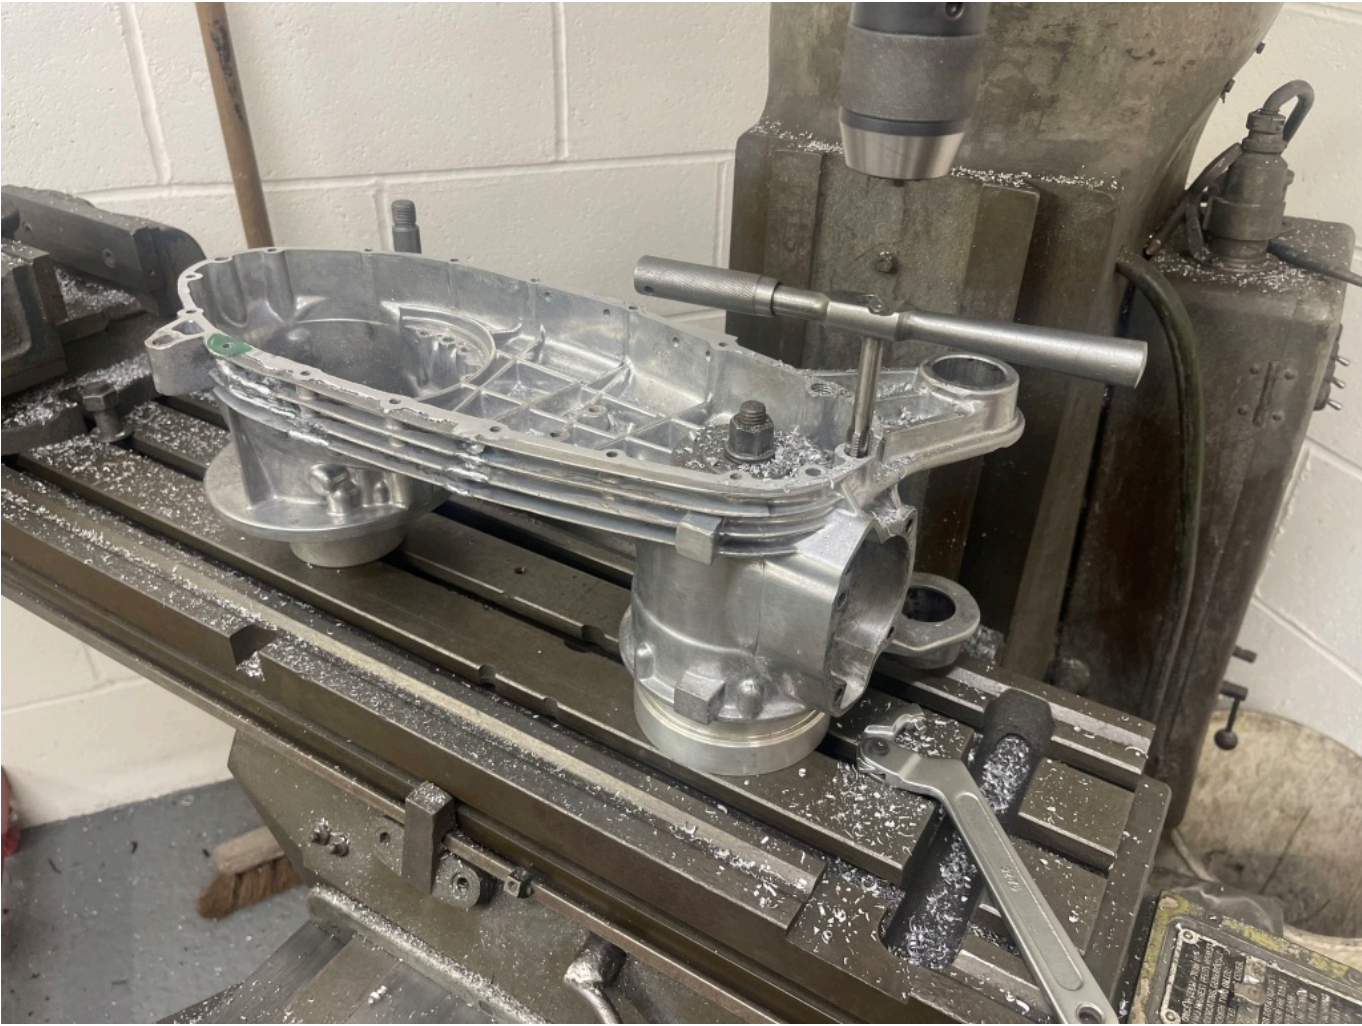
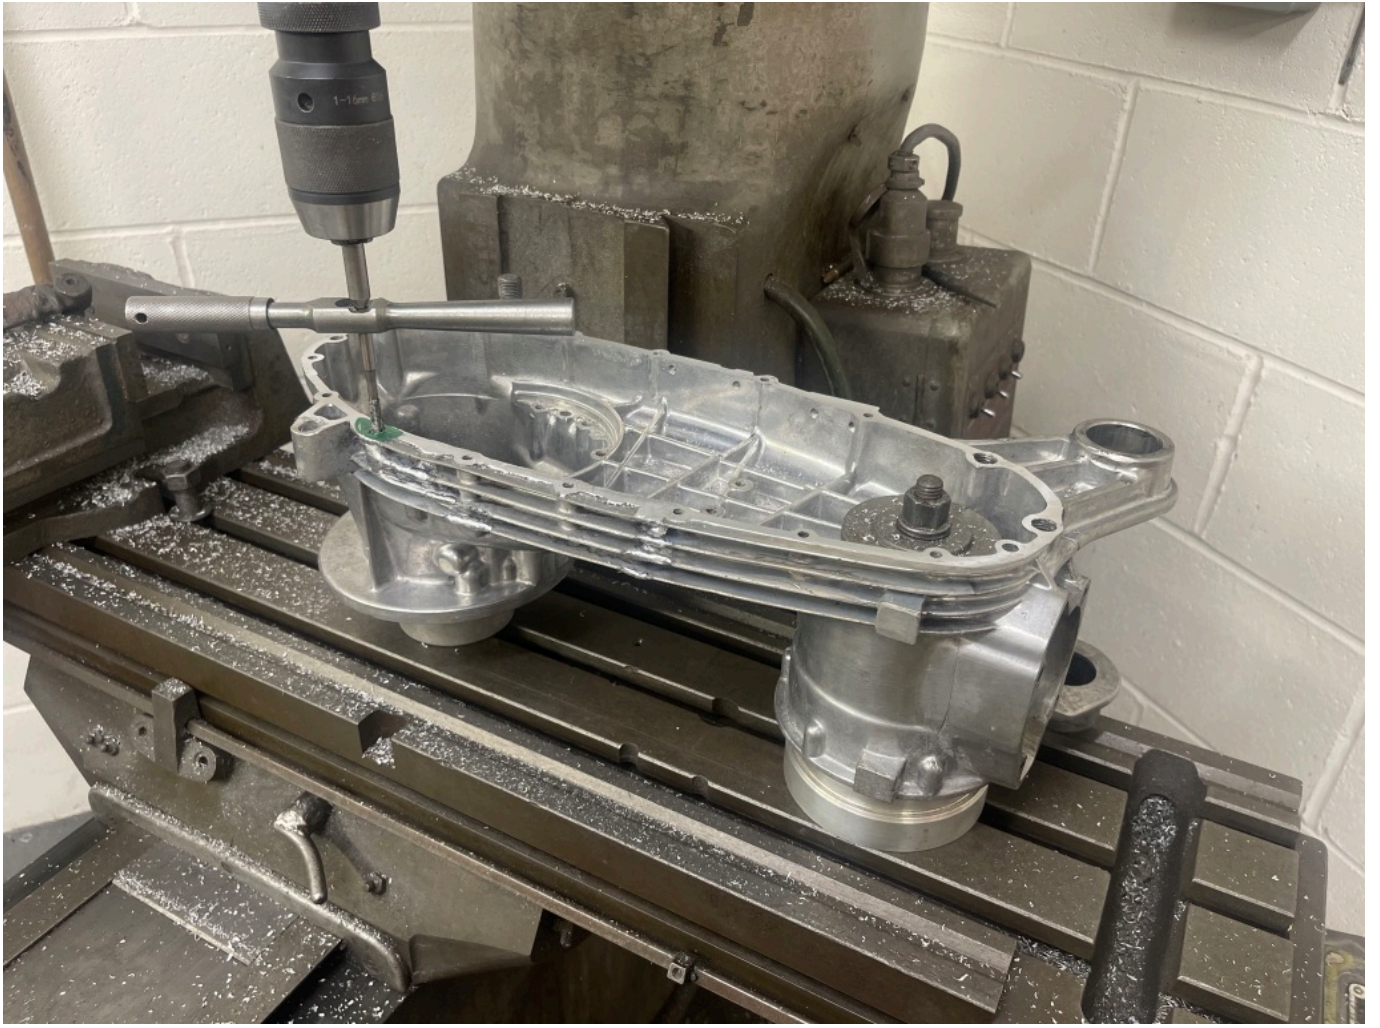
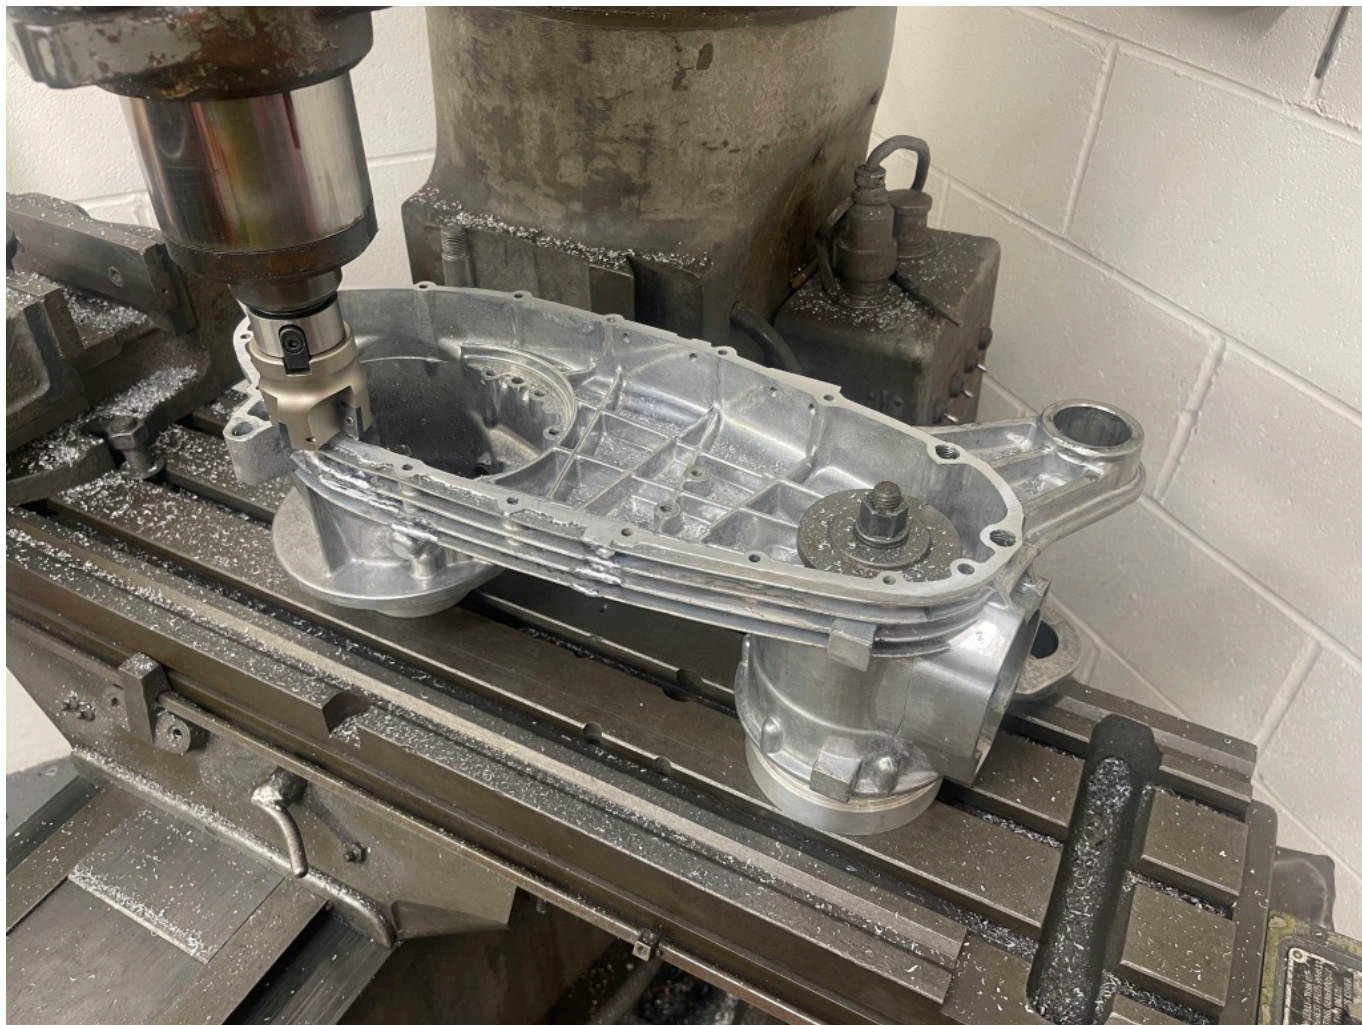
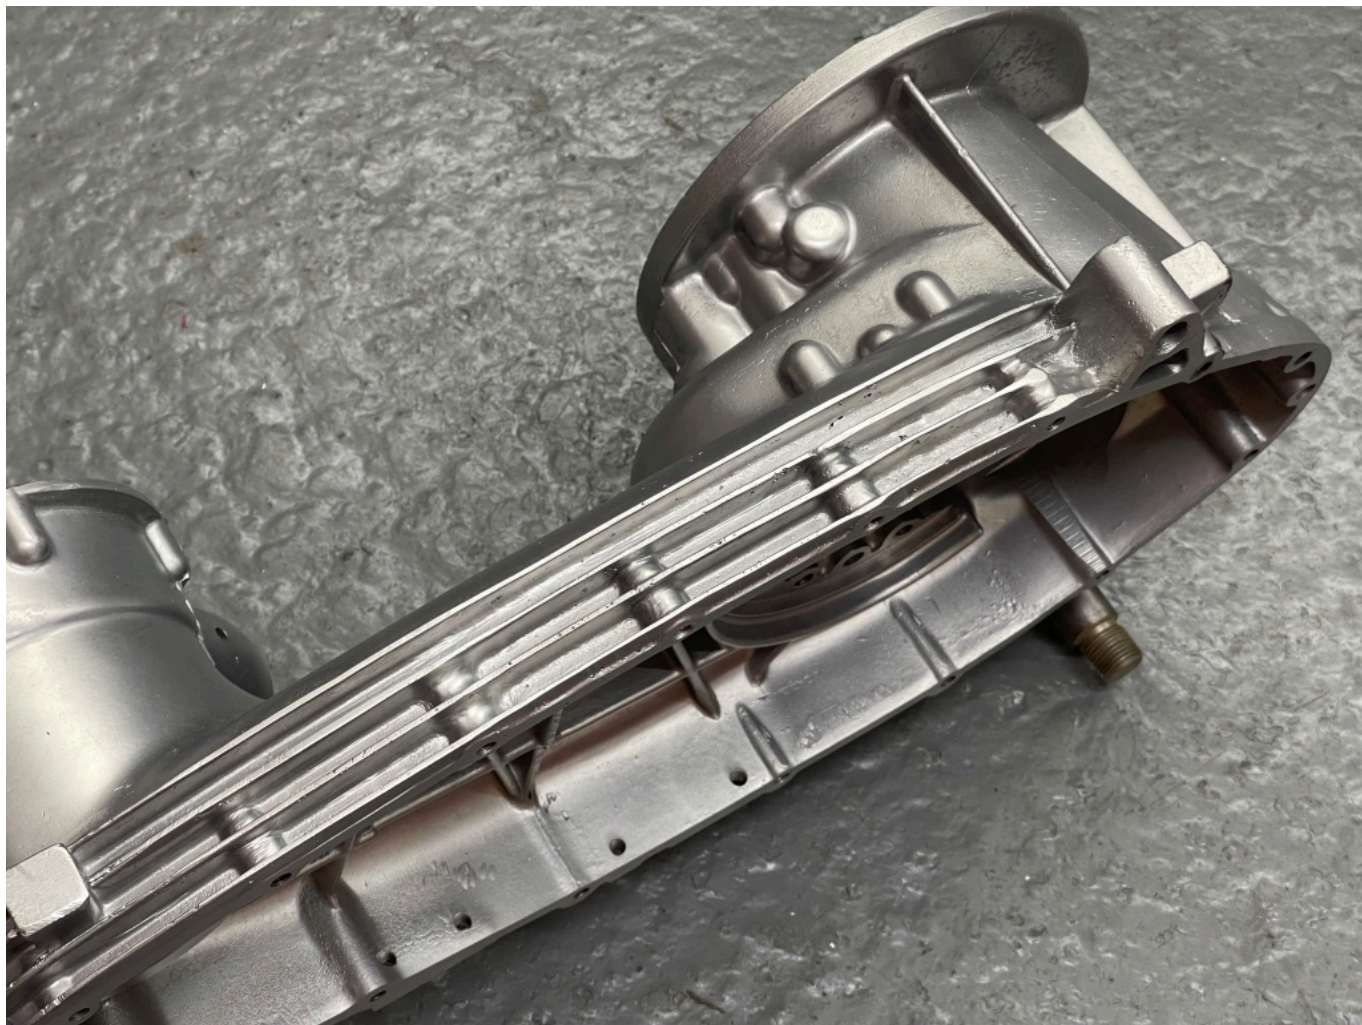
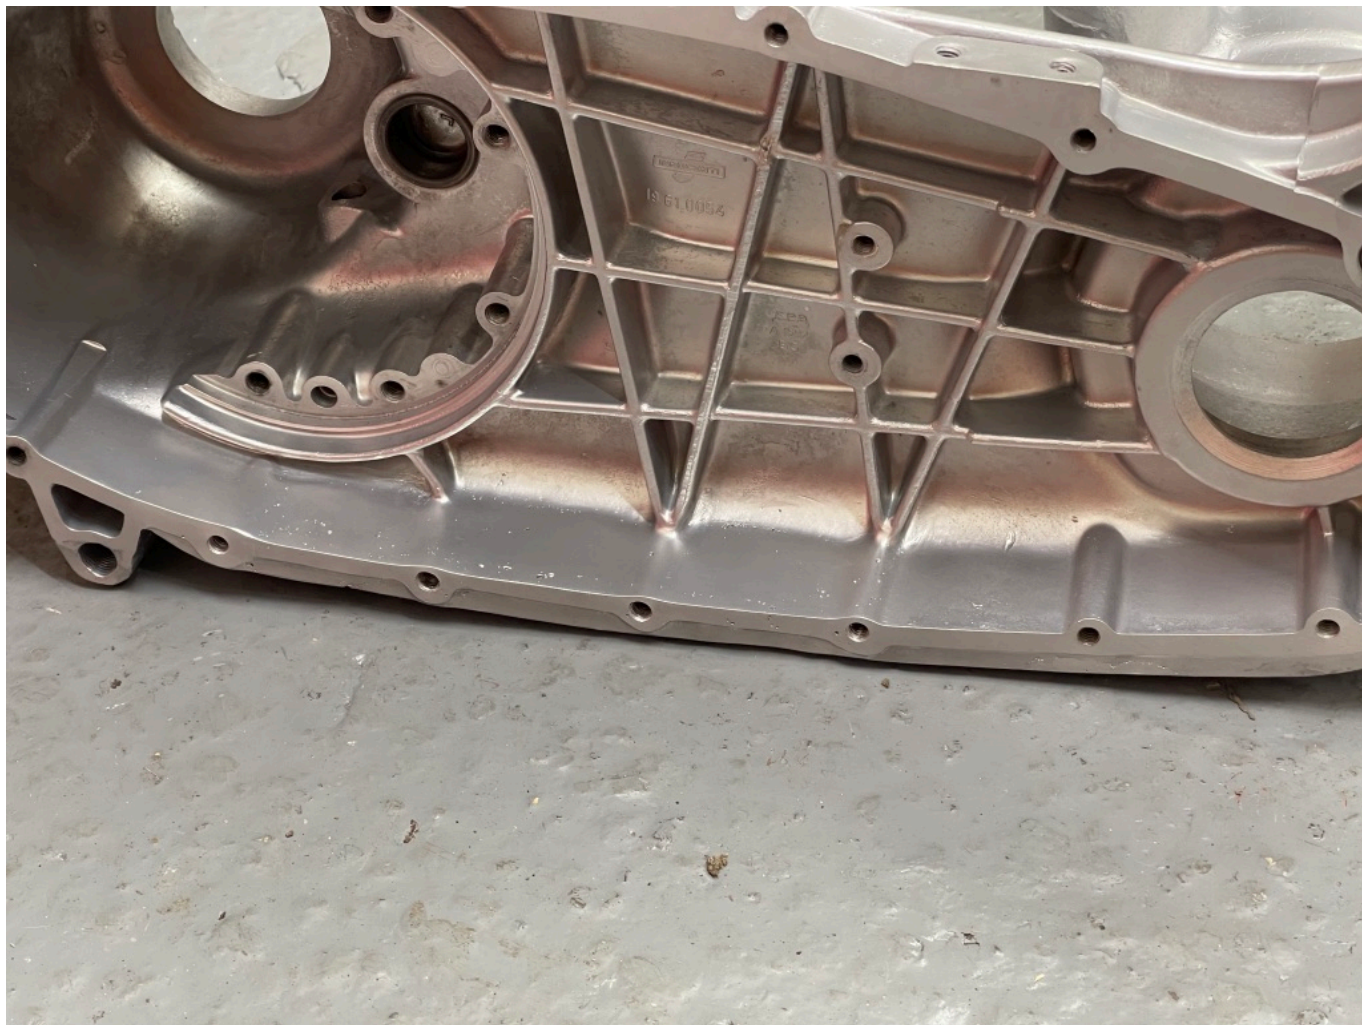
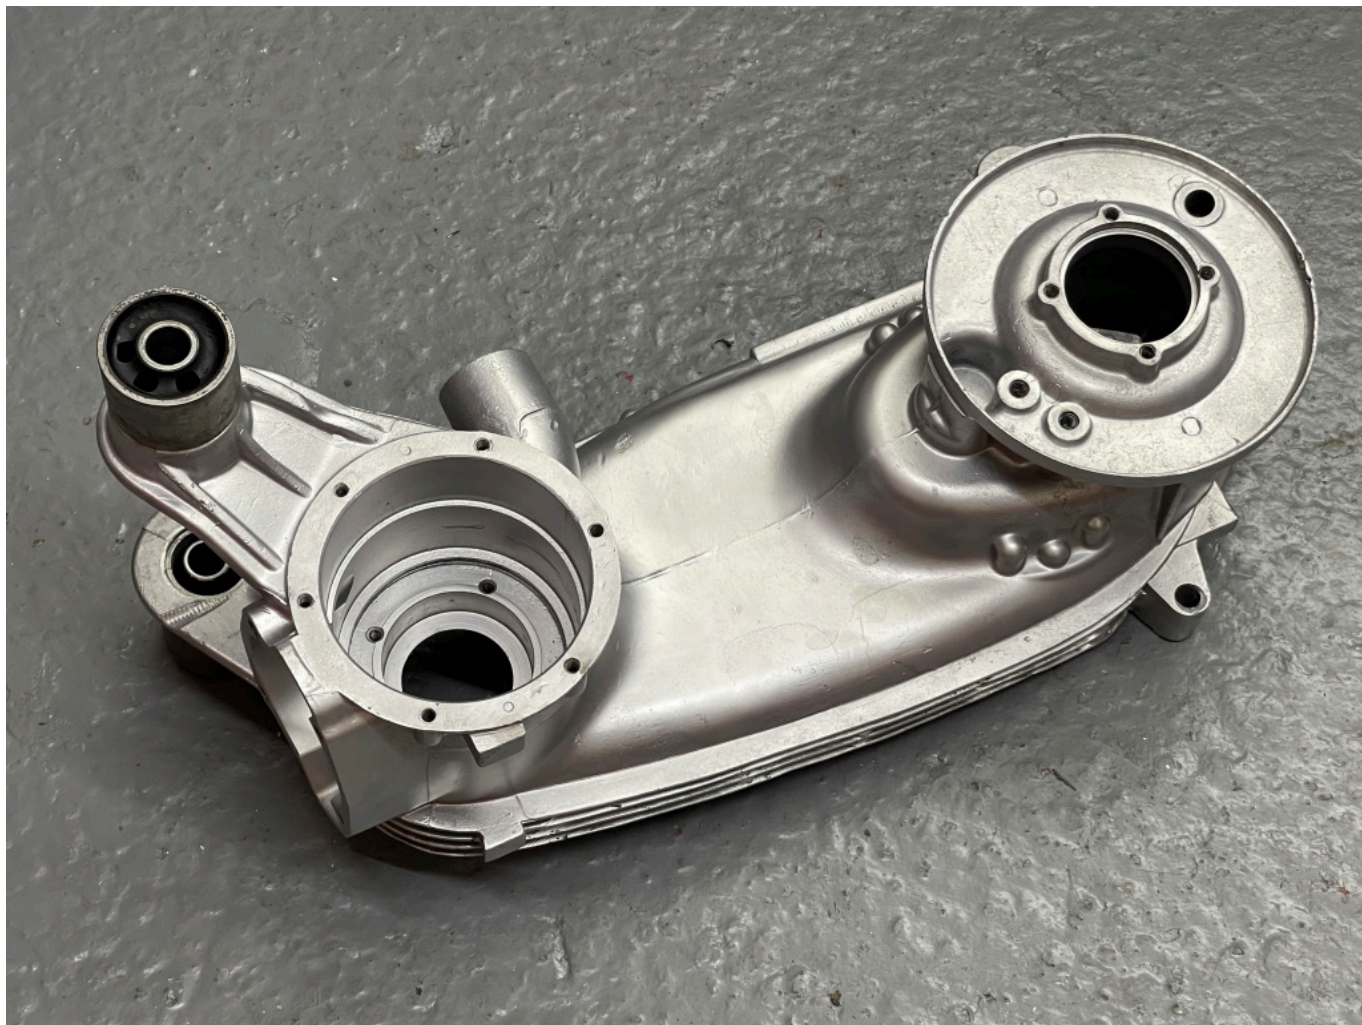
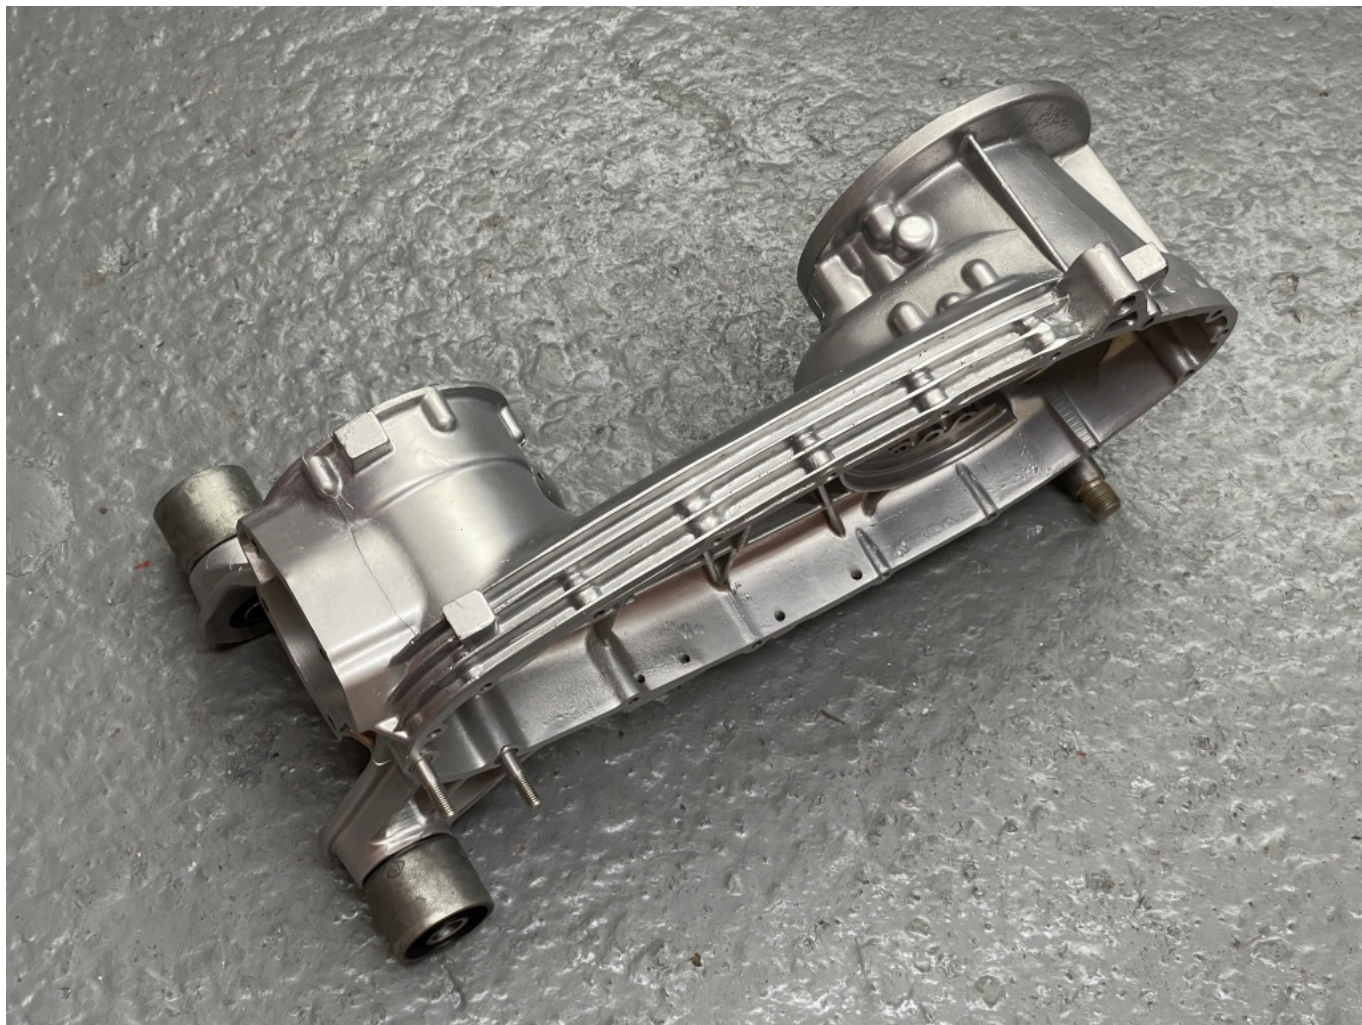
Well it's a bit of a mystery, the customer had no idea but under close inspection I think it comes down to those horrible threaded studs that people are using these days. I hate them with a passion! Casings vary in thread depths, some, even new ones vary in different depths around the casing. If you fit these silly studs the heights are all going to be different, with some with loads of threads stuck out, some fine and some maybe with threads under the nut. Then crud gets into the little allen cap head meaning it a pain to clean out to remove them. Then you've the issue of they are threaded all the way down, gripping the casing on fitting and removing and then the issue with the gaskets catching – for me what is wrong with a good old nice and neat stronger stud with a straight un machined section that locks in the same place and all the nuts look nice and neat at the same heights.

What I think happened – was there was a bad repair with an alloy thread insert which was welded but left a void under the thread, then when the silly stud was fitted maybe a little bit too tight it pulled the thread insert and the lower part of the casing came away.

It's a shame really the casing is absolutely mint, there was only one thread repair and a couple of previous repairs, the rest of the threads were as factory! Apart from the swan neck holes were very oversized so I fitted a pair of MB stepped studs.

So with some grinding, shaping, welding, machining, grinding and more shaping then finally cleaned up with bead and aqua blasting the casing is back like new.
