Engine – Repair transfer crack

THIS IS A COMMON REPAIR

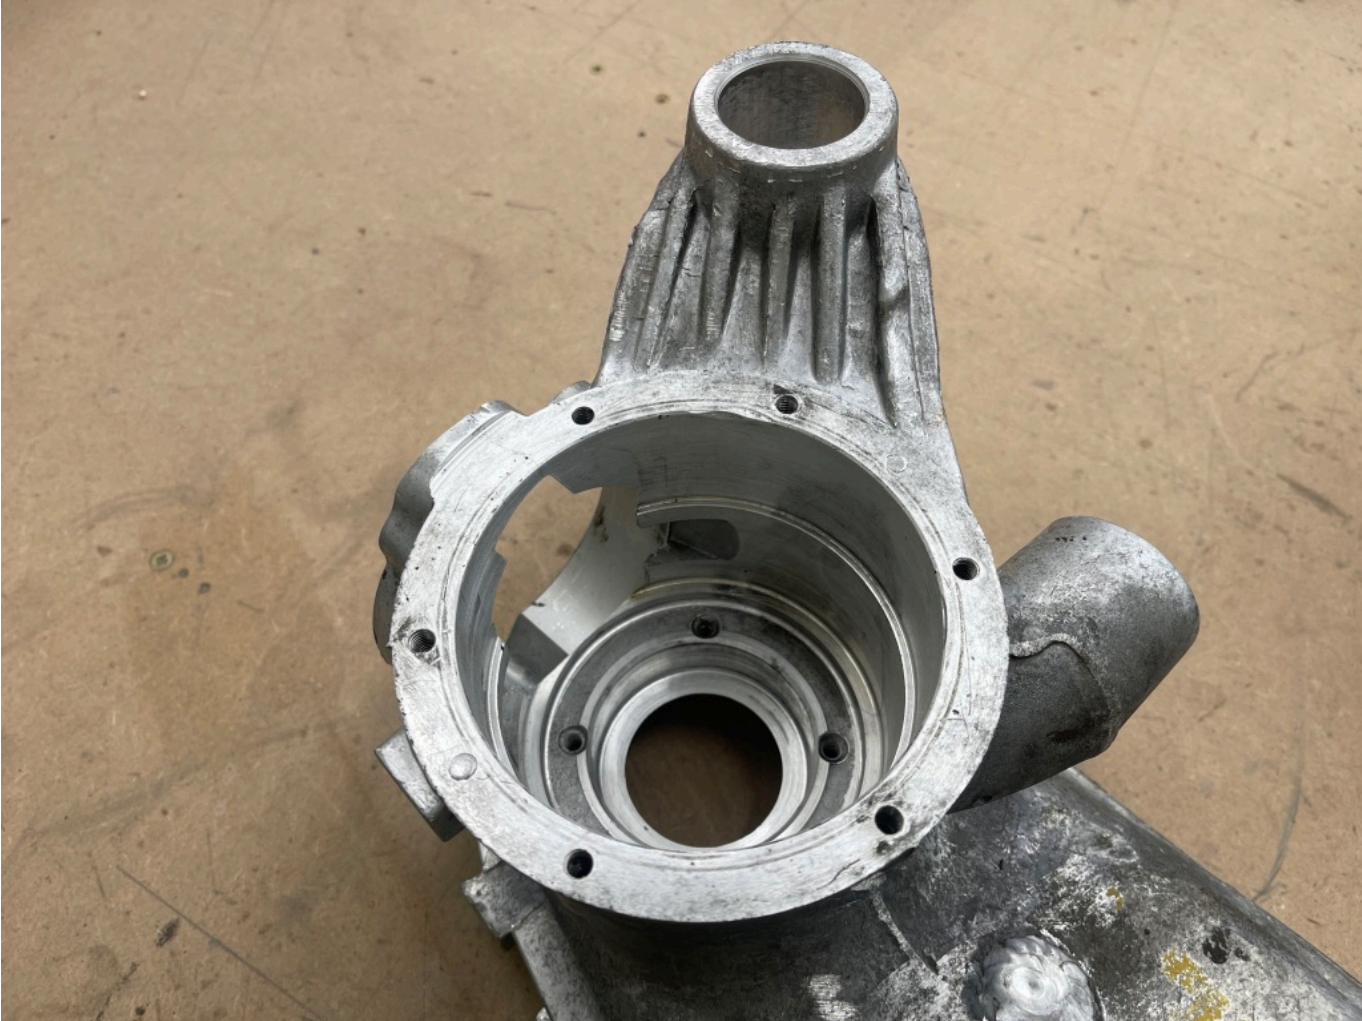
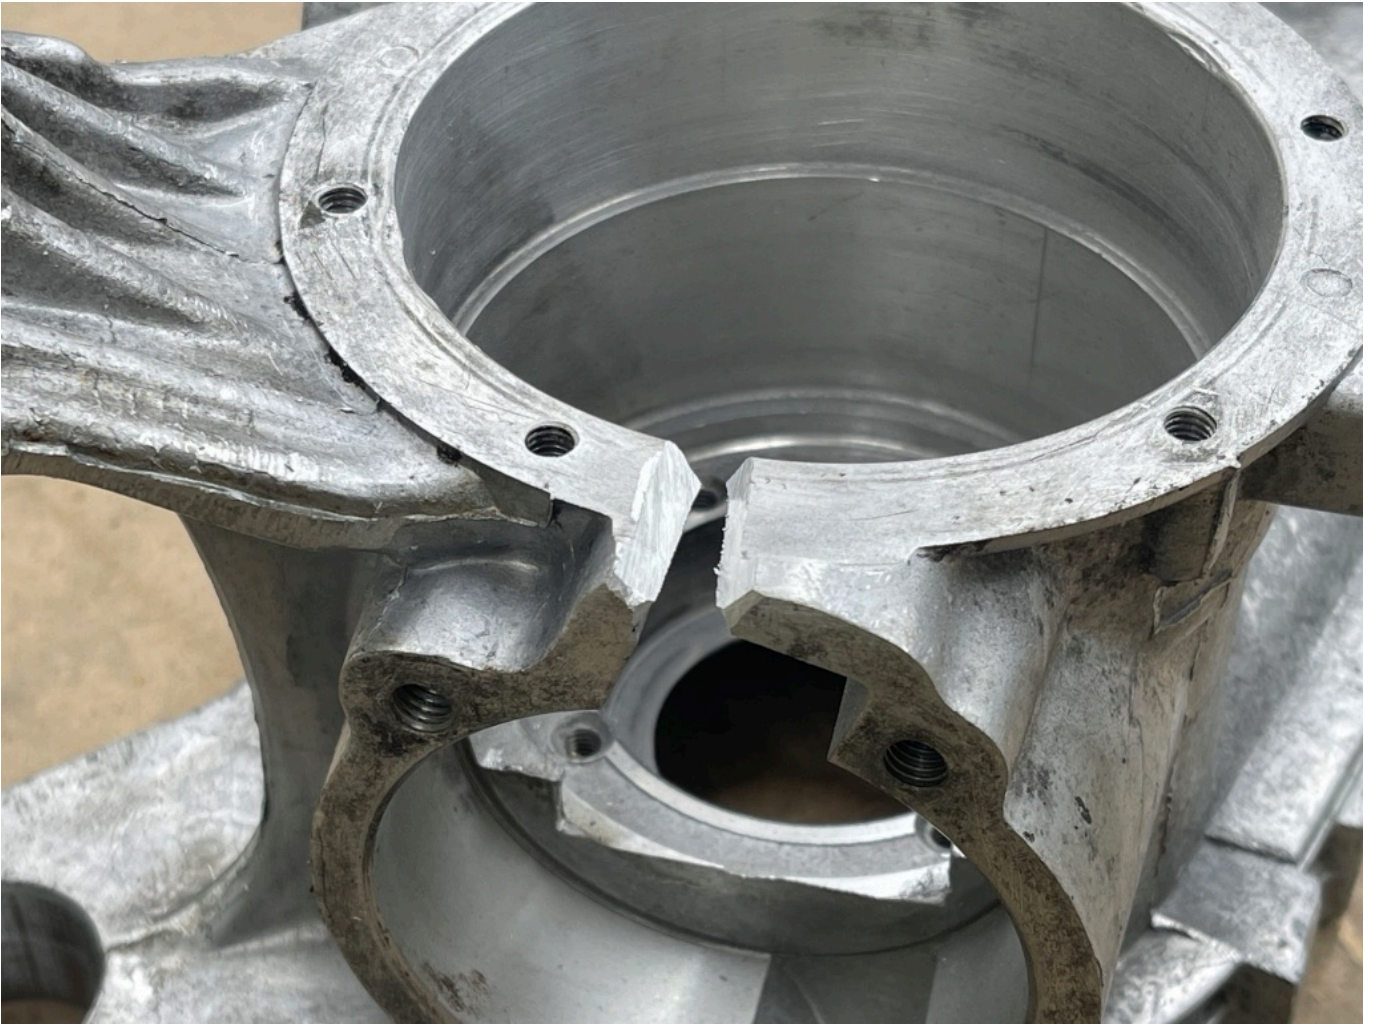
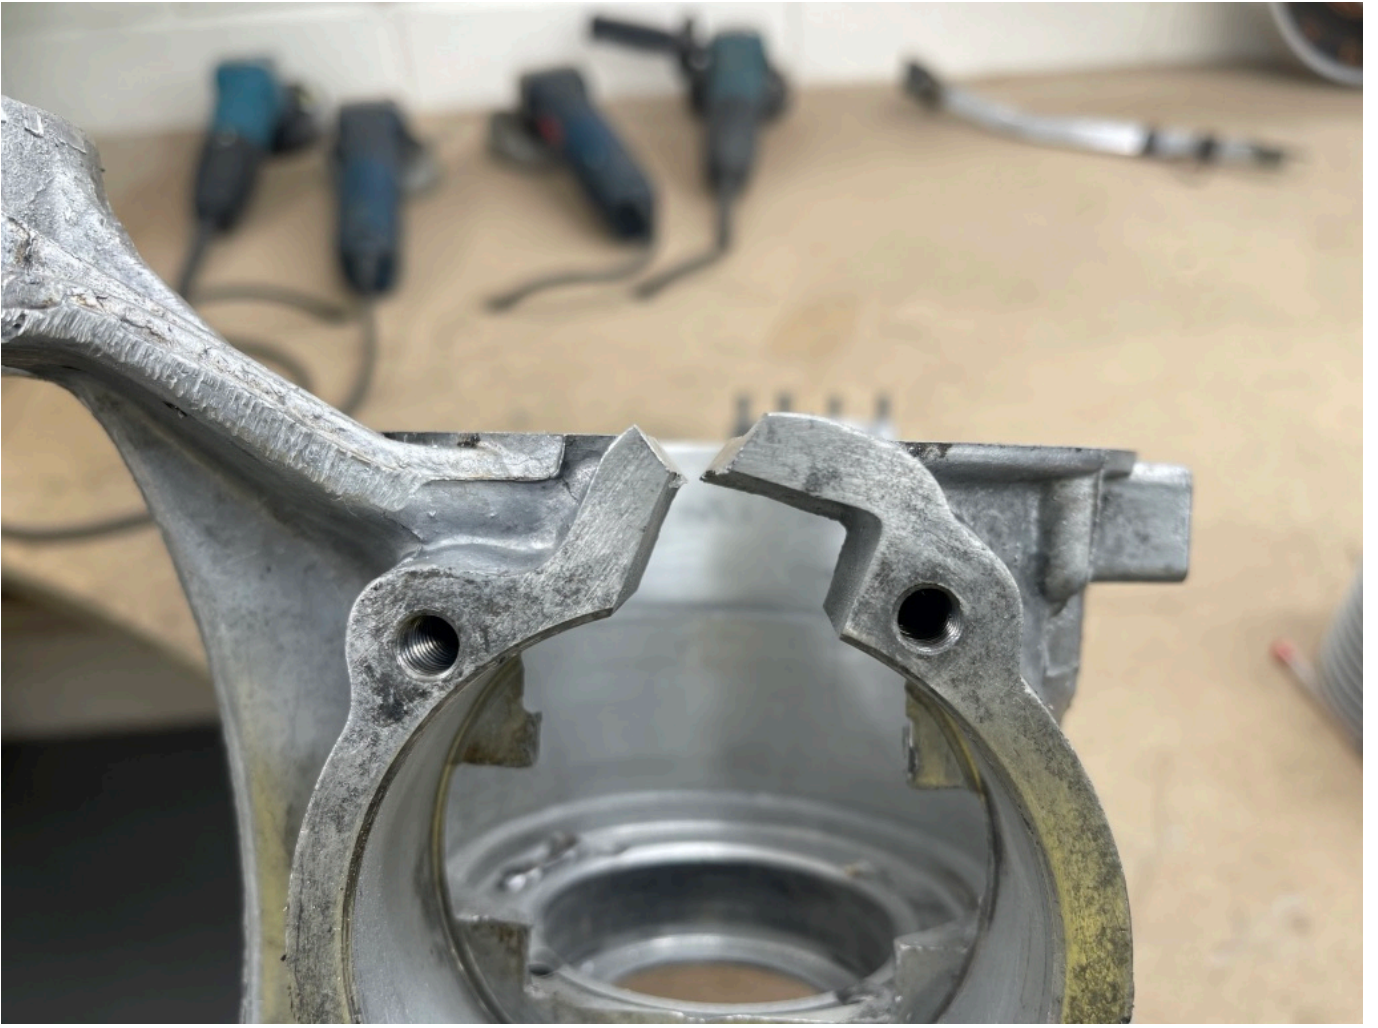
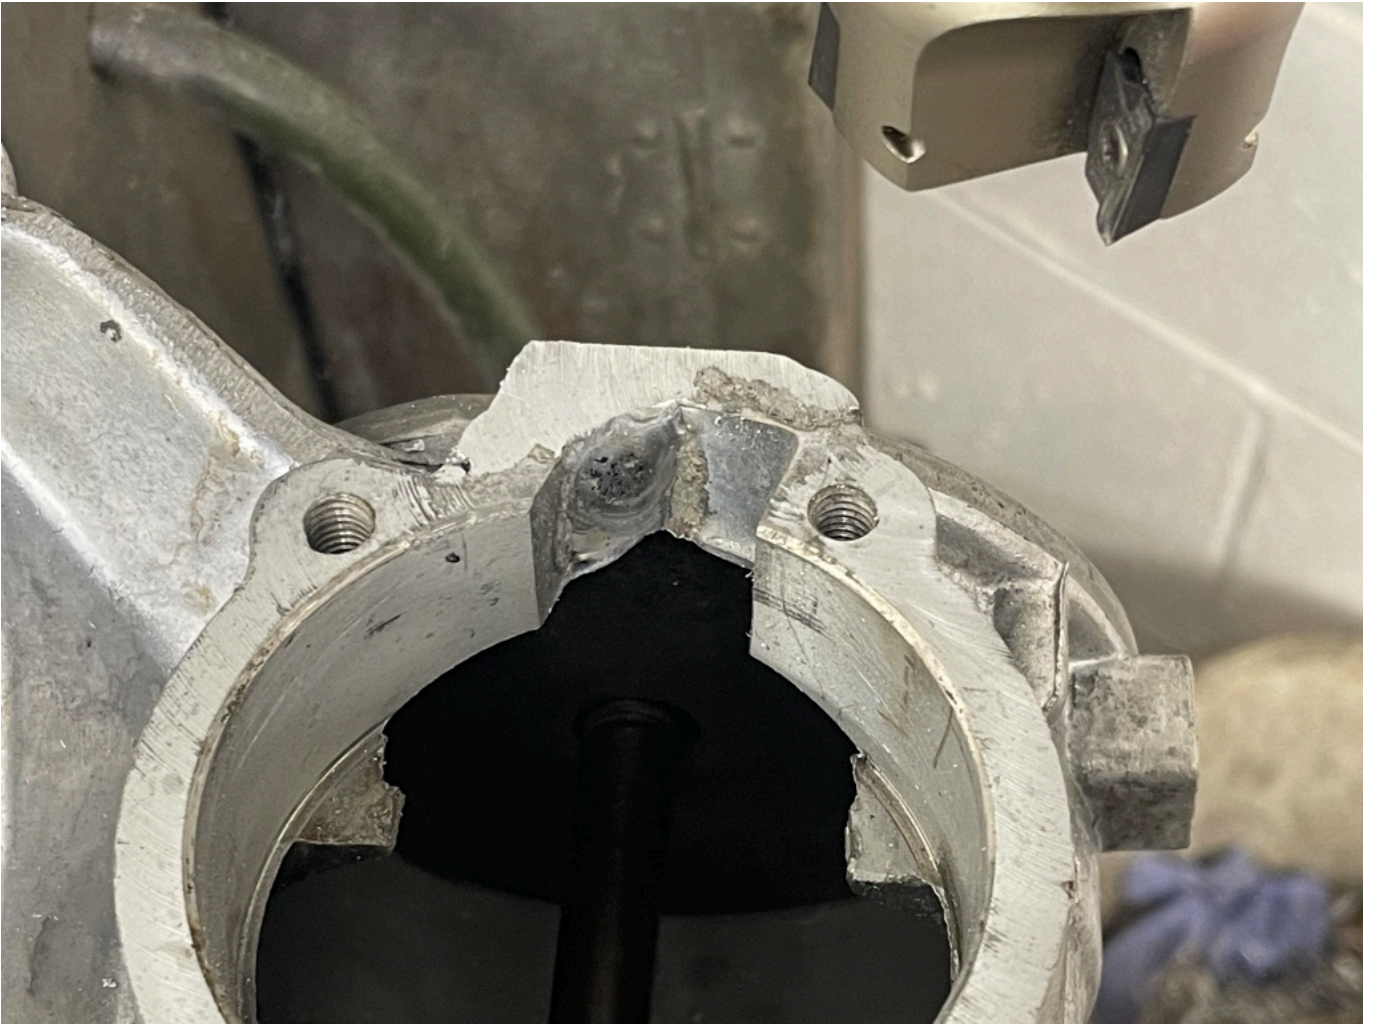
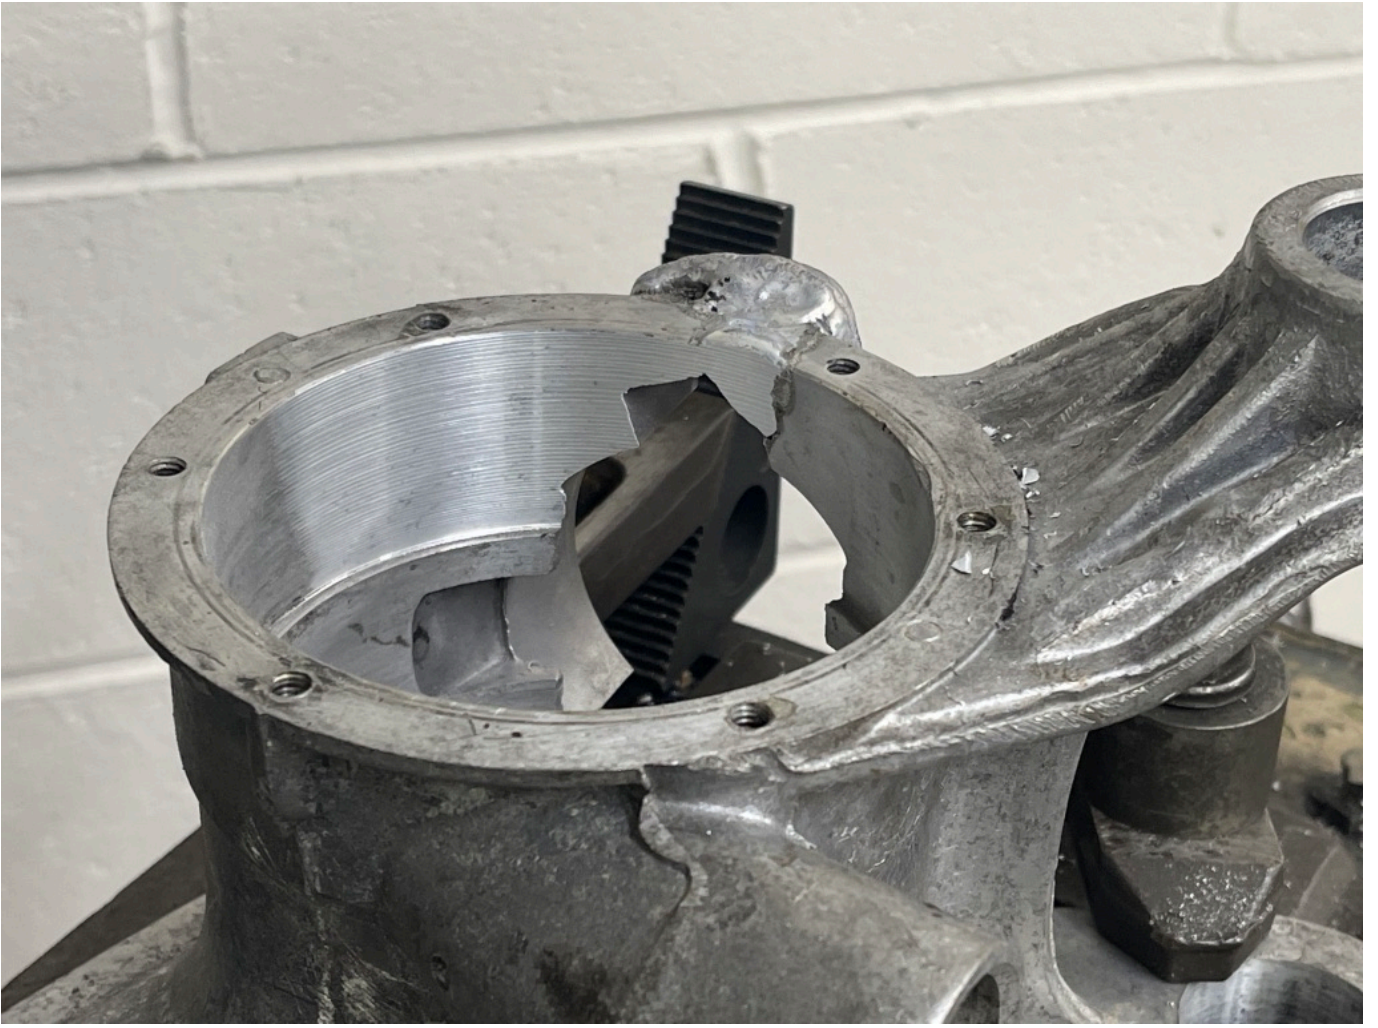
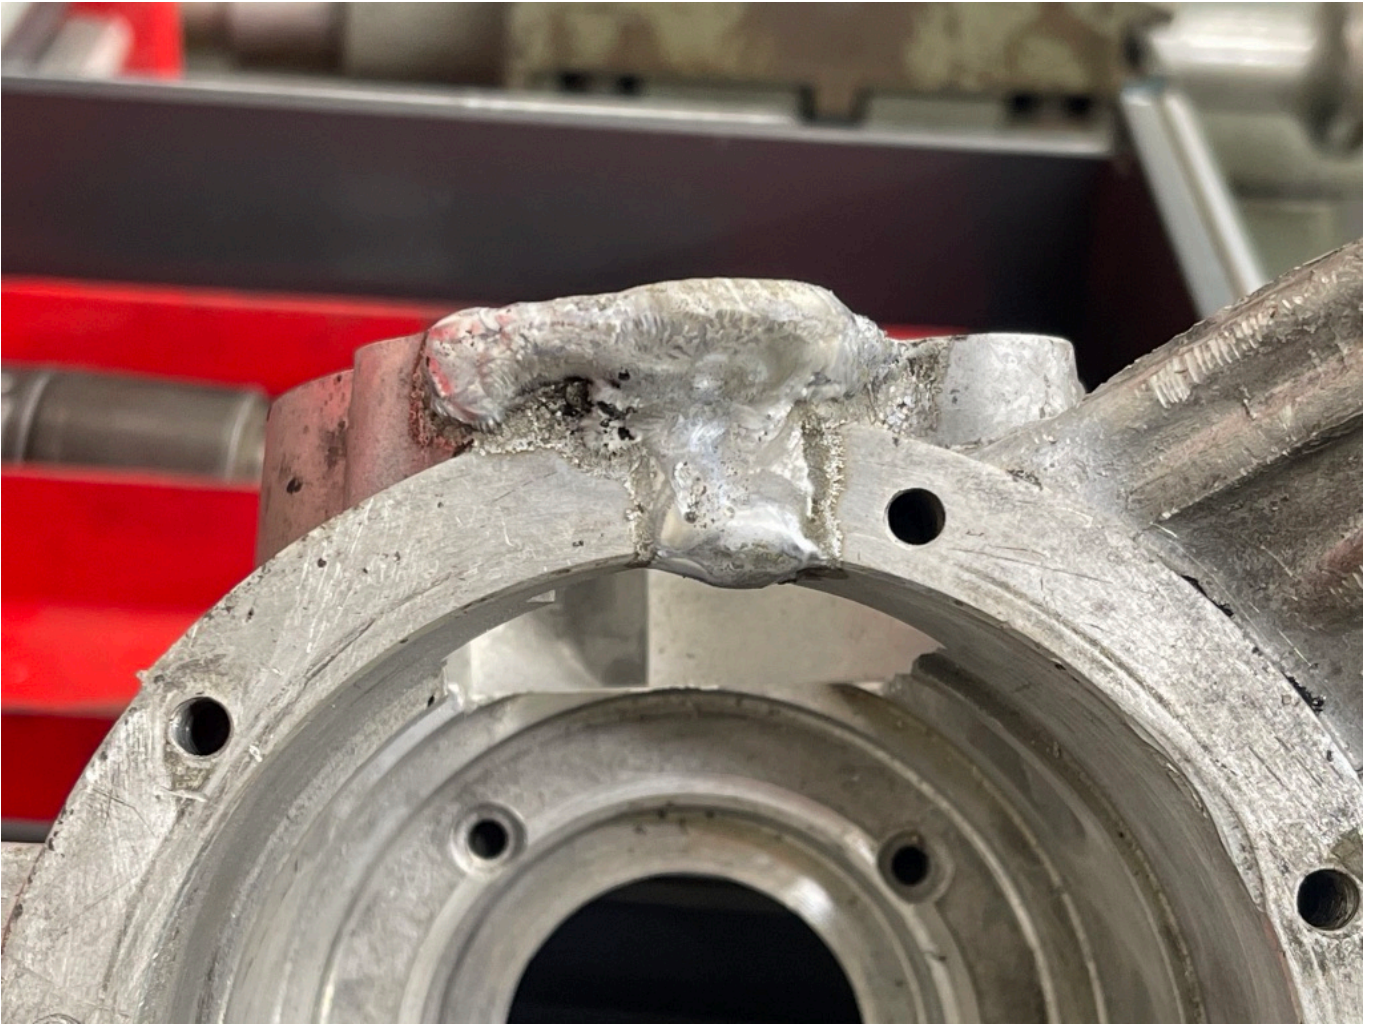
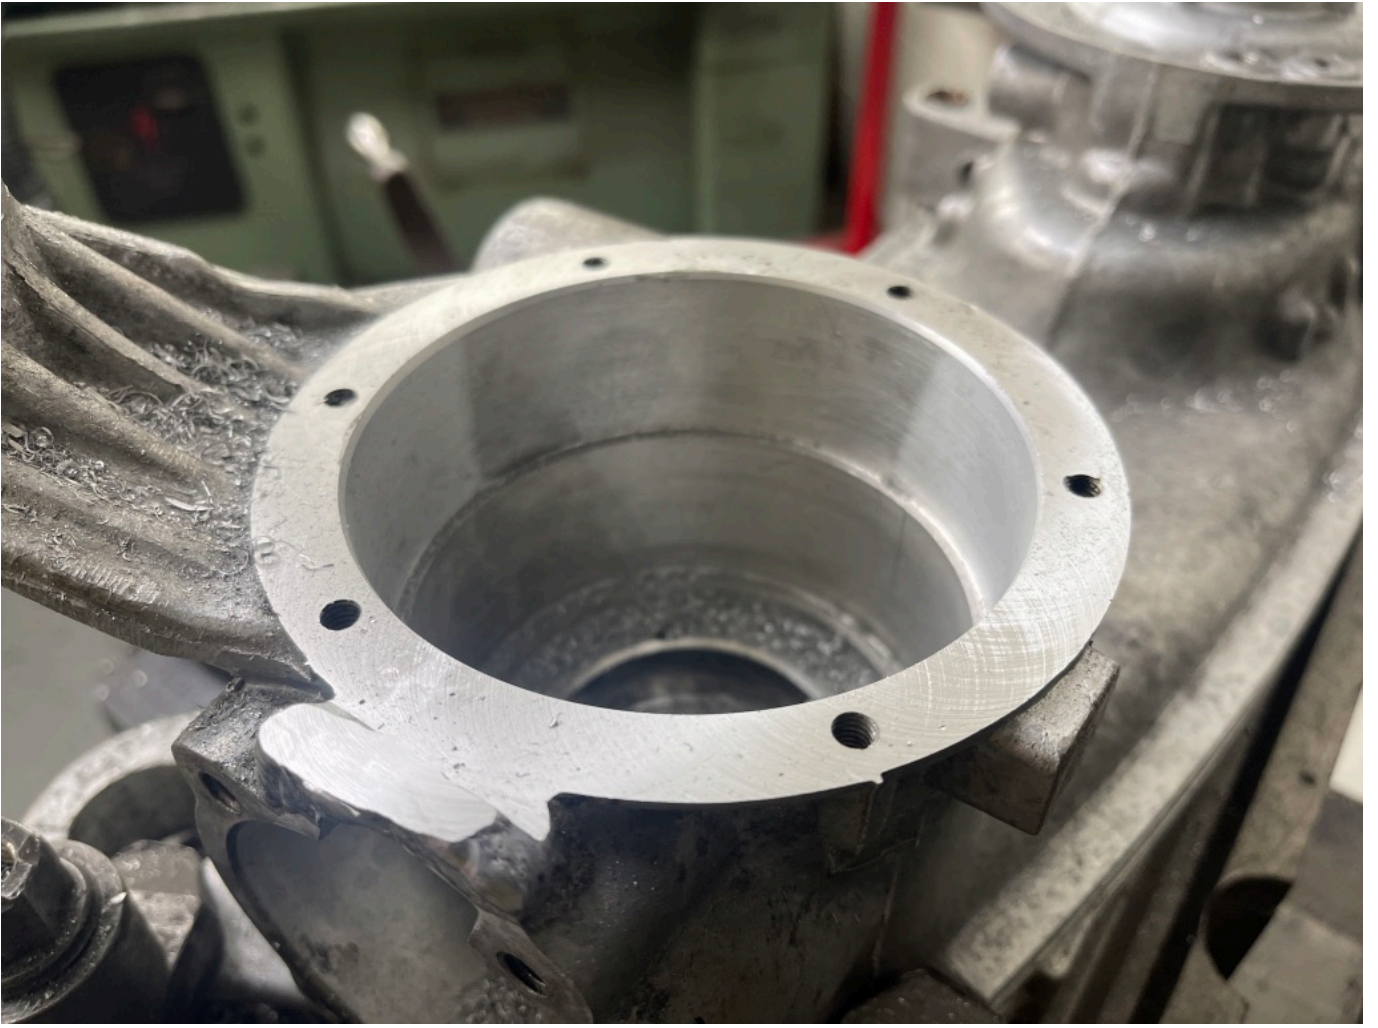
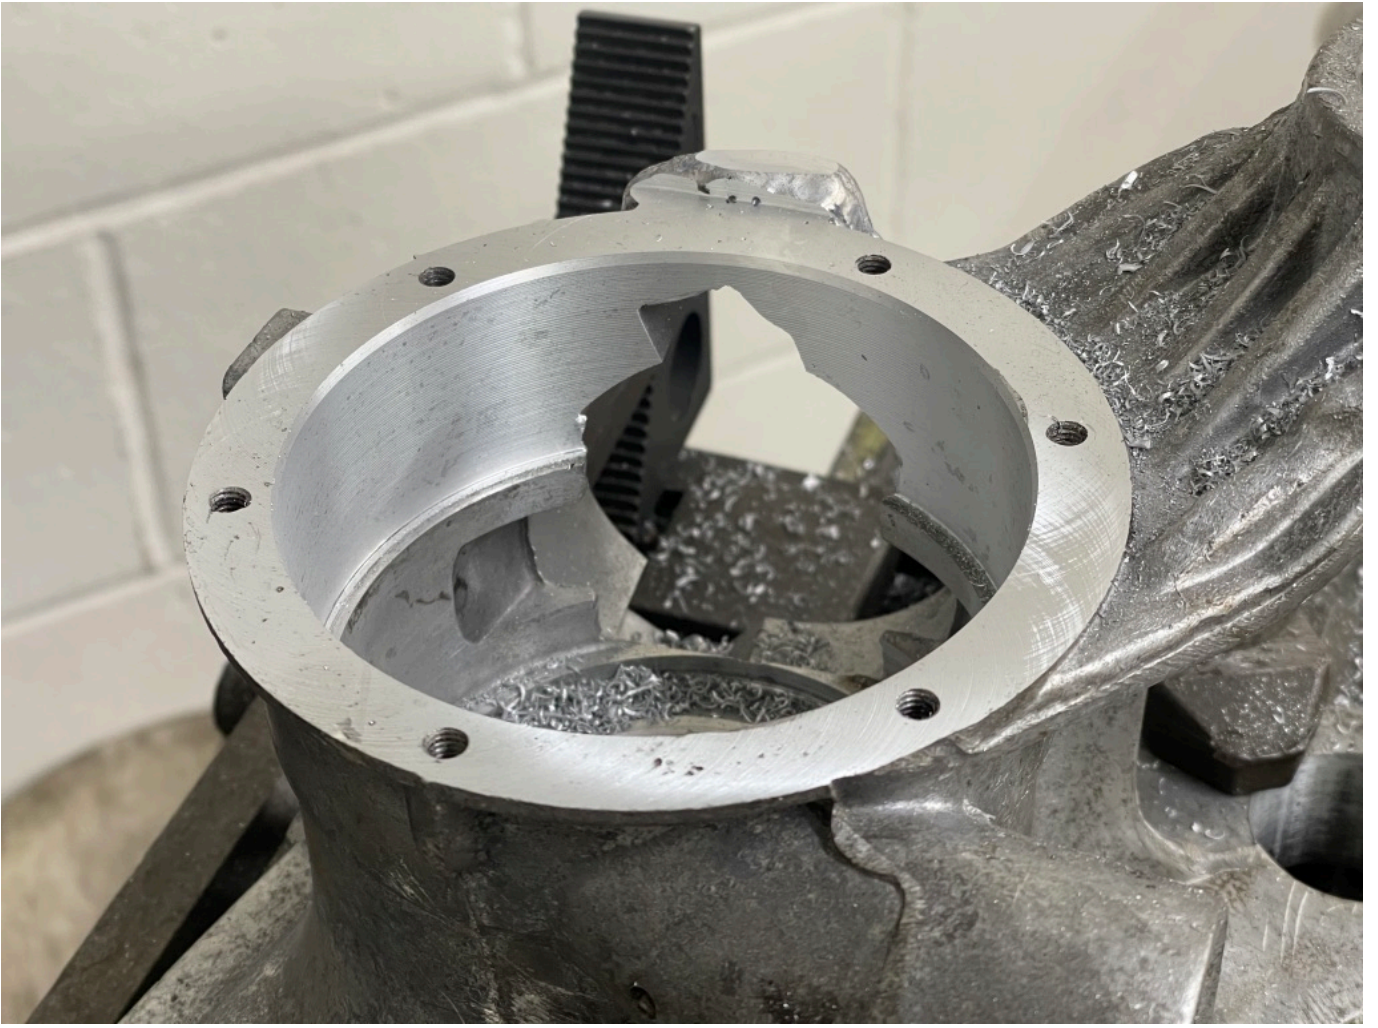
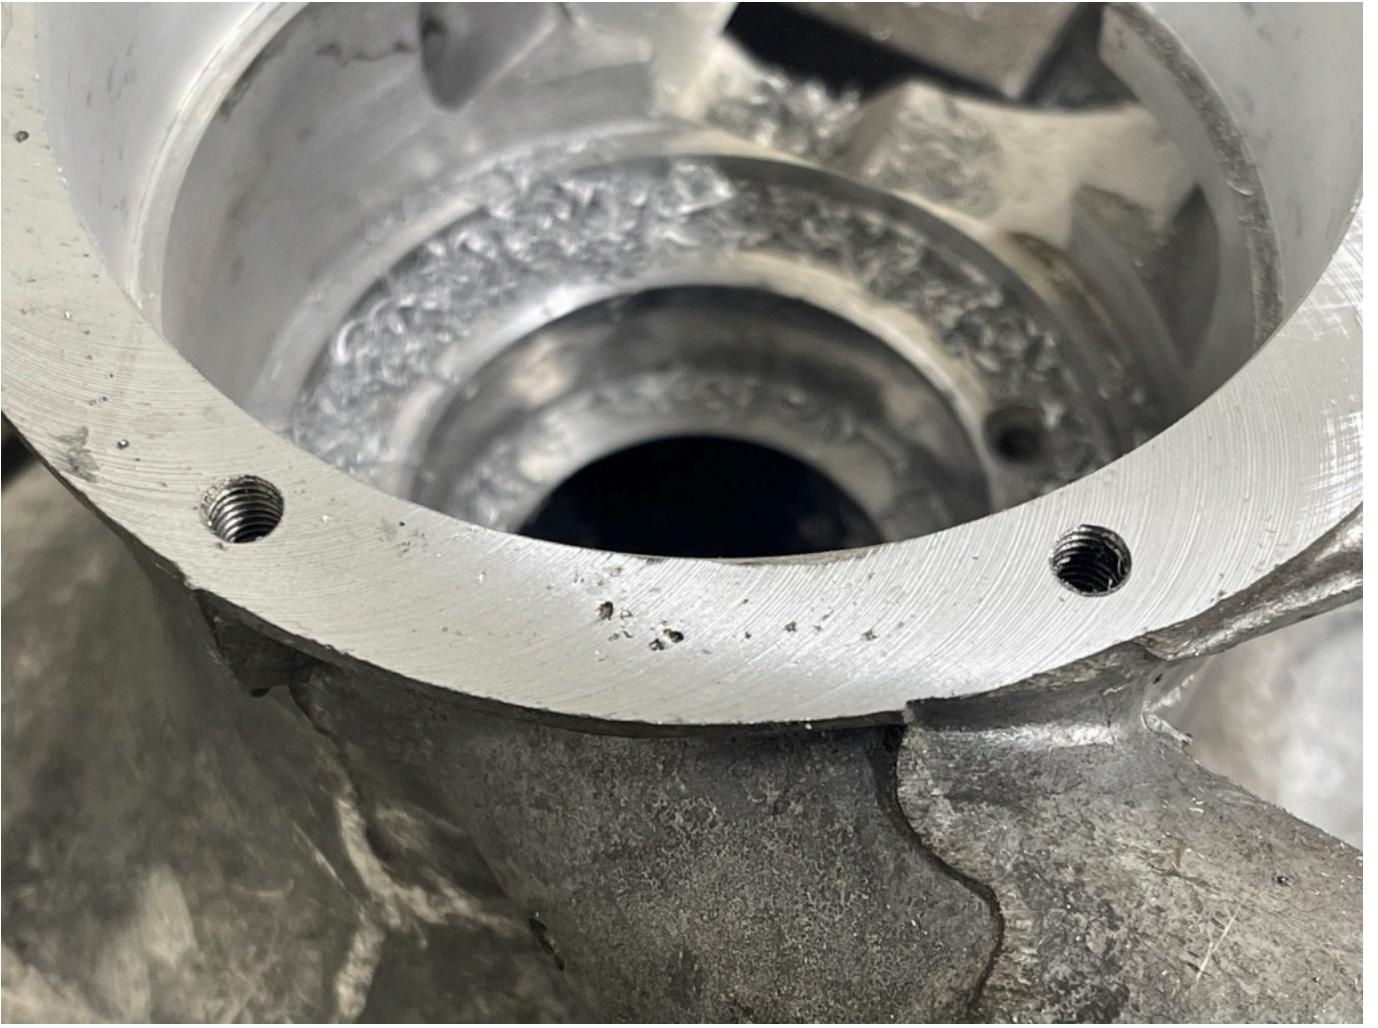
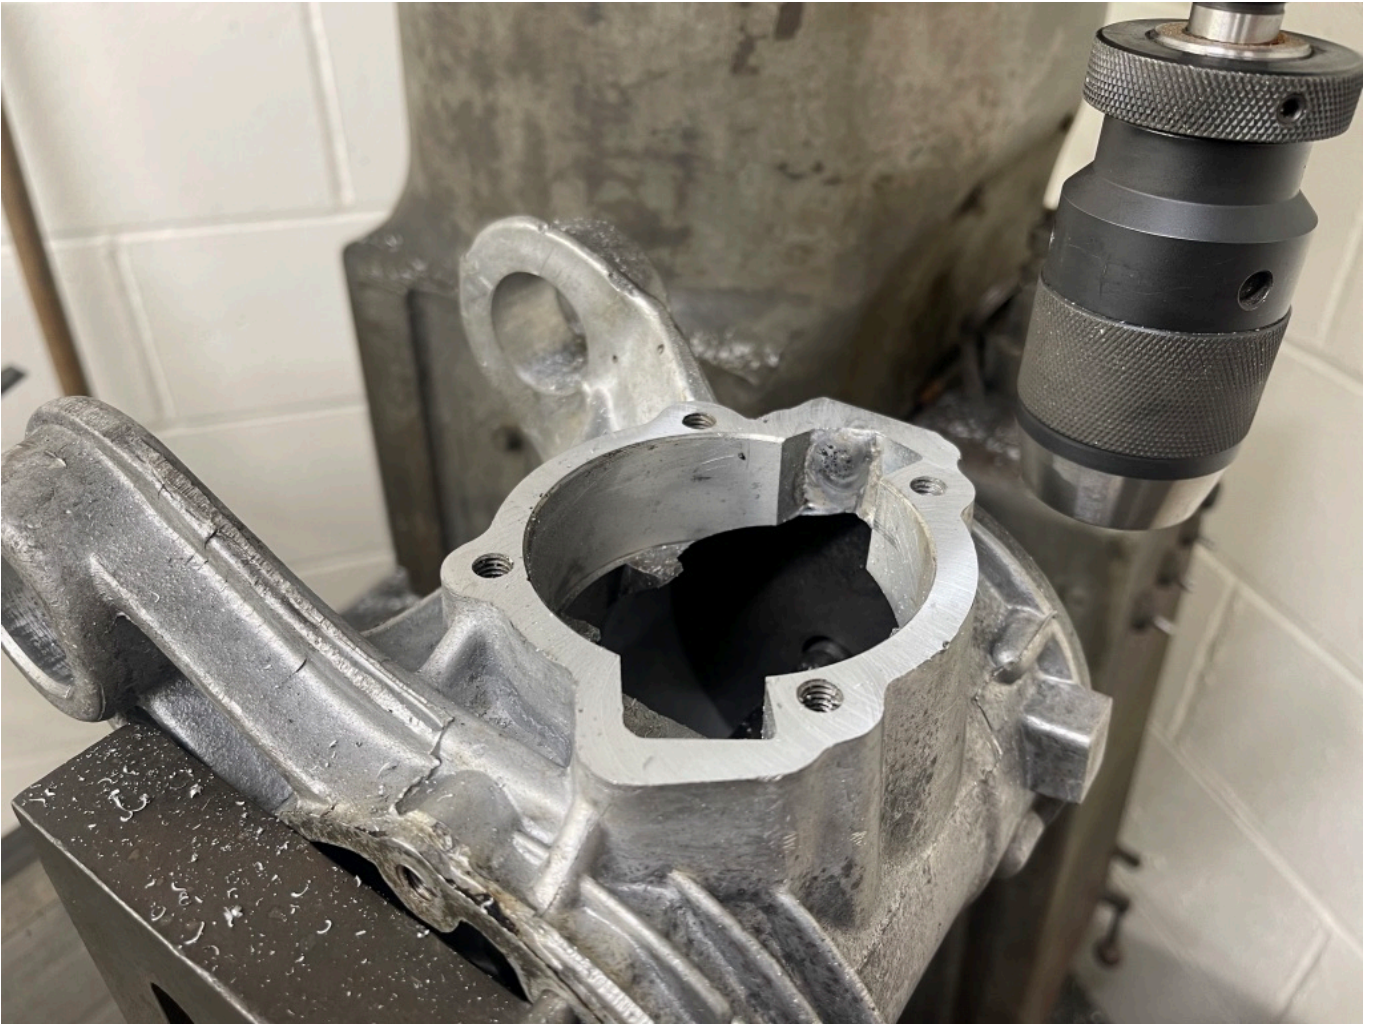
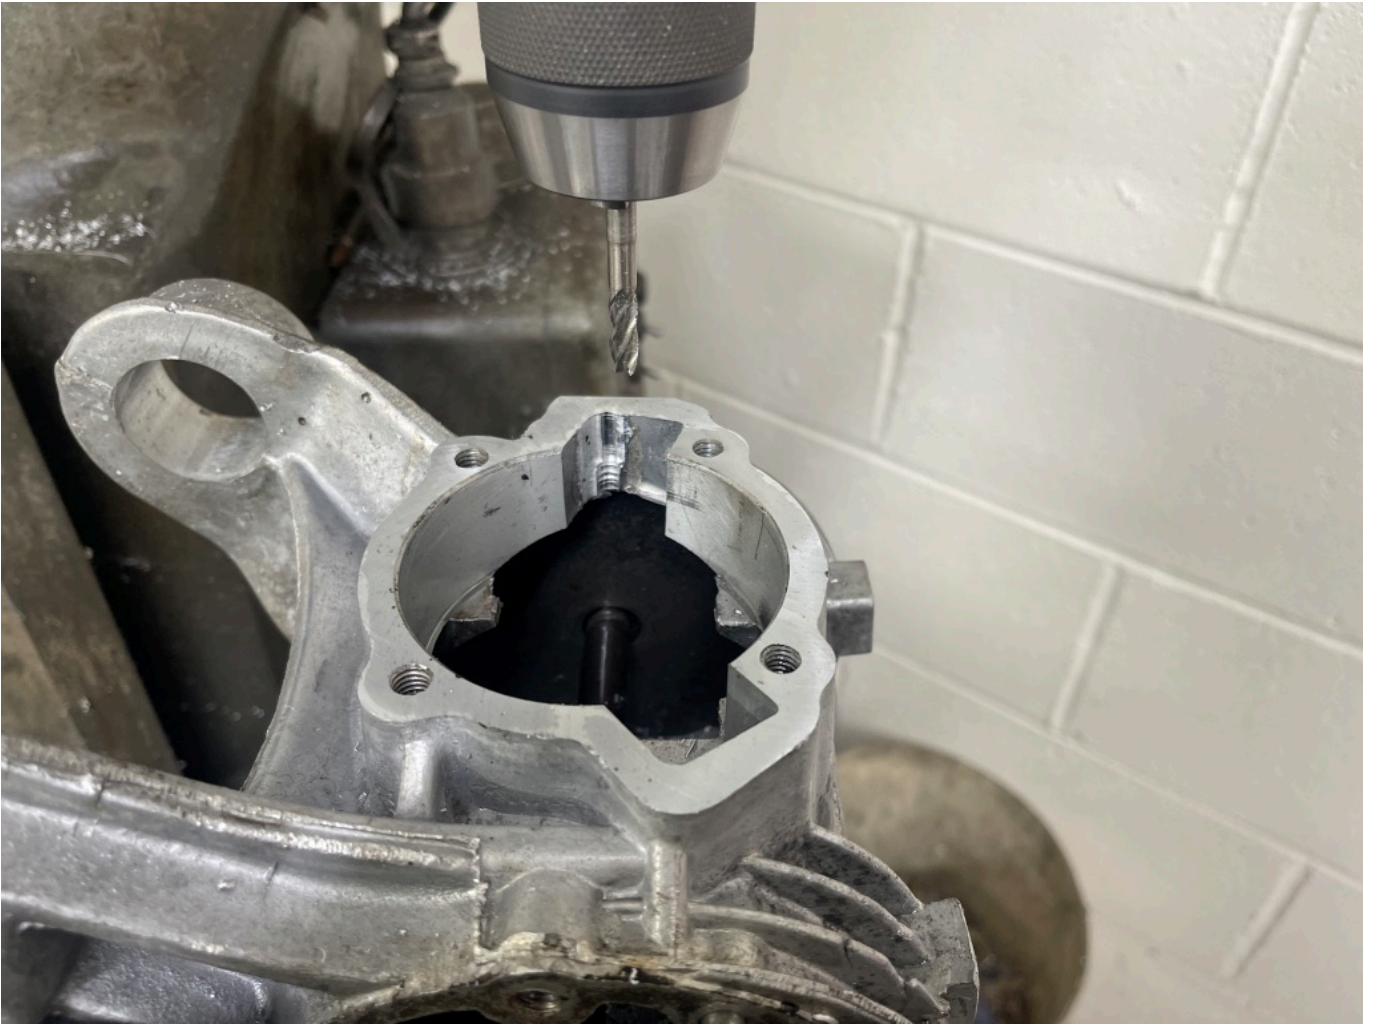
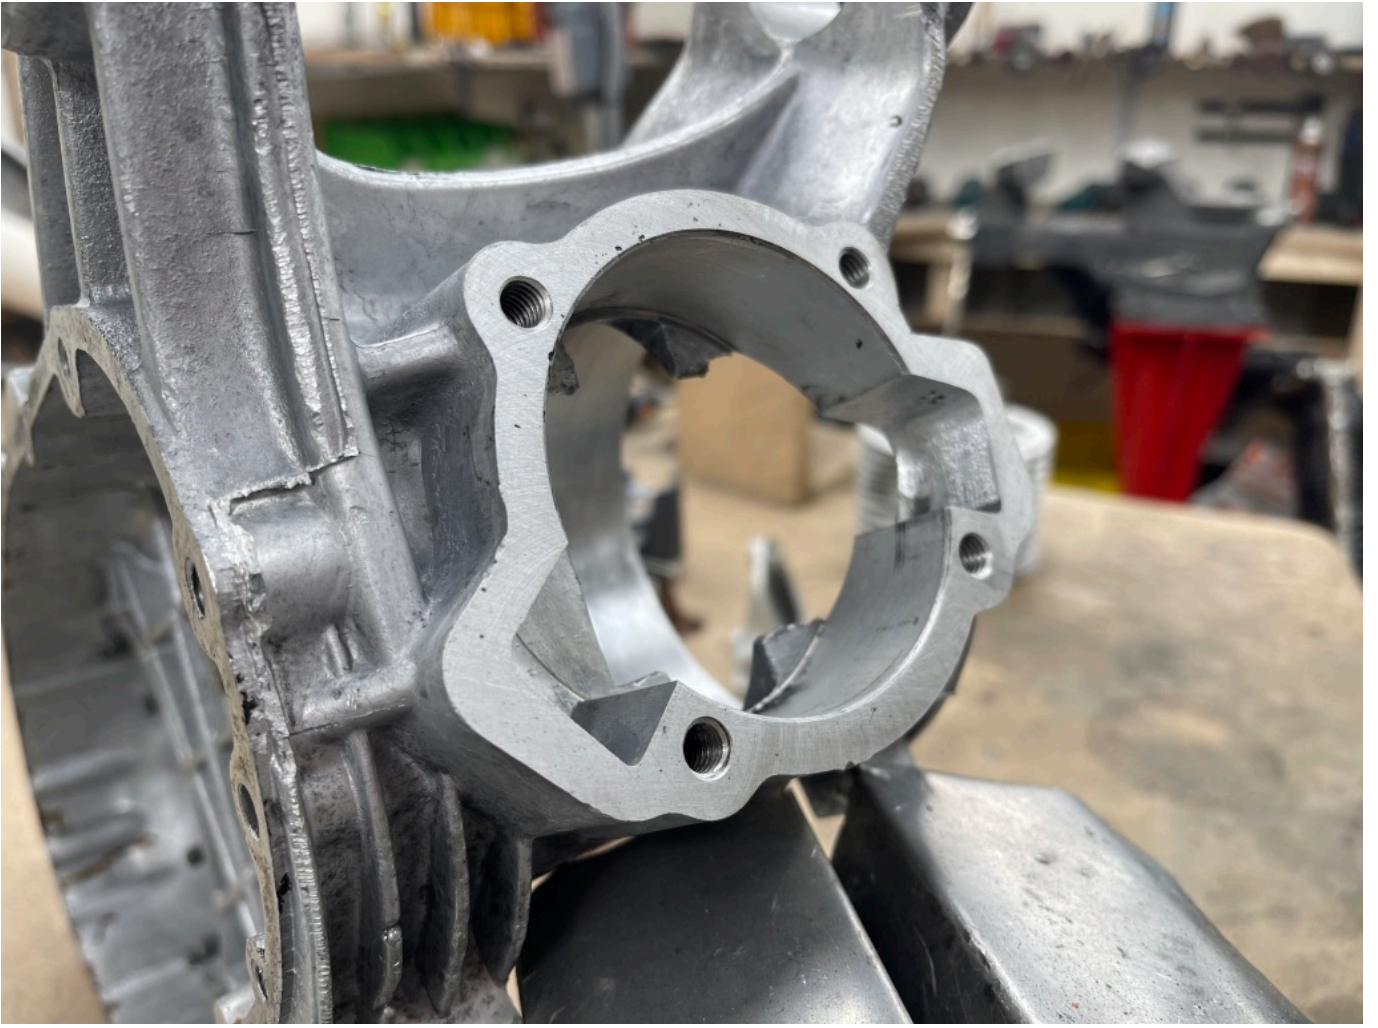
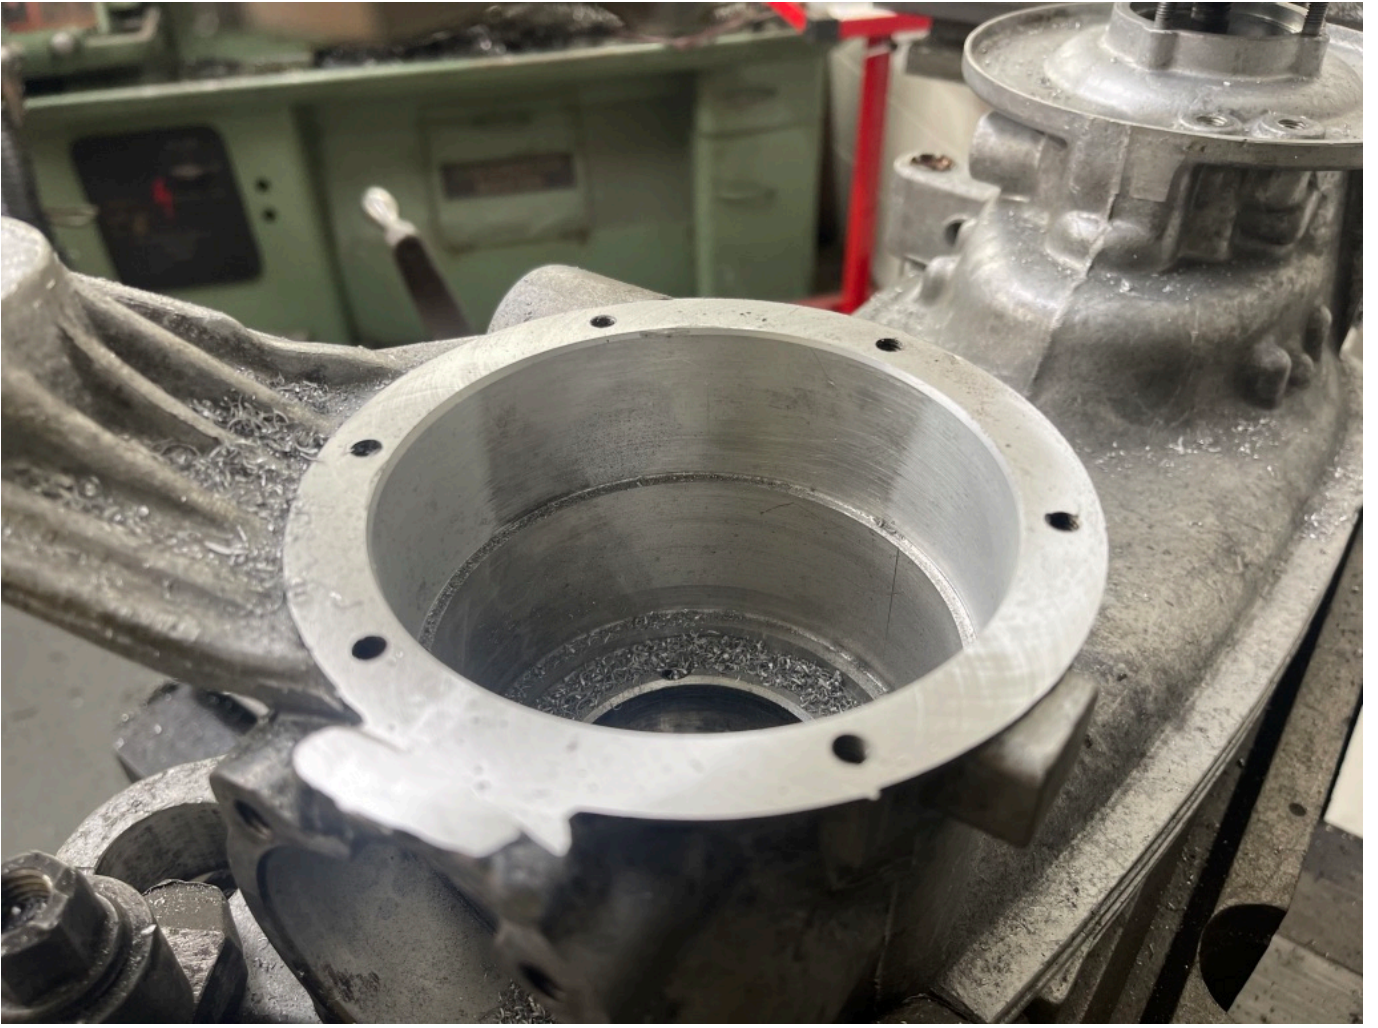
The weakest part of a Lambretta engine is between the transfer port on the mag housing side. It's common to see a fine crack – these cracks leak especially when the engine warms up and needs welding to repair them.

This was another one of those casings, you can tell by the finish of the weld. And check out the casing where its been machined you can see little holes all over, not just in the welded area, the casing is like Swiss cheese. Probably not one to leak through the casing but this is why you need petrol resistant gasket sealer on every face.

Check out the machining you can see there are areas not cleaned up as its set up and machined to get the casing back to true.

As this is the weak area I use stronger welding rods than the casing and build up more to add strength after machining.

Any casing welded will distort. In fact a normal casings set up correctly on a miller will find some the faces move and distort – even worse if your welding on the gasket faces or adding a bump stop or replacing an engine mount.
