MB Services – Casing restoration

Another TV200 engine repaired and restored at MB Scooters. Seems I do get through a few TV motors!

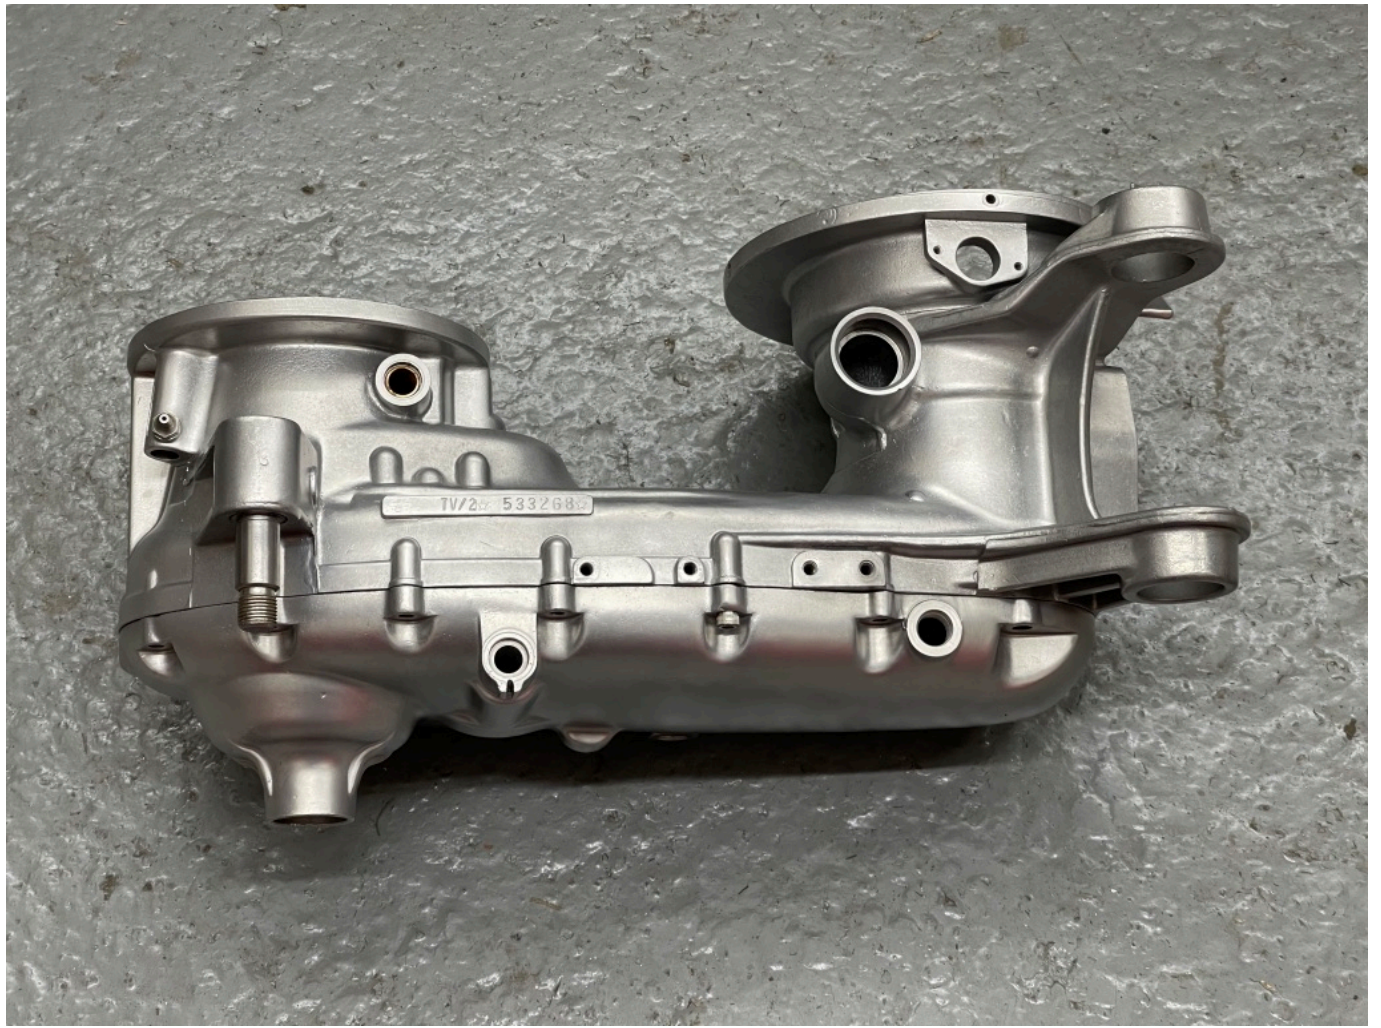
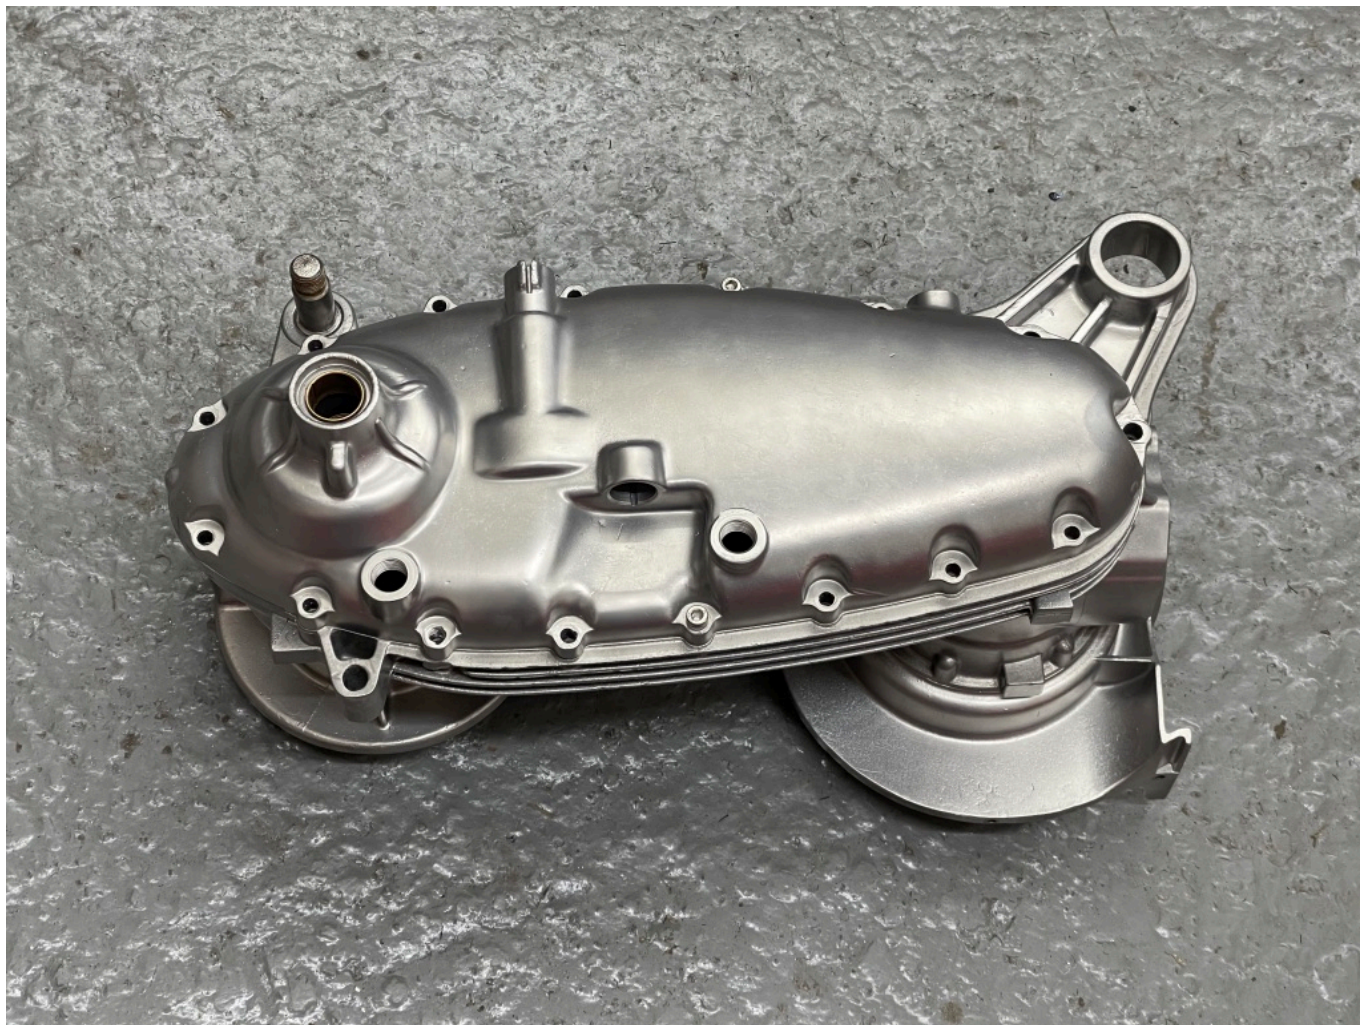
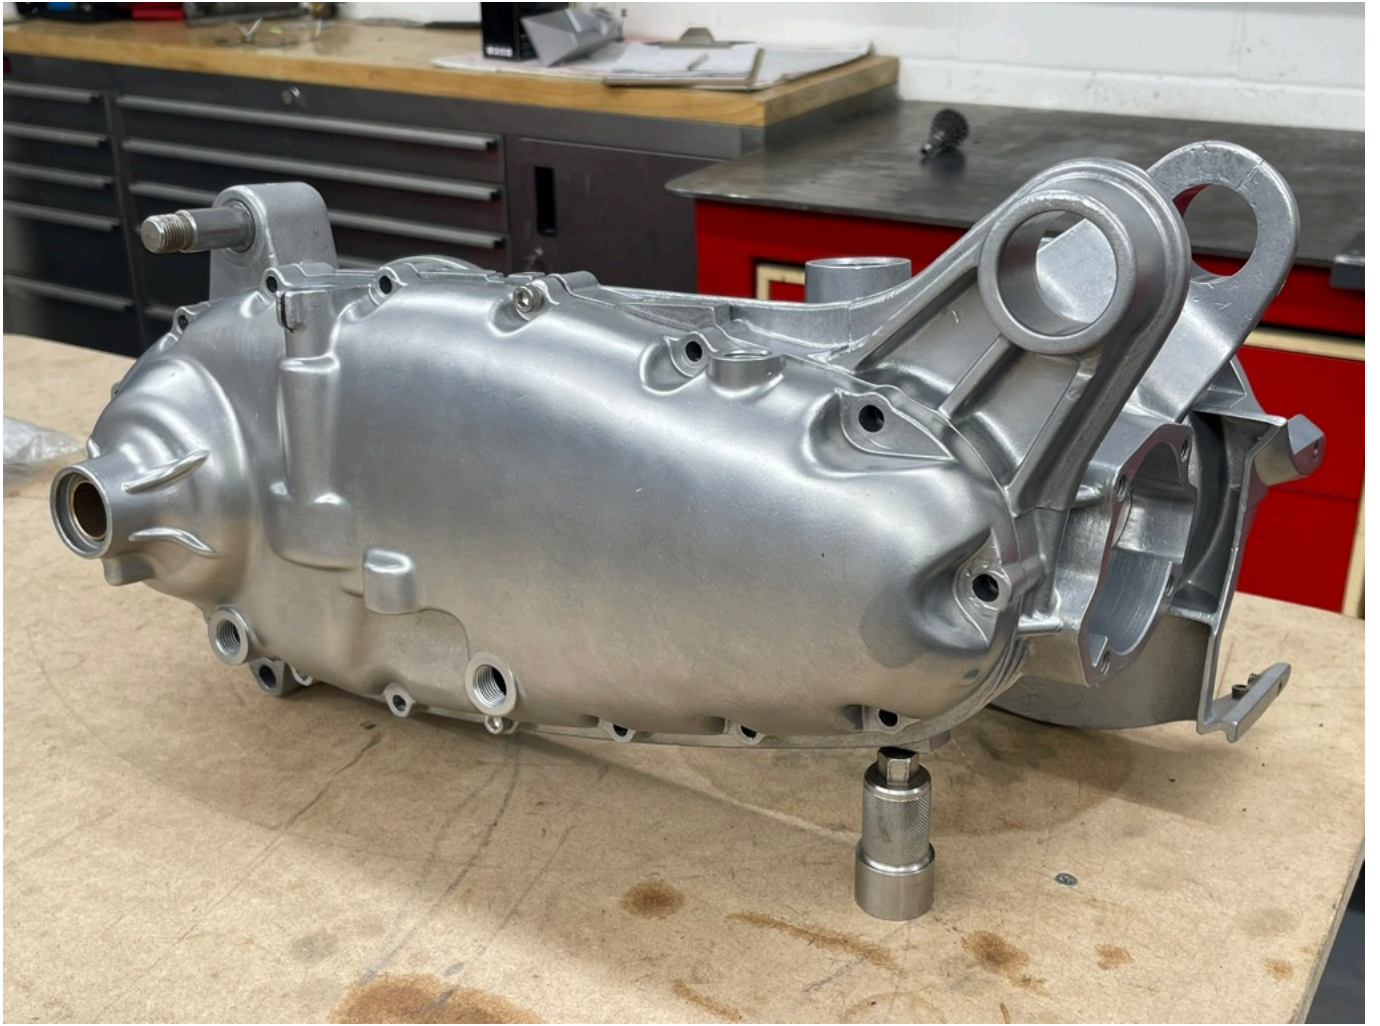
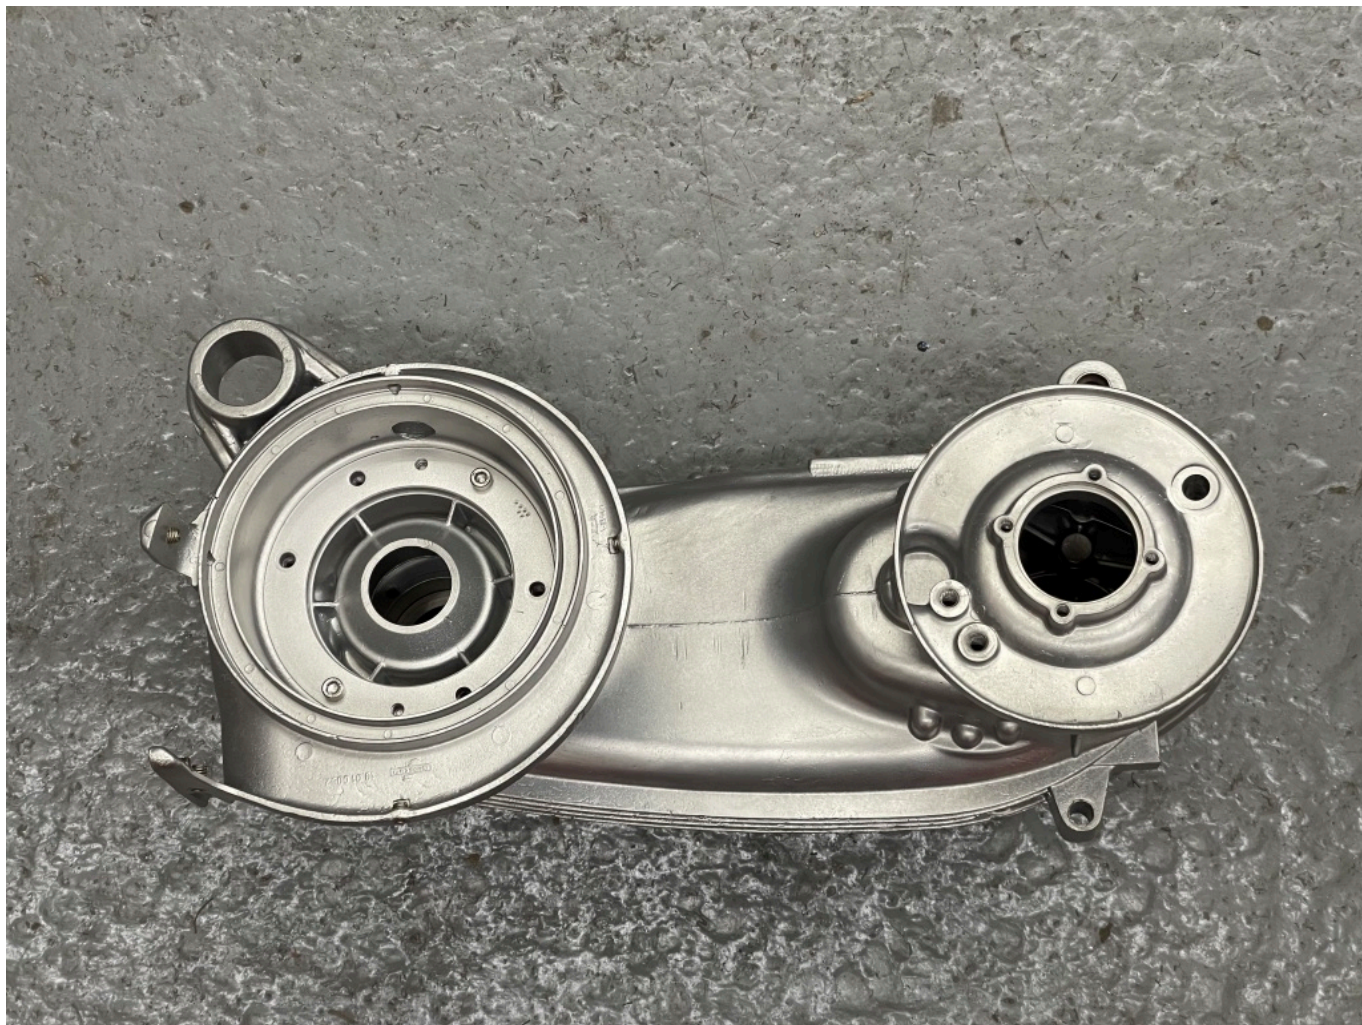
This casing was no exception. After it was ultra sonic cleaned, there was marks and pitting to the 3 casing parts. Some areas were better than others, so decided to make it look similar all over to blend in the pitting and patina by using different media in our rumble machine. The side cover was so bad which is very common that I had to hand polished and grind out deep marks then run it over the polishing machine before it was bead blasted prior to the rumbling system.

On this one I've actually added more pitting to make it all look the same which has blended it in all over. I've then worked it down and given it a semi shine in the rumbler then finished it off with a shine and blend in the aqua blaster.

Note – I've kept the original looks by leaving the casting flashes so it's got that factory look.

This casings had some grinding, welding, fettling and some threads repaired with MB inserts – then it's been restoration finished the MB way – all done in house!

Now there's various ways we can restore casings depending on the customer and what can actually be done with what we have in hand. It's so easy to just bead blast a casing or aqua blast a casting. Our quickest way to make a casing nice after so welding work is to bead blast then aqua blast one.
