# Engine – Repair casing mouth

## CON ROD SNAPPED CASING REPAIR

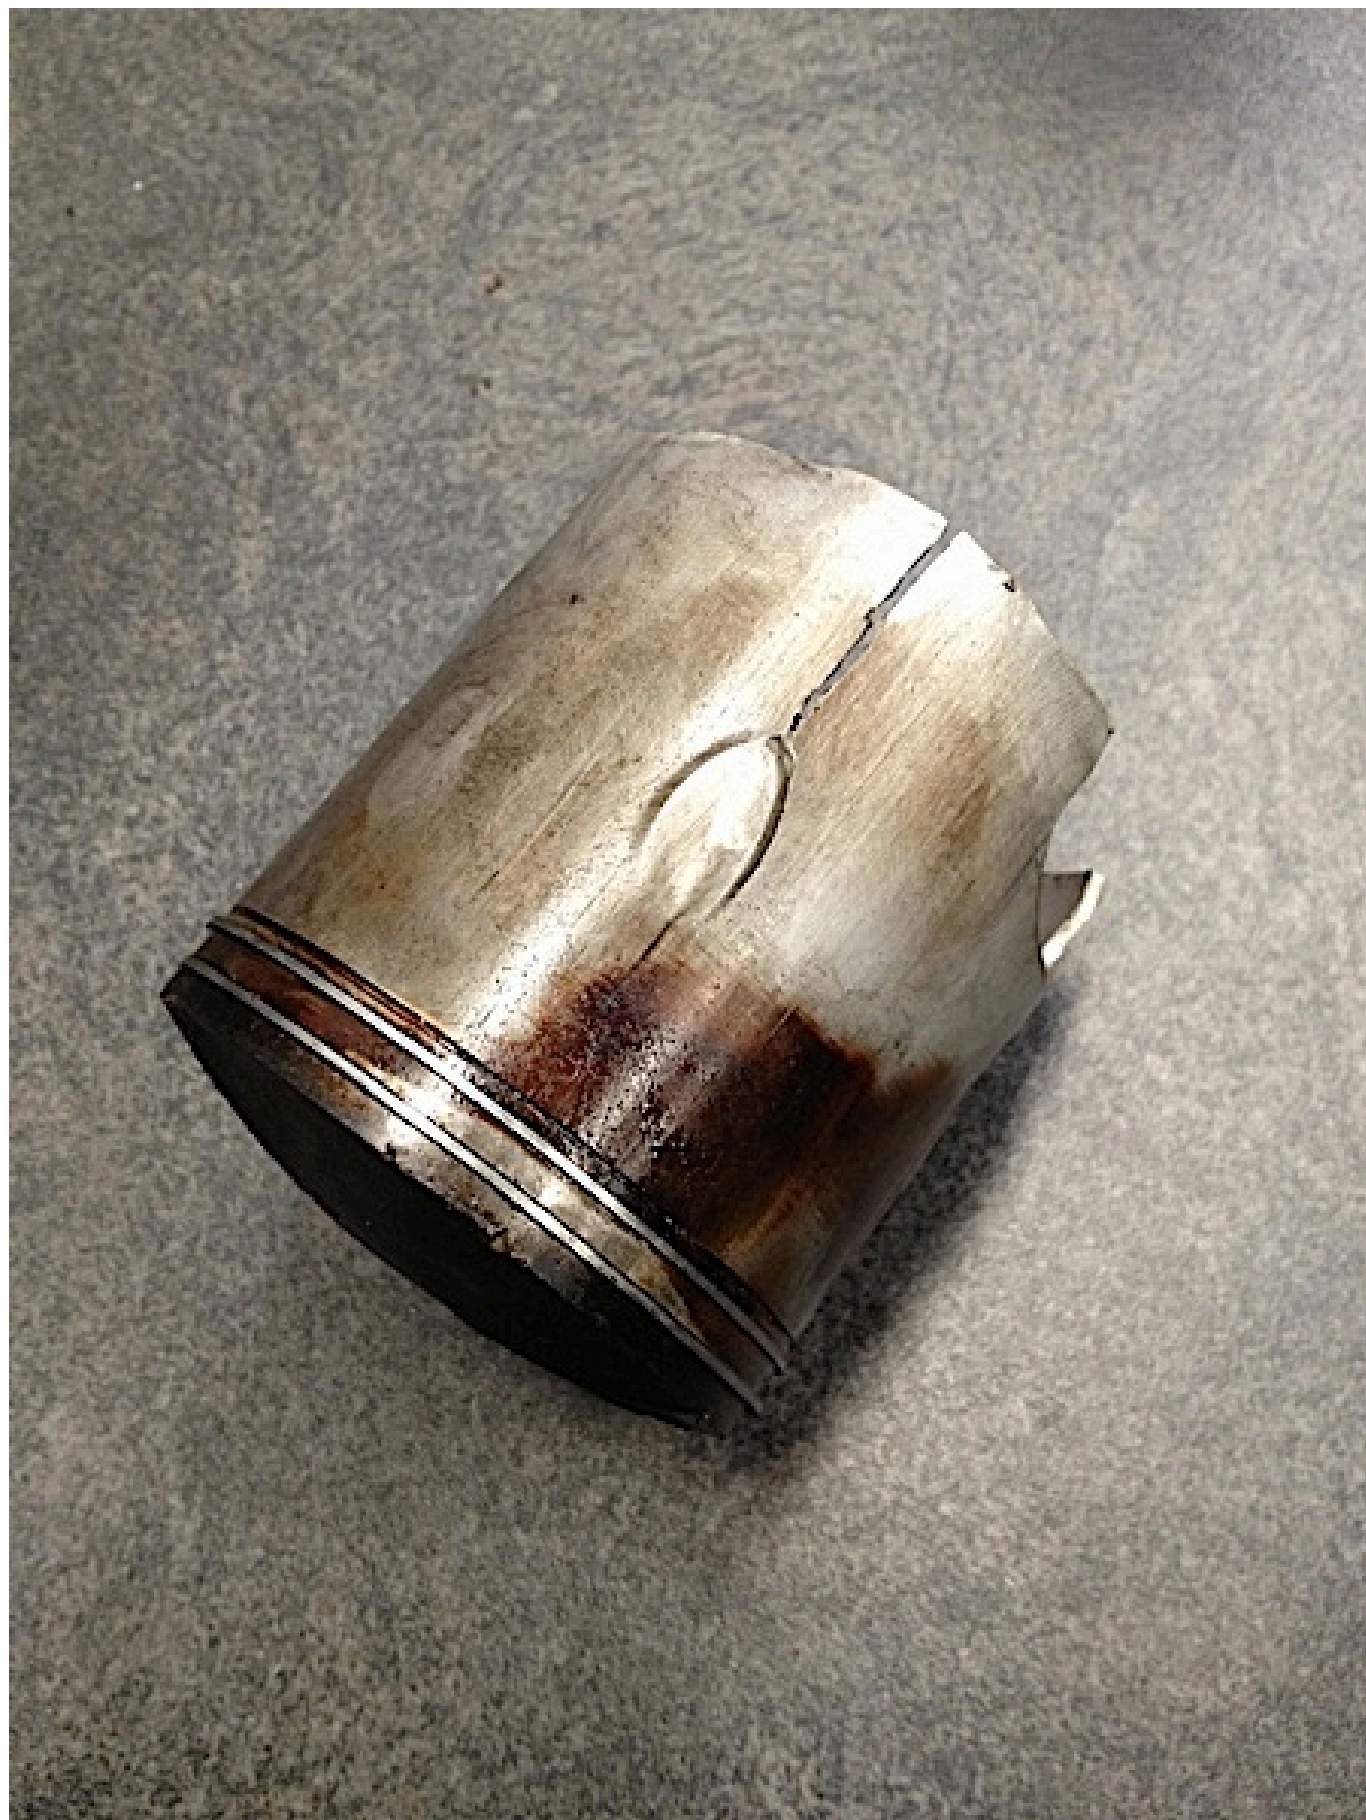
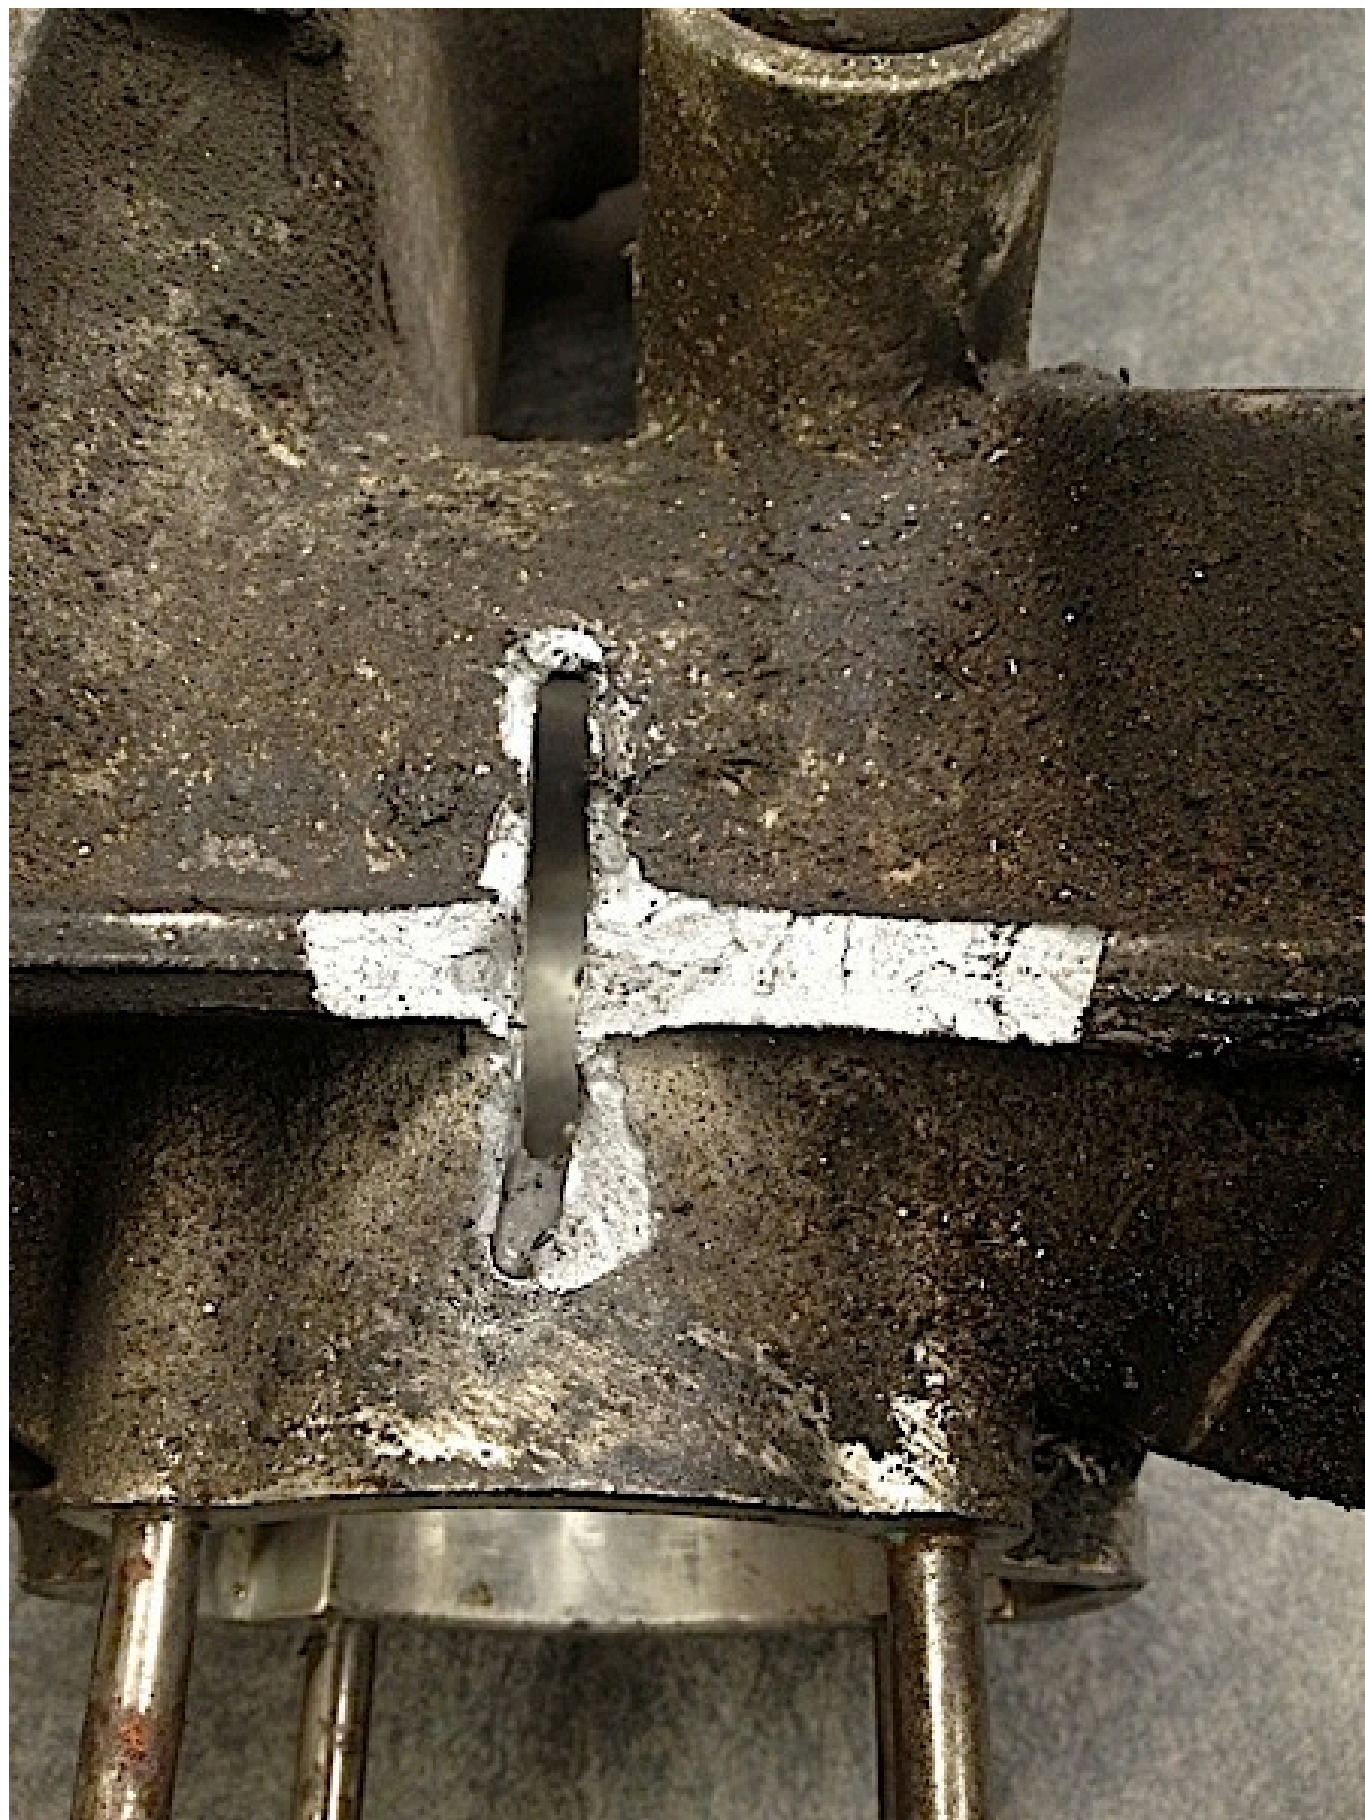
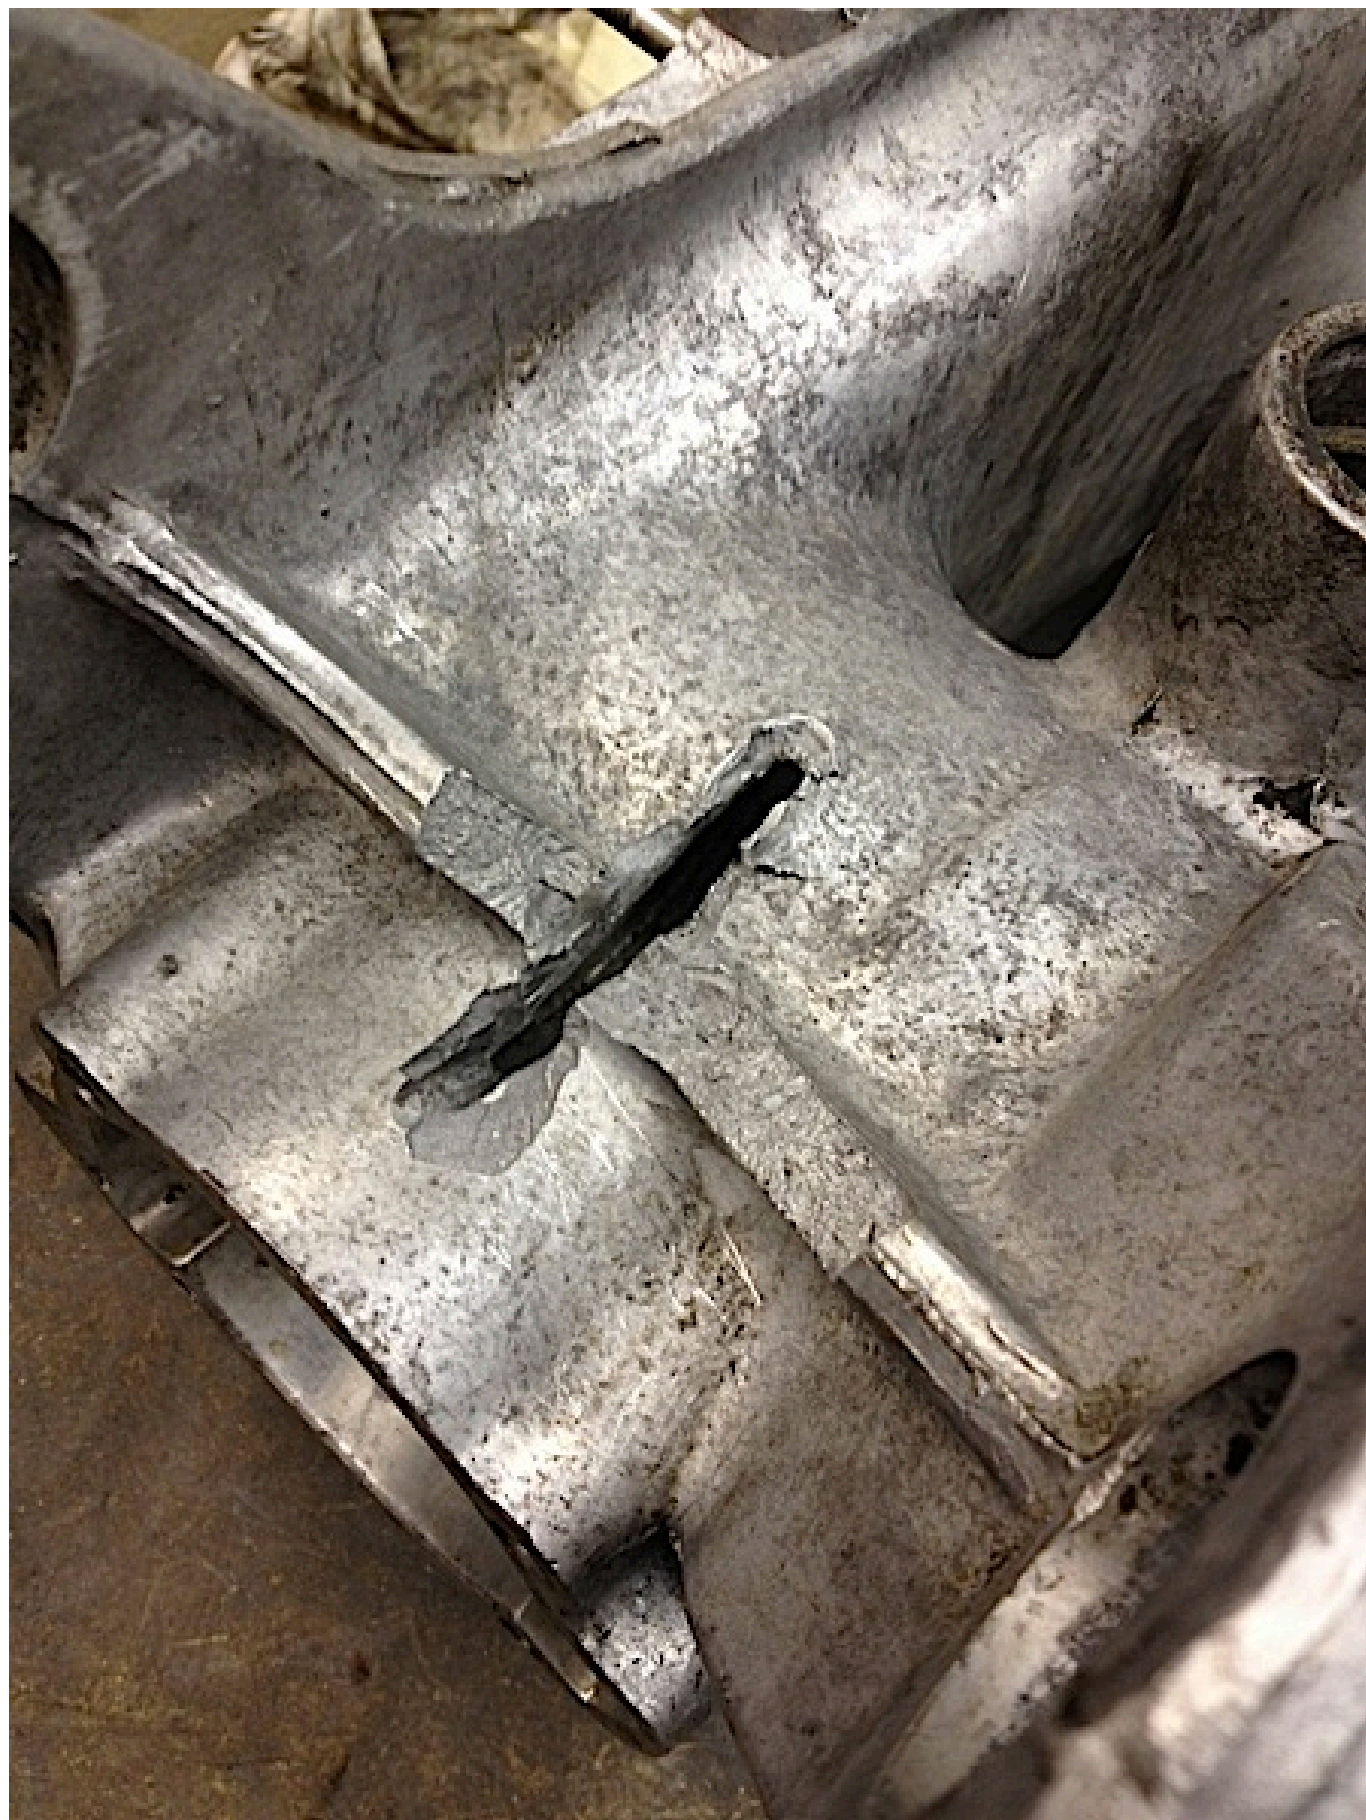
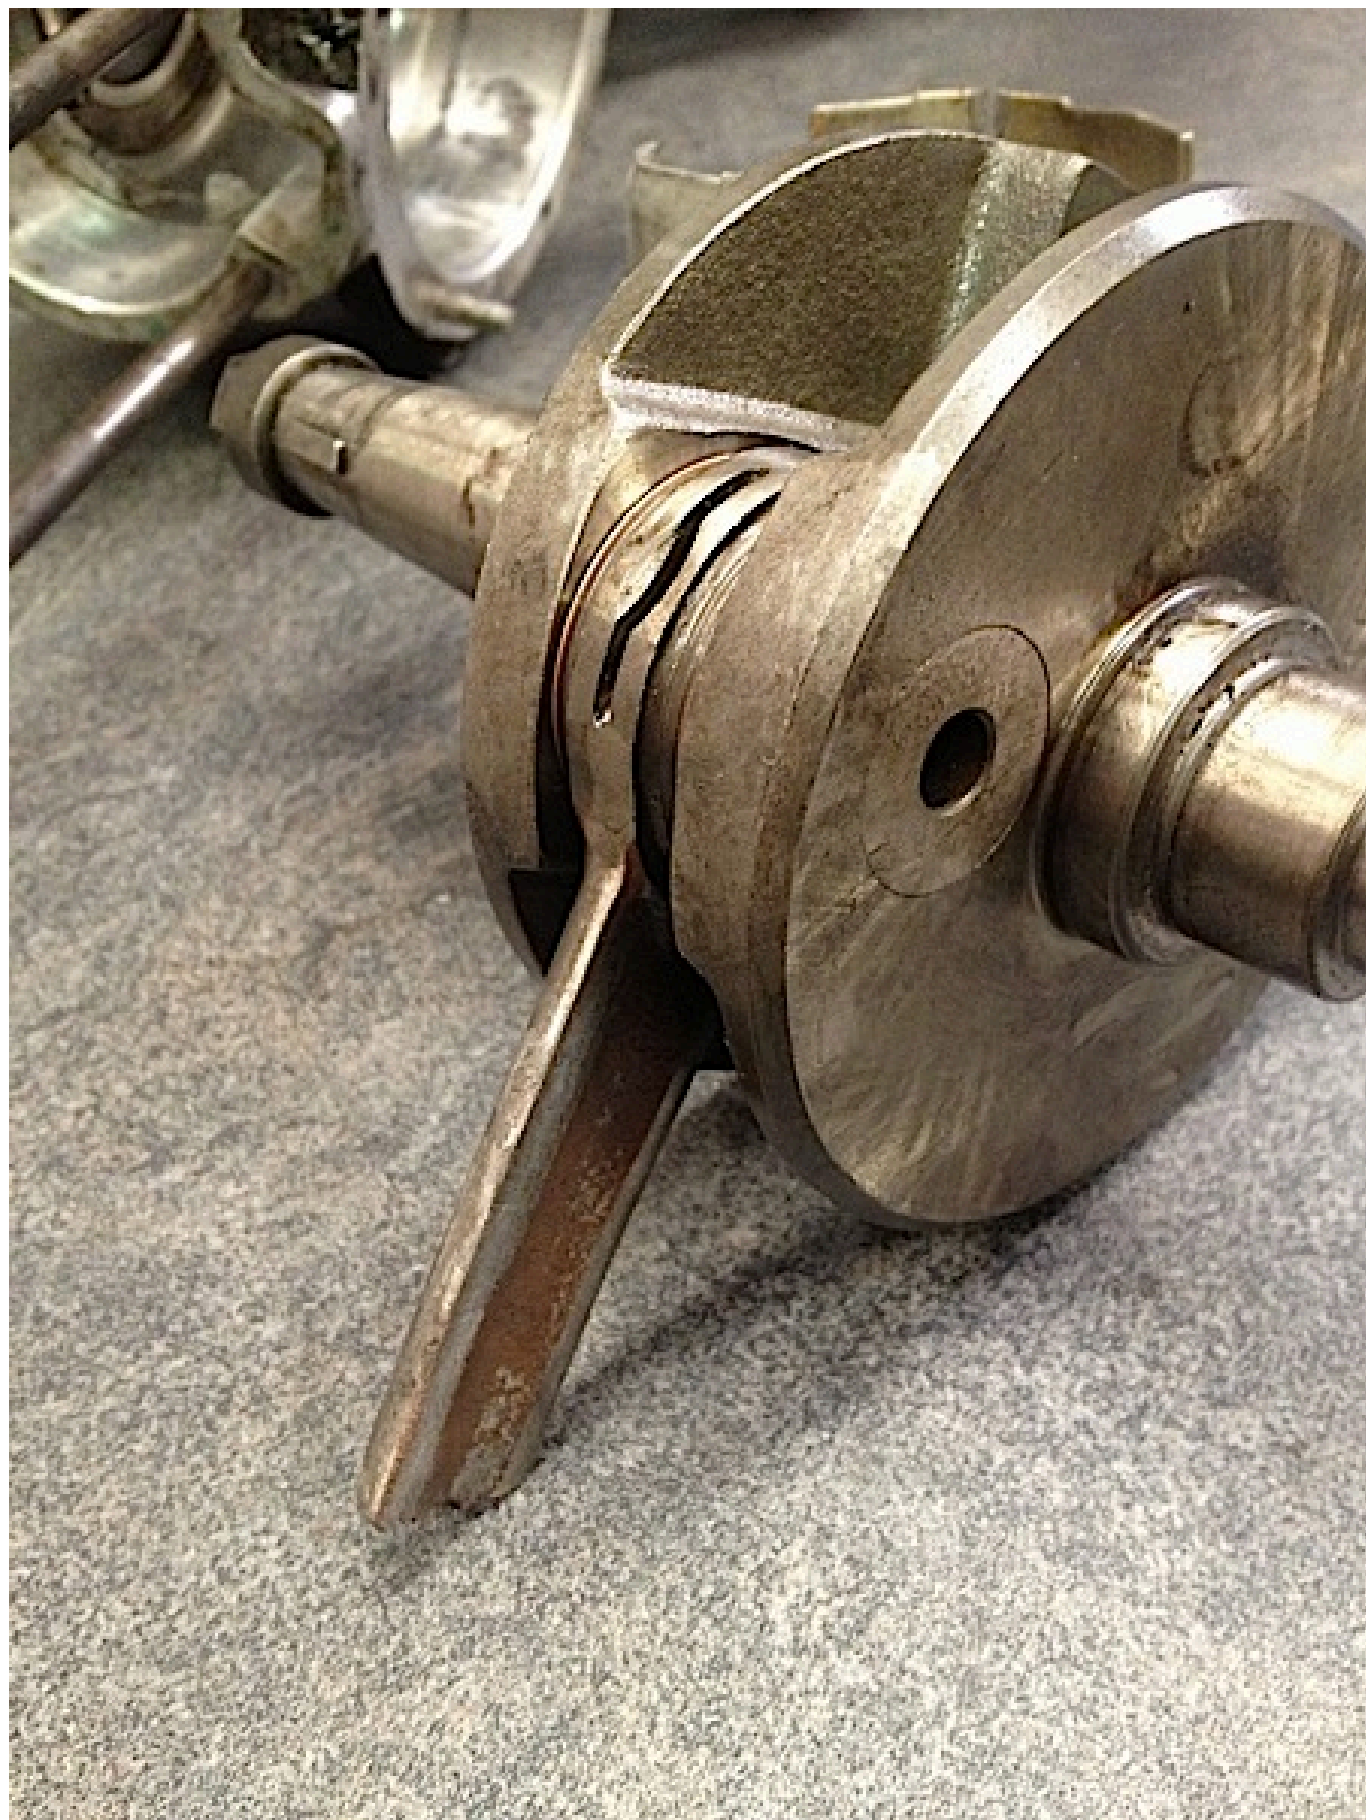
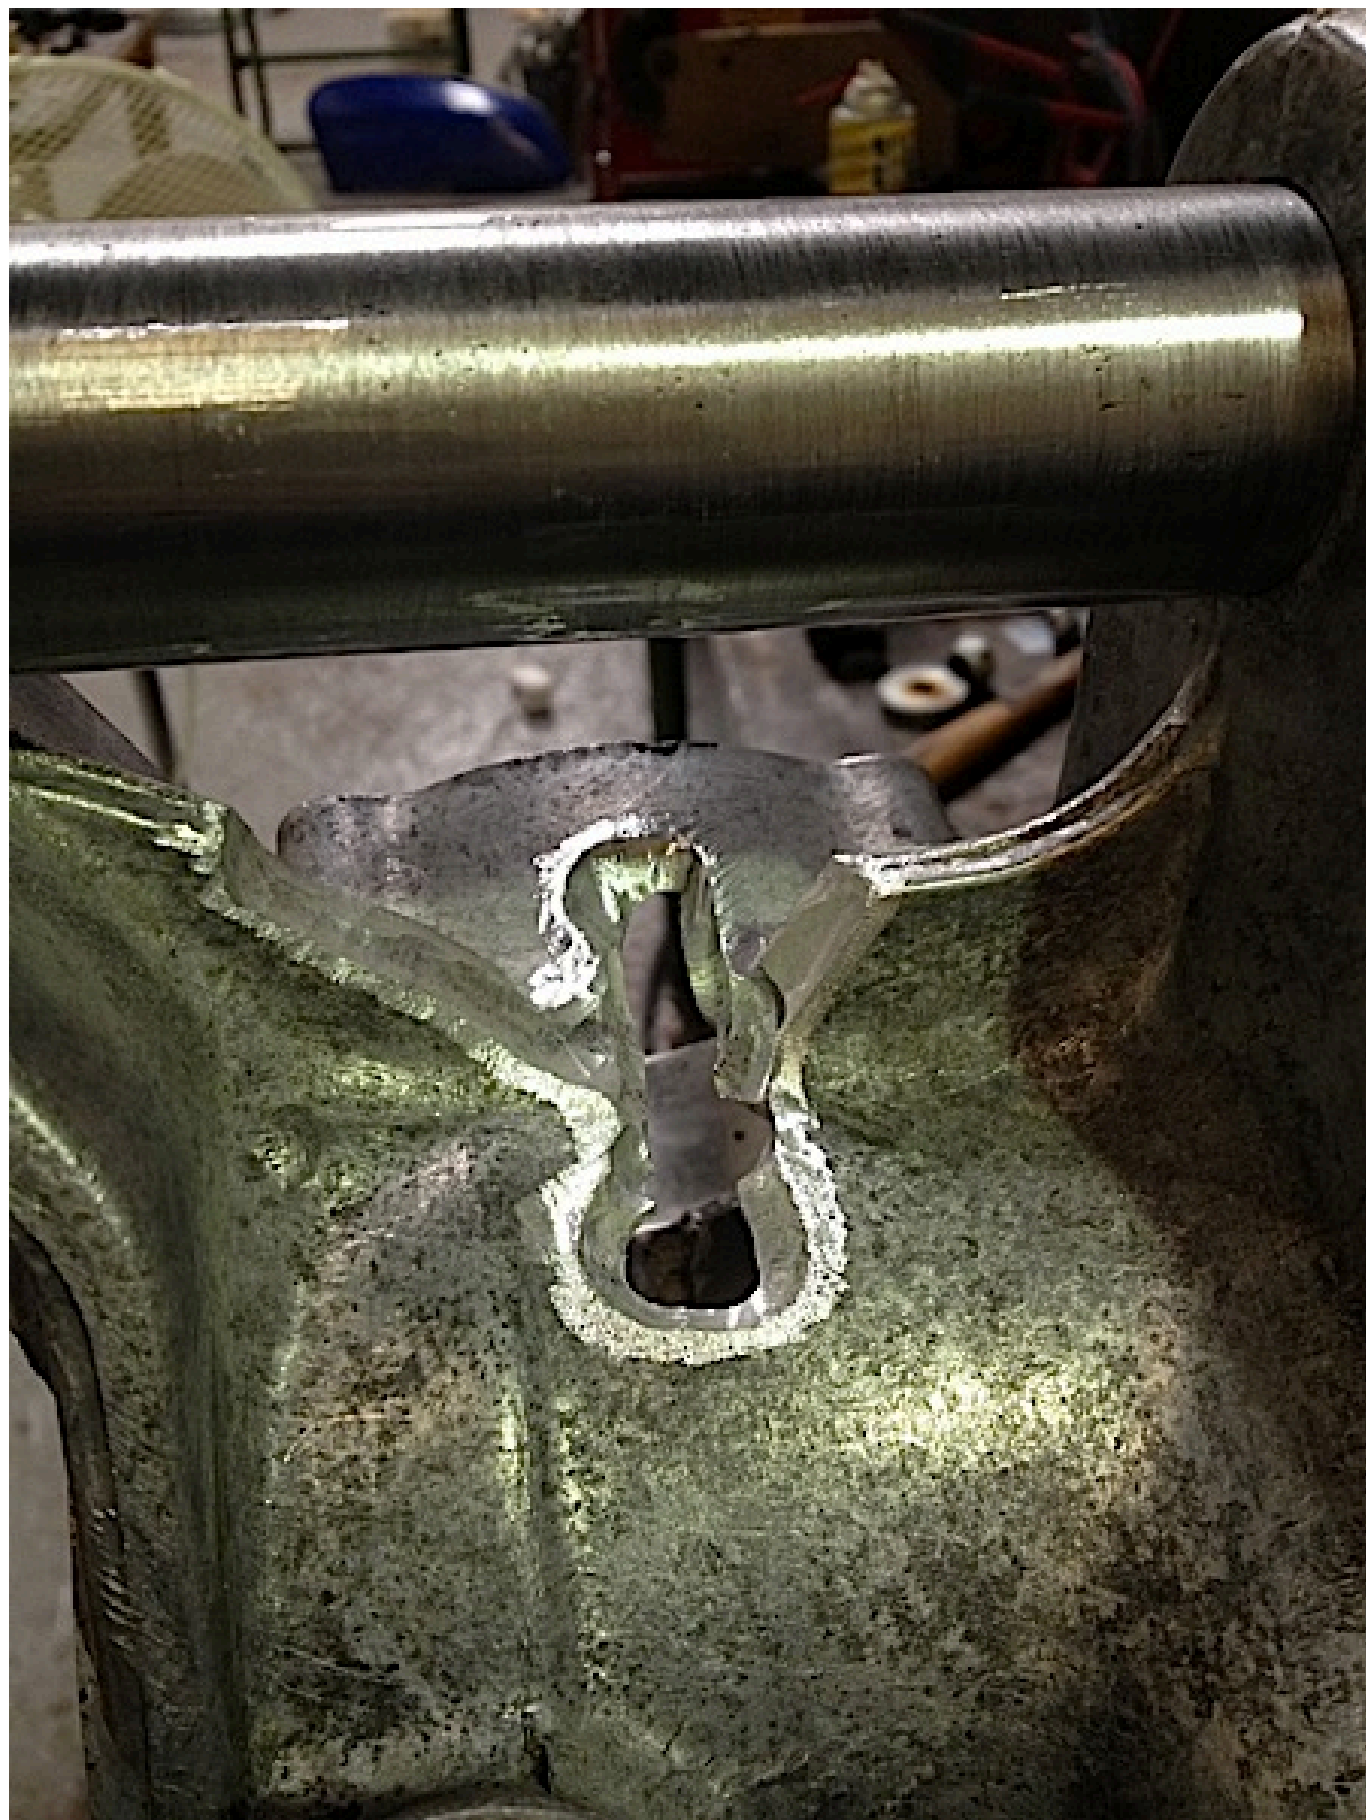
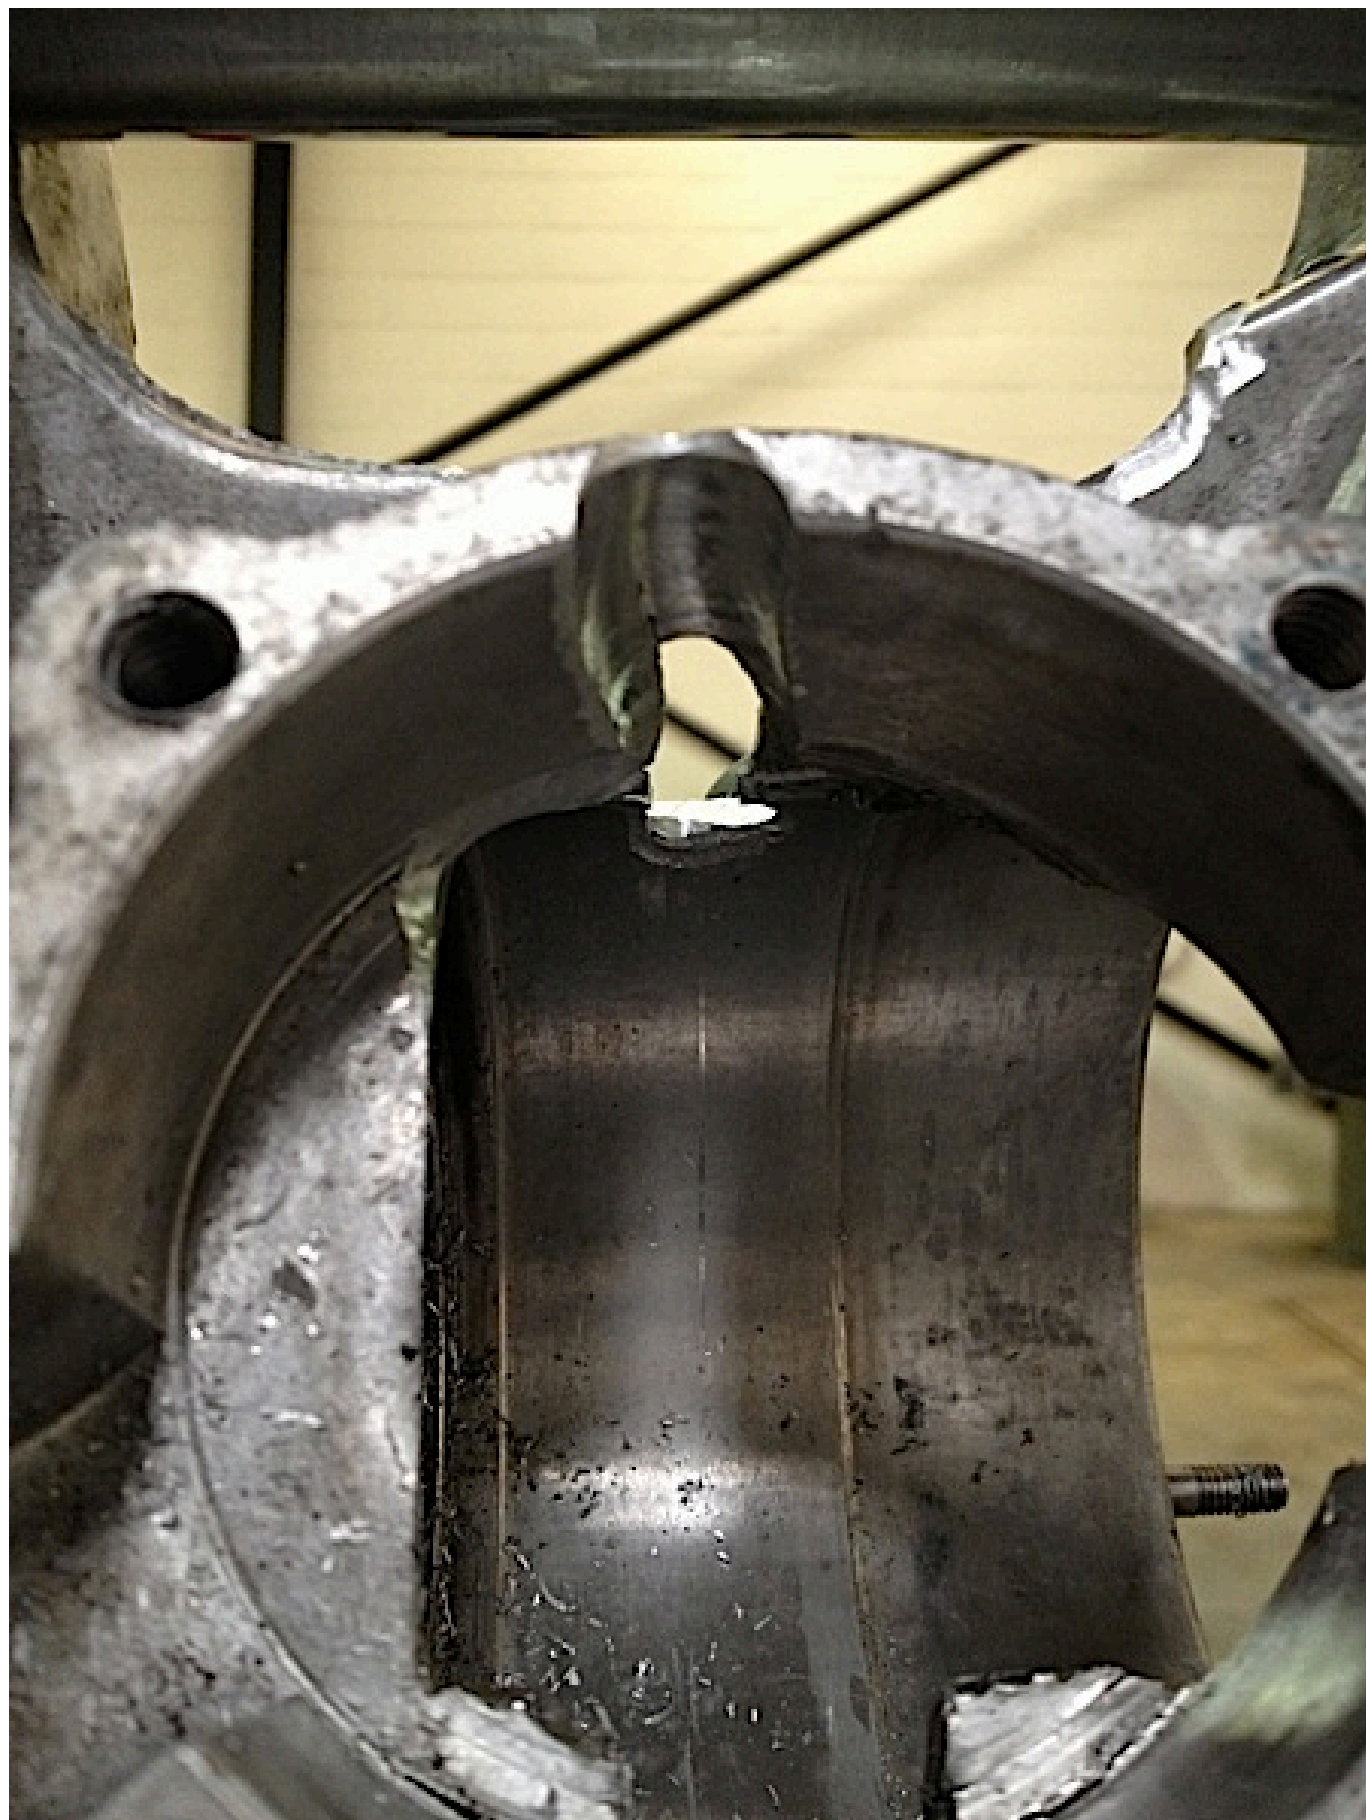
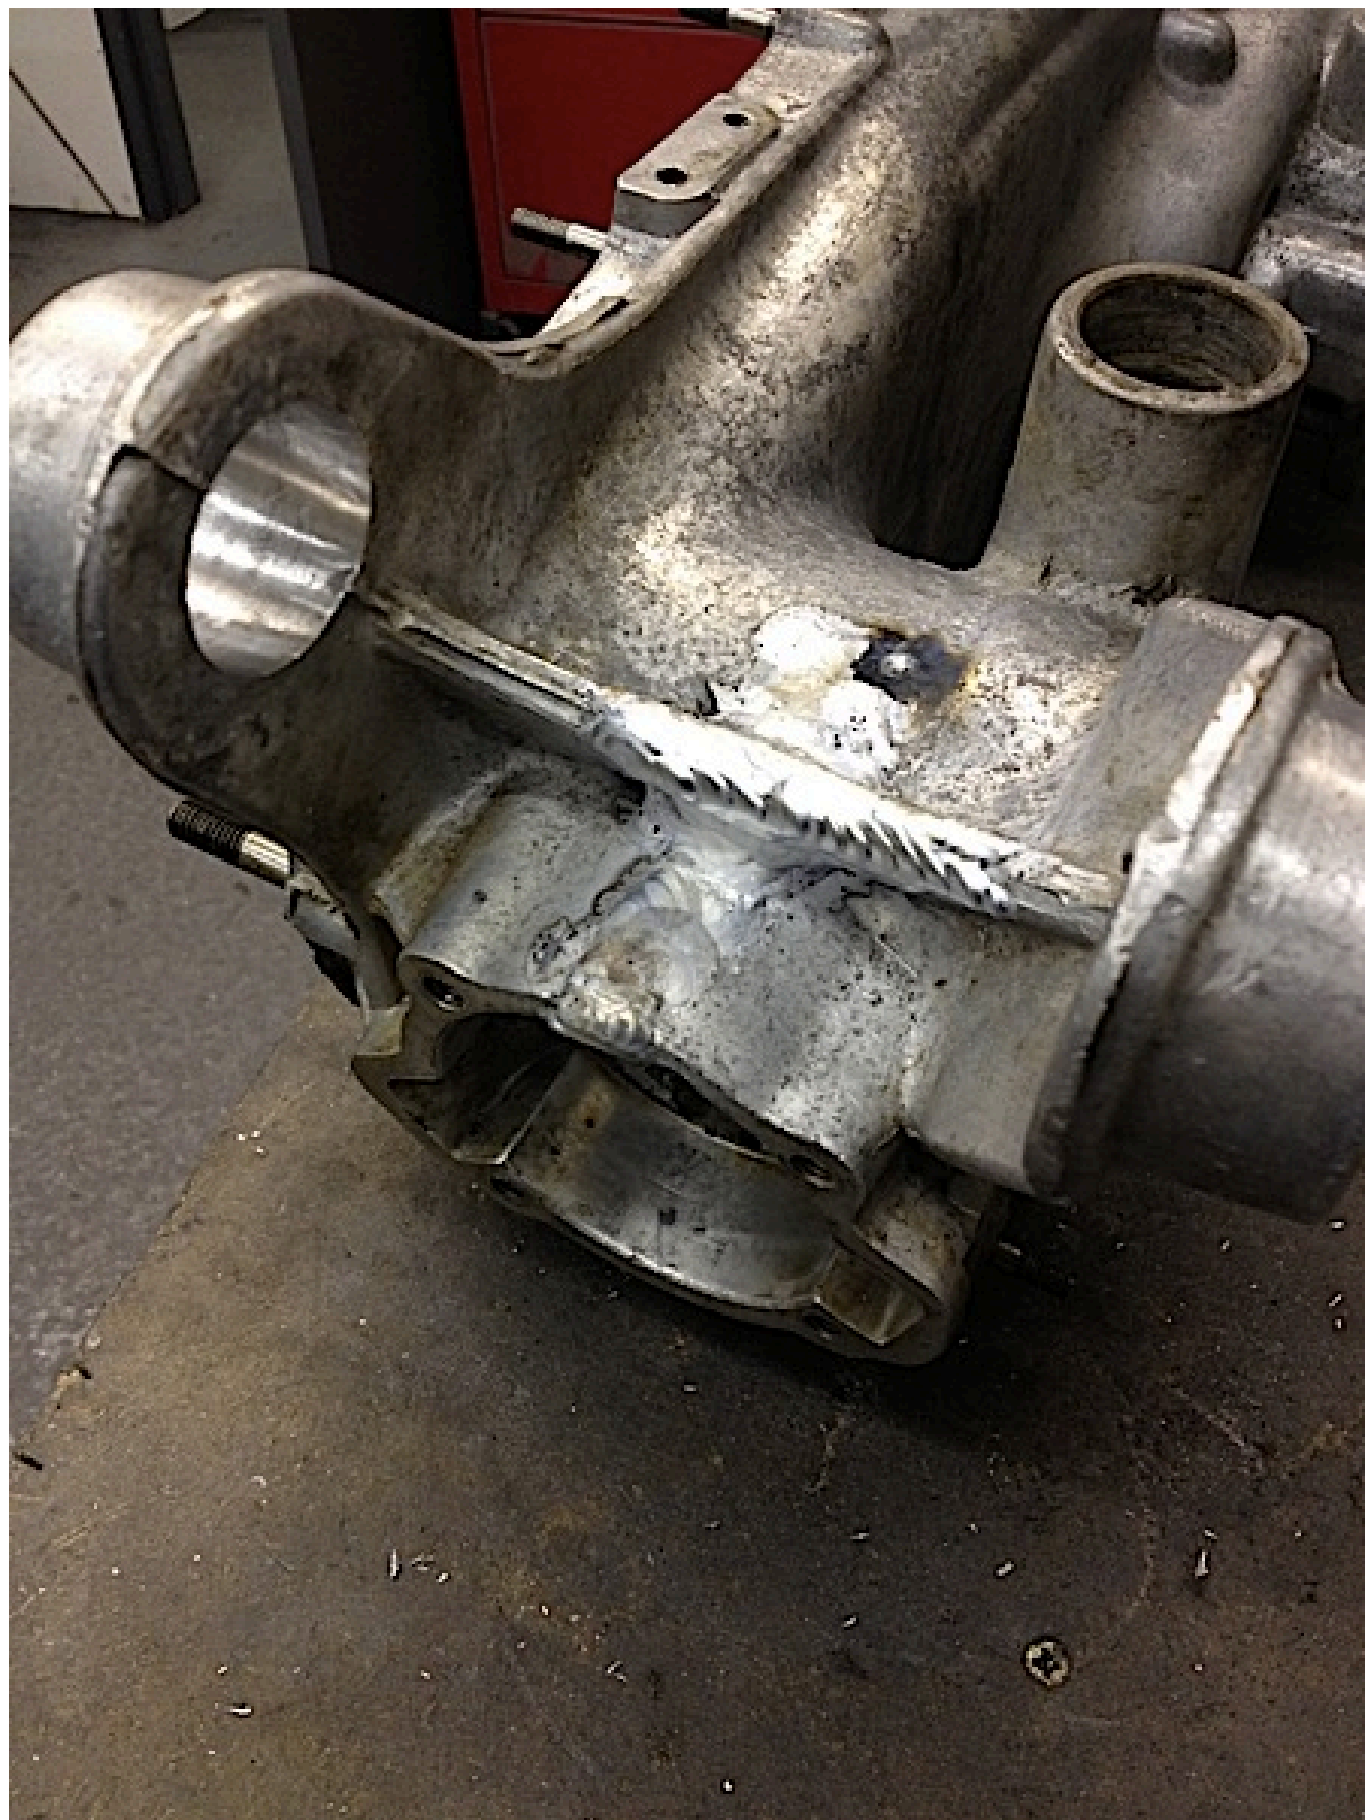
A good customer called today with this casing. Ouch! An AF crankshafts con rod had snapped and wrecked the casing!

He also brought in one of our MB super thin pistons, in fact it's the thinnest version of all our pistons, of course it had cracked but not all the way through. Wow, how strong are our pistons? It totally saved the cylinder which was a cast iron version and had no damage. We've seen a PM rod snap in the same place on an RB and again the piston didn't shatter! When we say a forged piston is stronger this is the proof, you don't get this with cast pistons, usually the cylinder is also destroyed.

Unfortunately the casing didn't hold. On first inspection it looked a simple job to repair. But as I started to prep it for welding I was chasing cracks all over. It's a typical Indian 200 the little noggins in the casing were all cracked one had already disappeared so it was a case of follow the cracks, grind them out, weld up the hole and make it look good.
