# Engine – Repair scrap to new

TOTAL SCRAP TO NEAR NEW, ALL IN A DAYS WORK

Another Genuine 200 ready to be put back on the road.

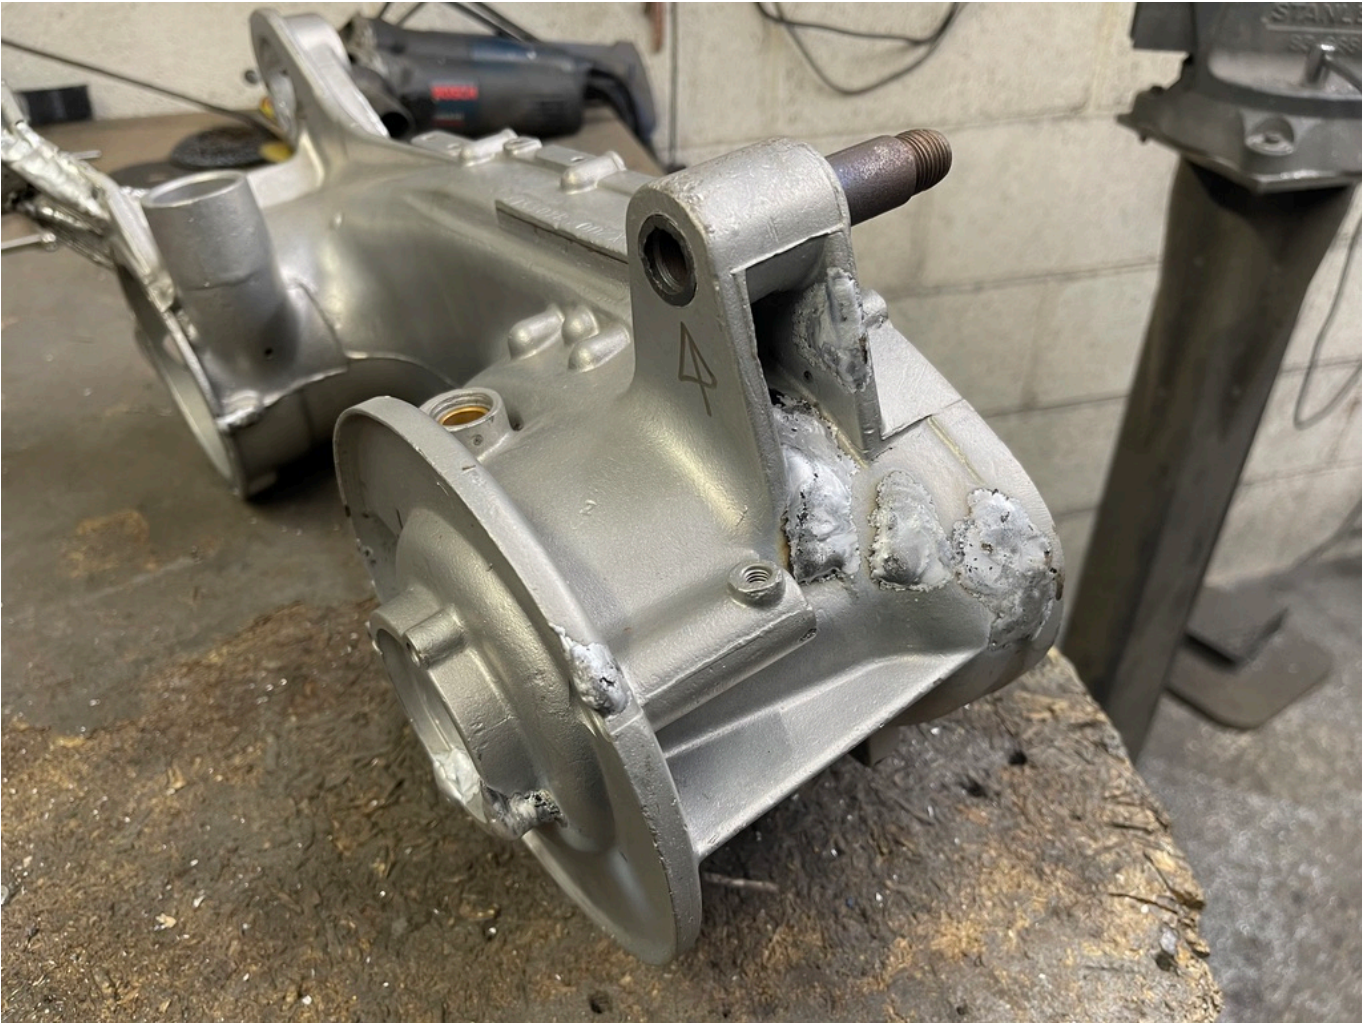
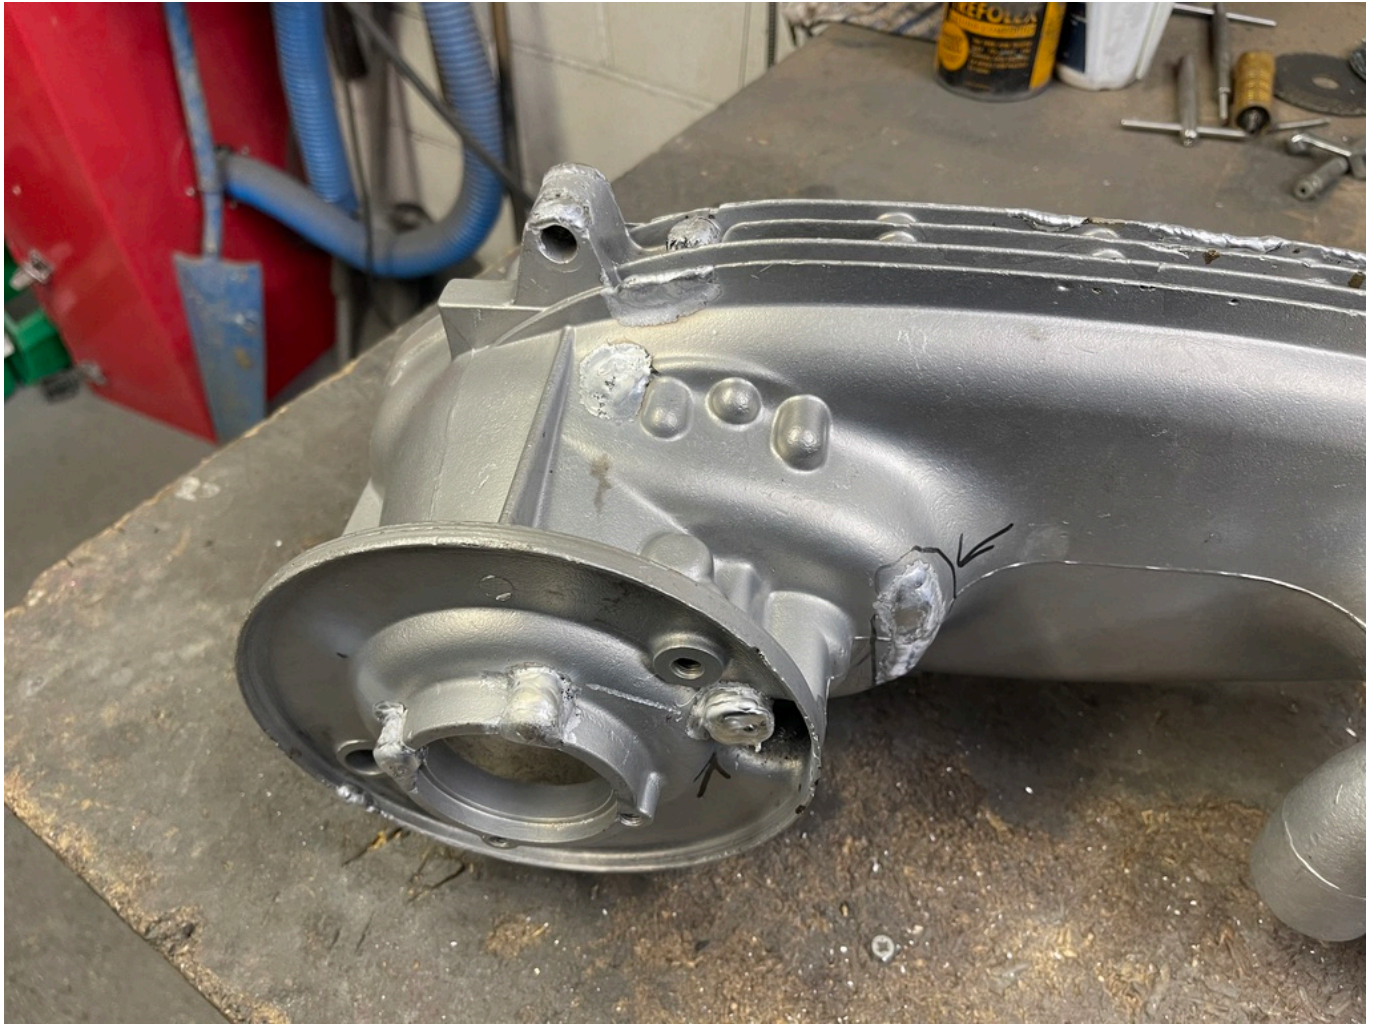
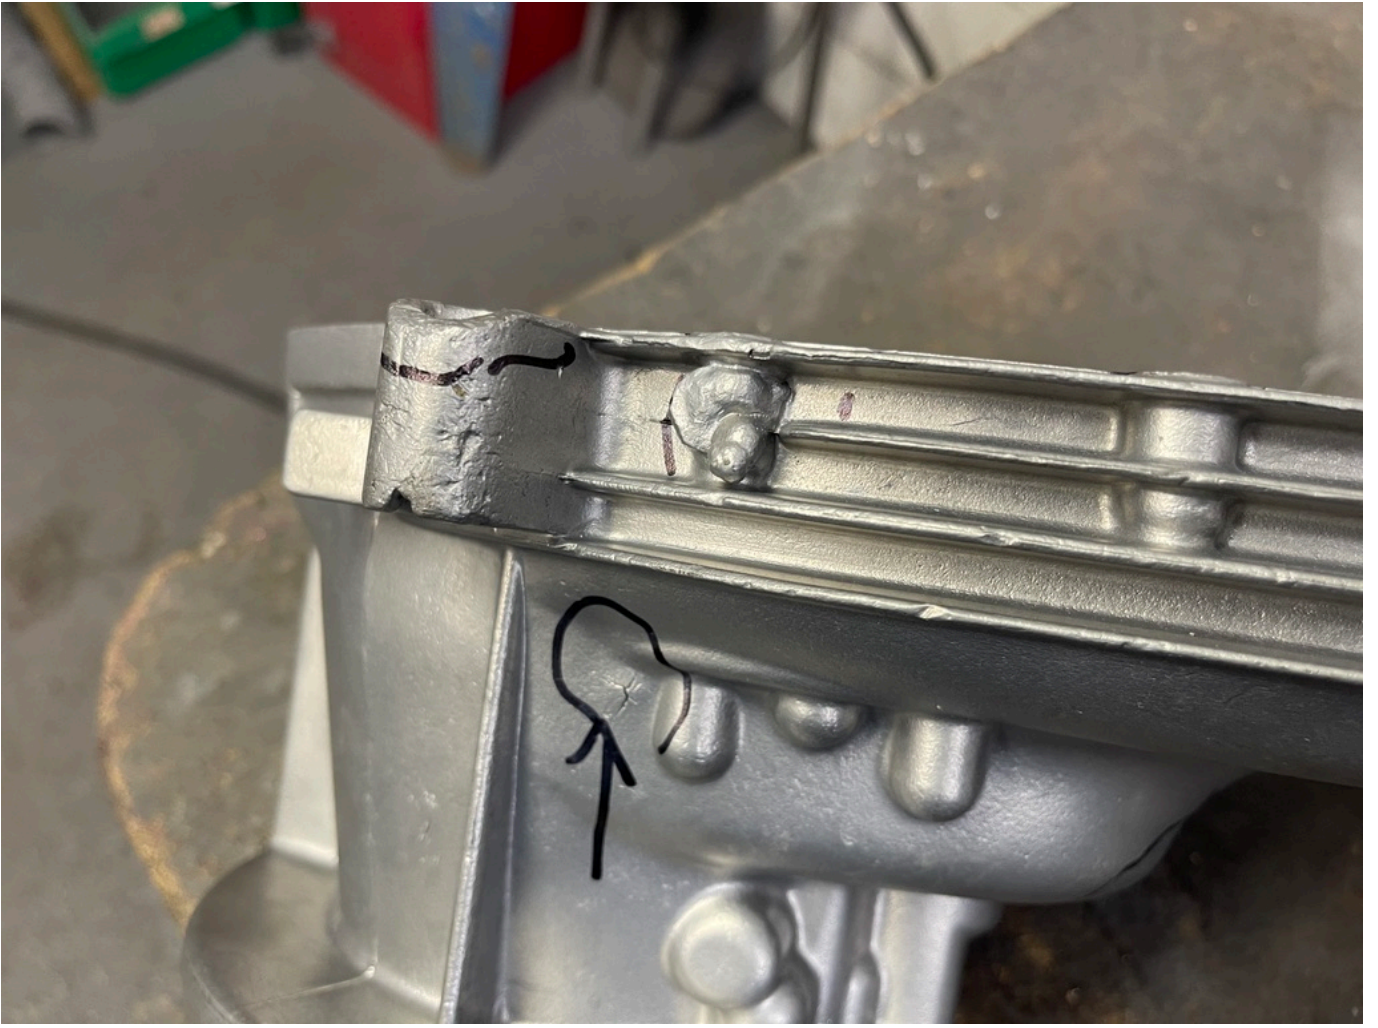
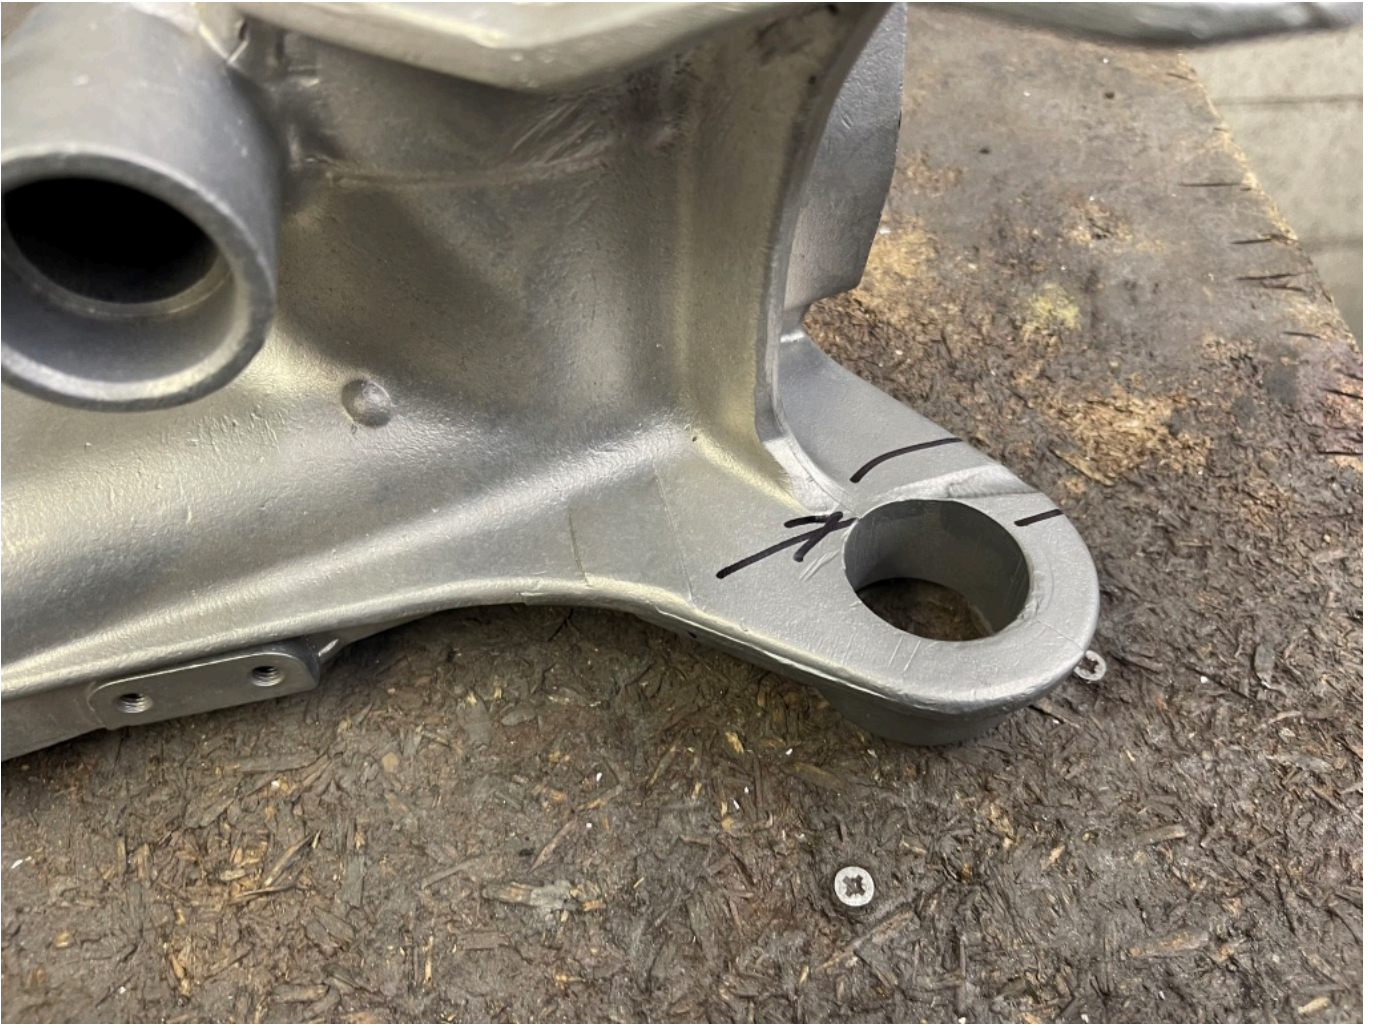
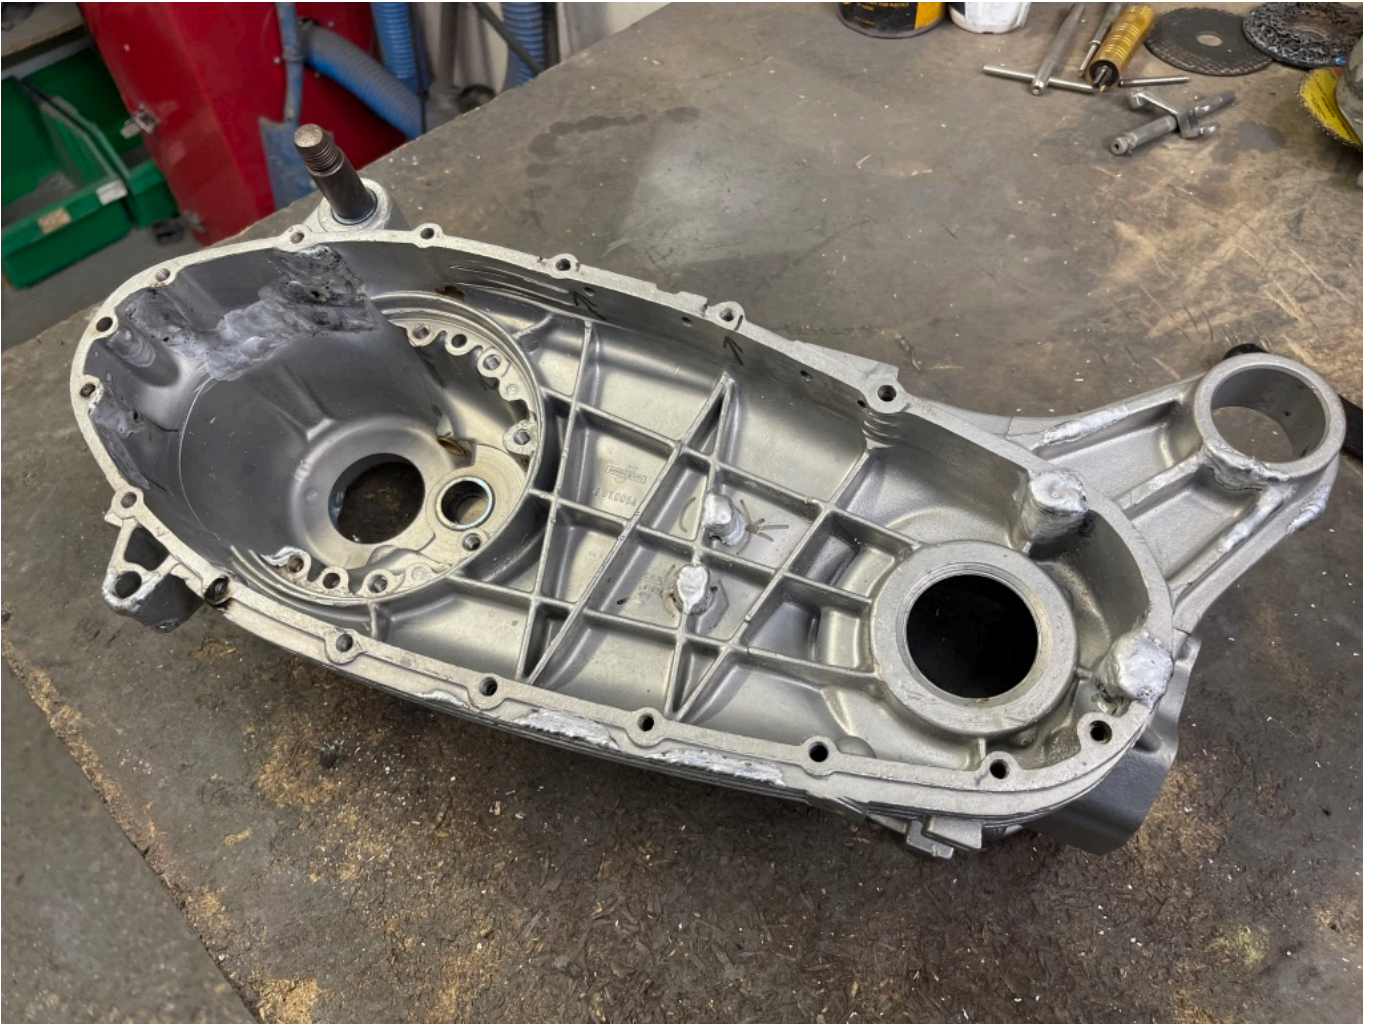
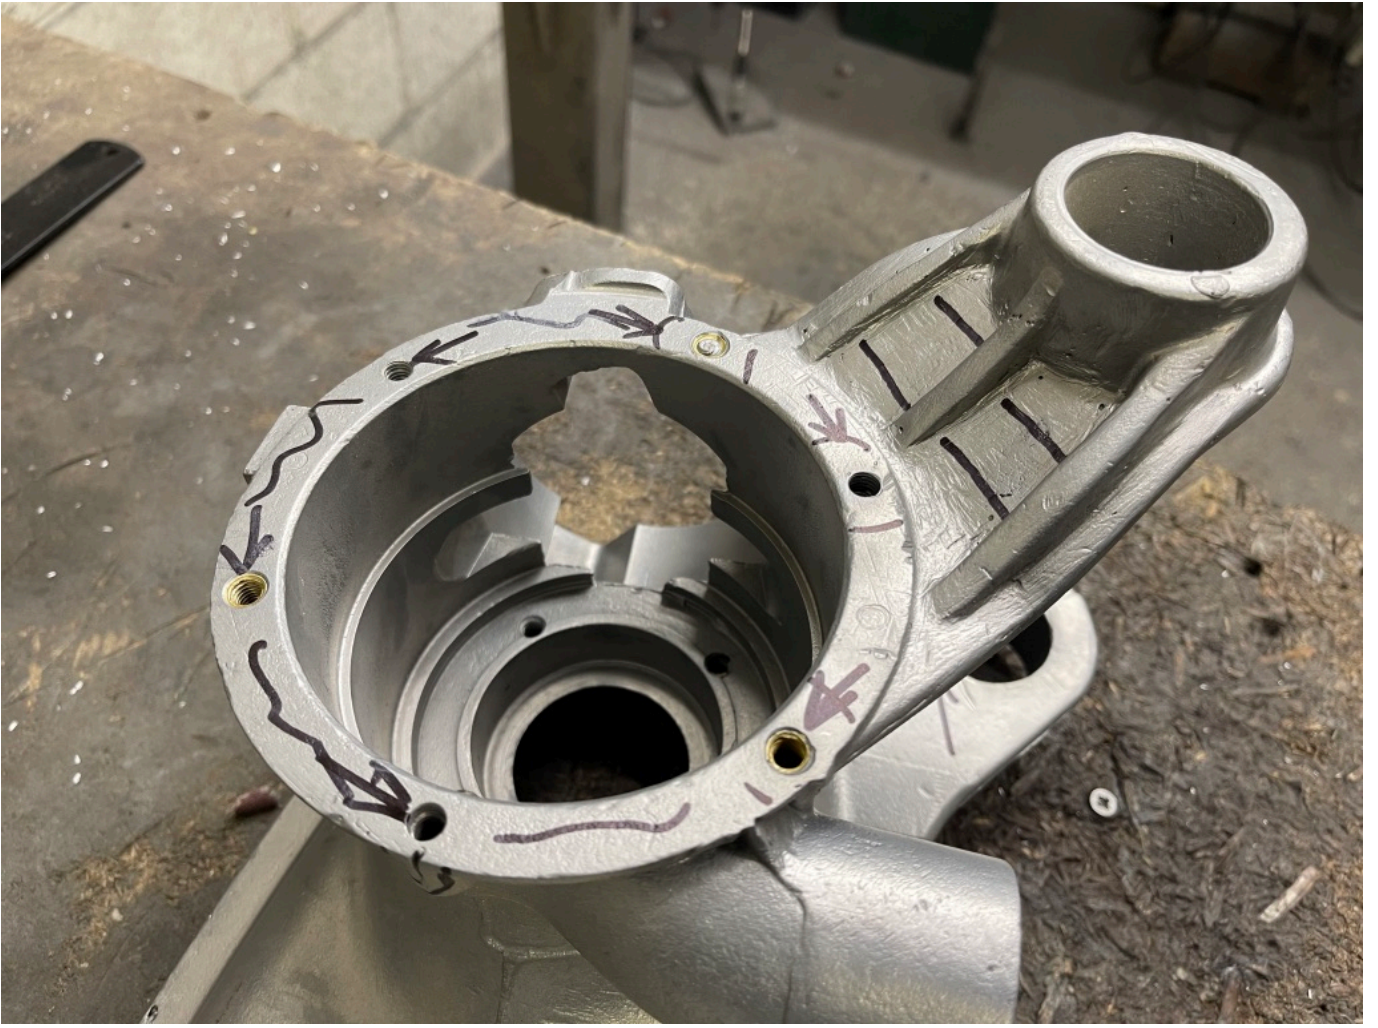
Nearly every thread was gone, or repaired in a bad way. There was cracks, and there was badly welded repairs, there was the obvious and there was some cosmetic wear. Even the rear brake cam was worn out as was the casing where the gear arm pivots! It was F@ked!

And so I went grinding out old welds, grinding out cracks, welding, machining, more drilling, tapping and fitting inserts and machining threads, then more grinding and grinding and polishing and finally finished off with our bead and aqua blasting services to hide all the work – after 15 hours it was done!
