Engine – Repair mag crack

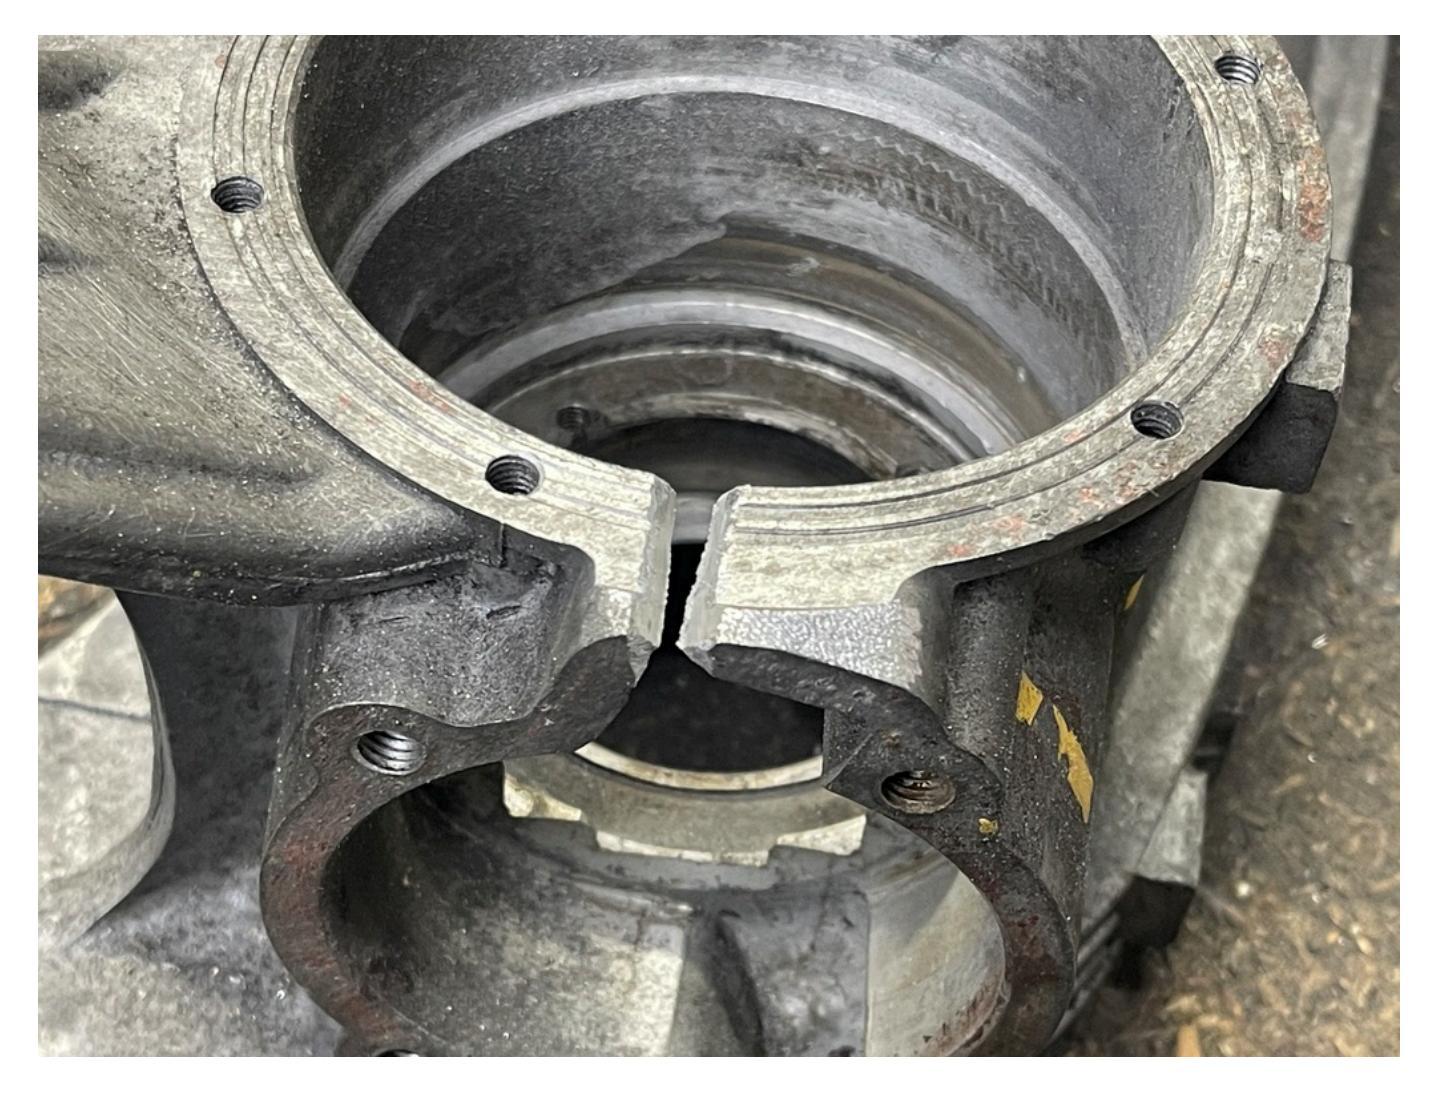
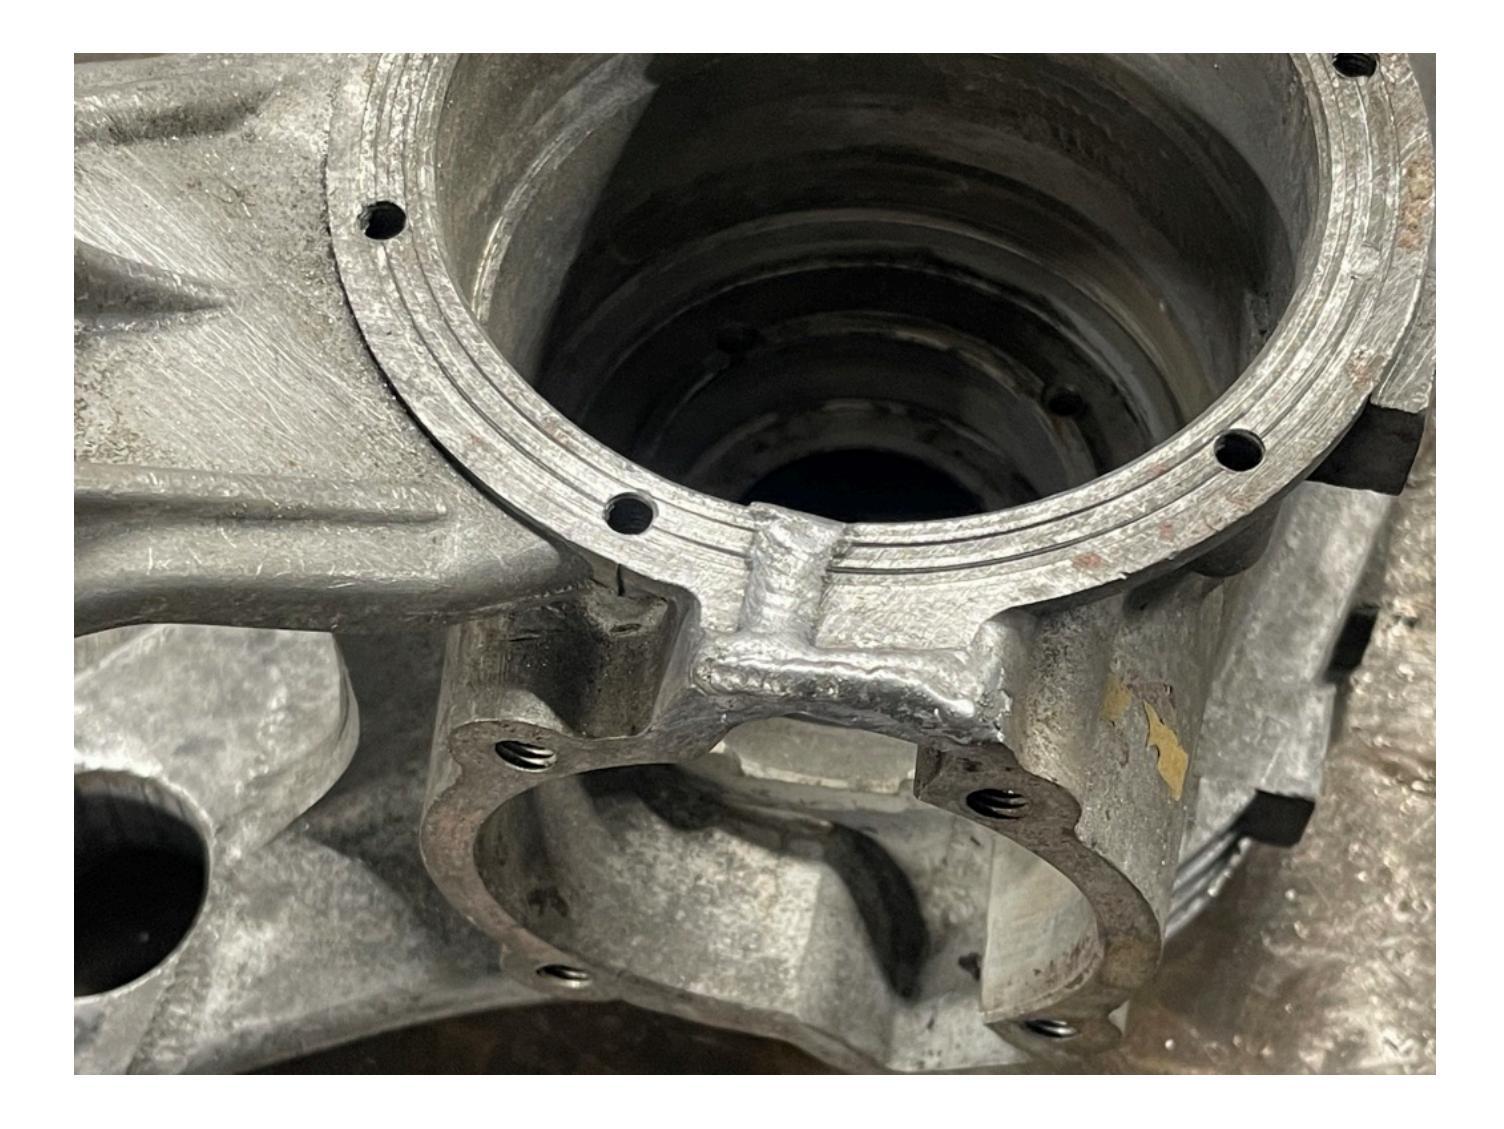
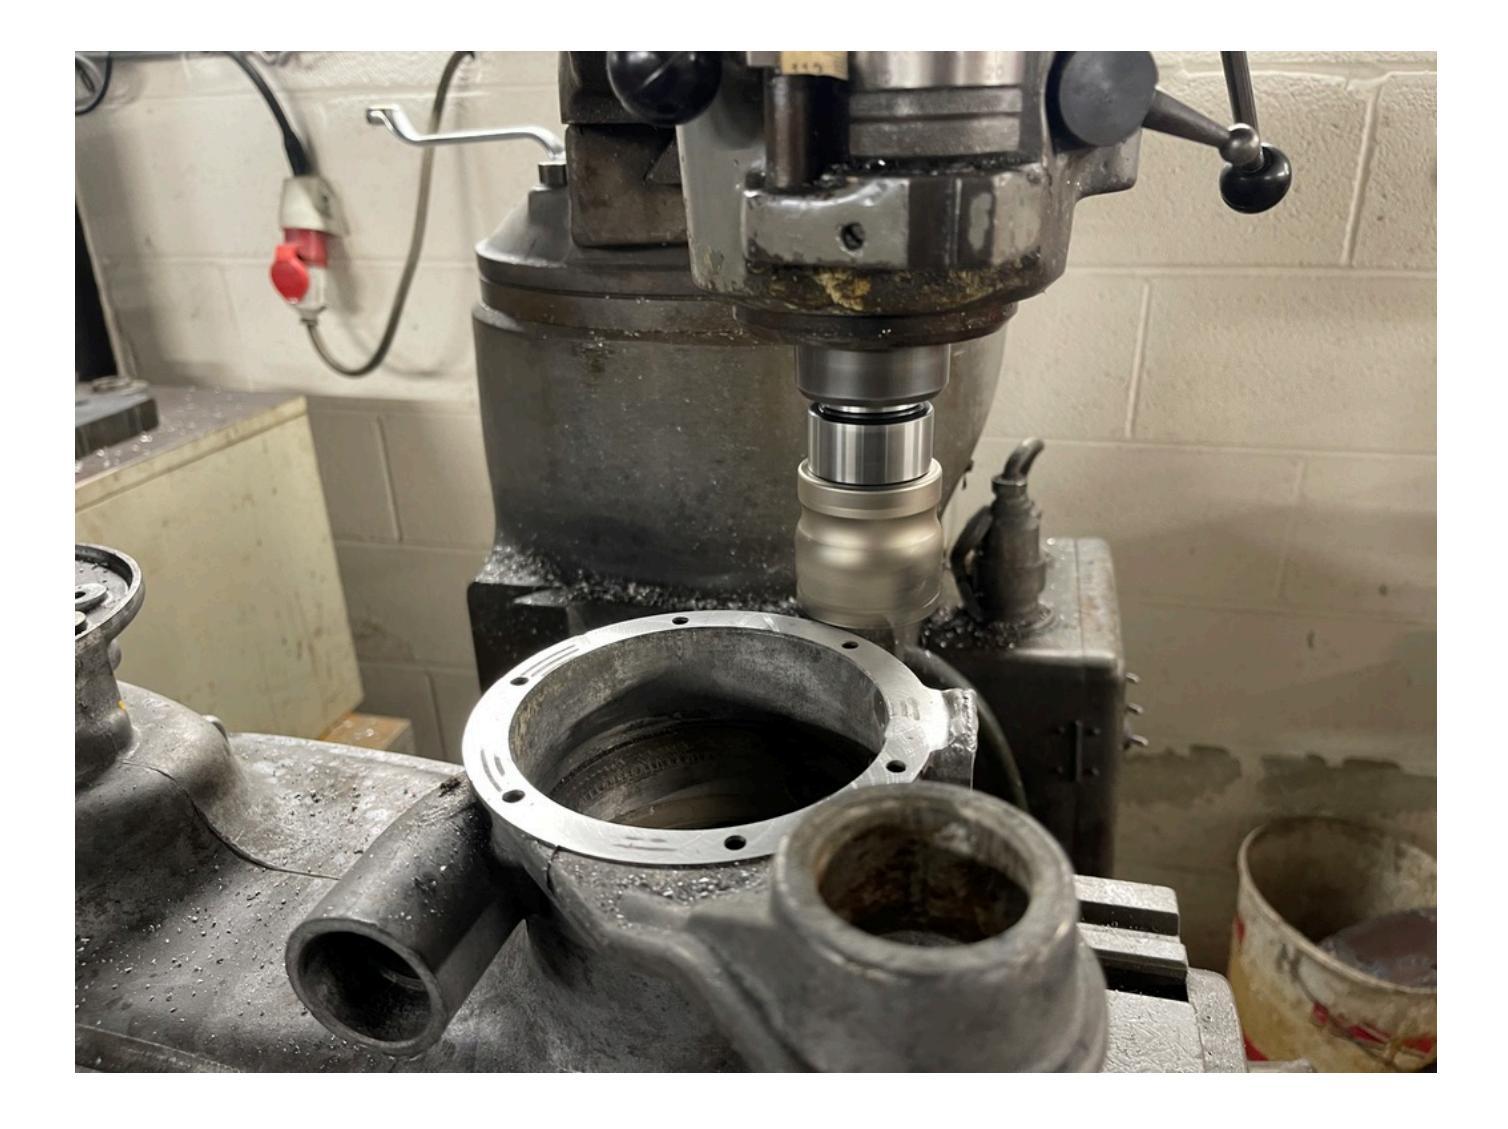
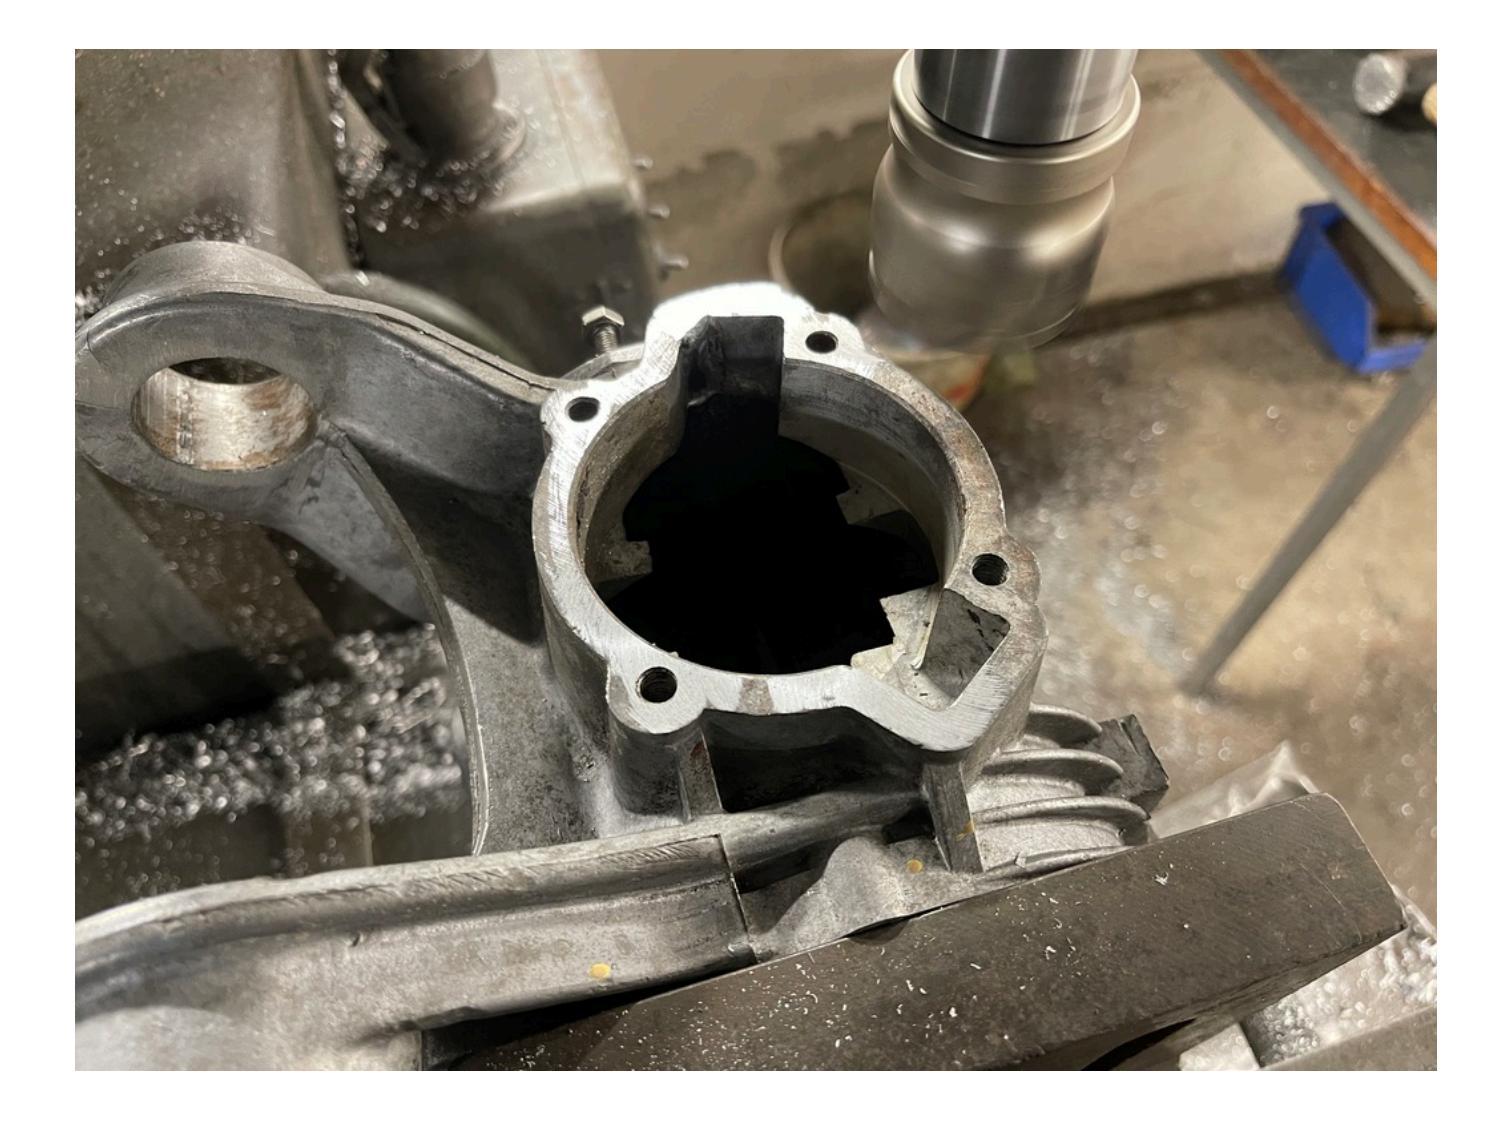
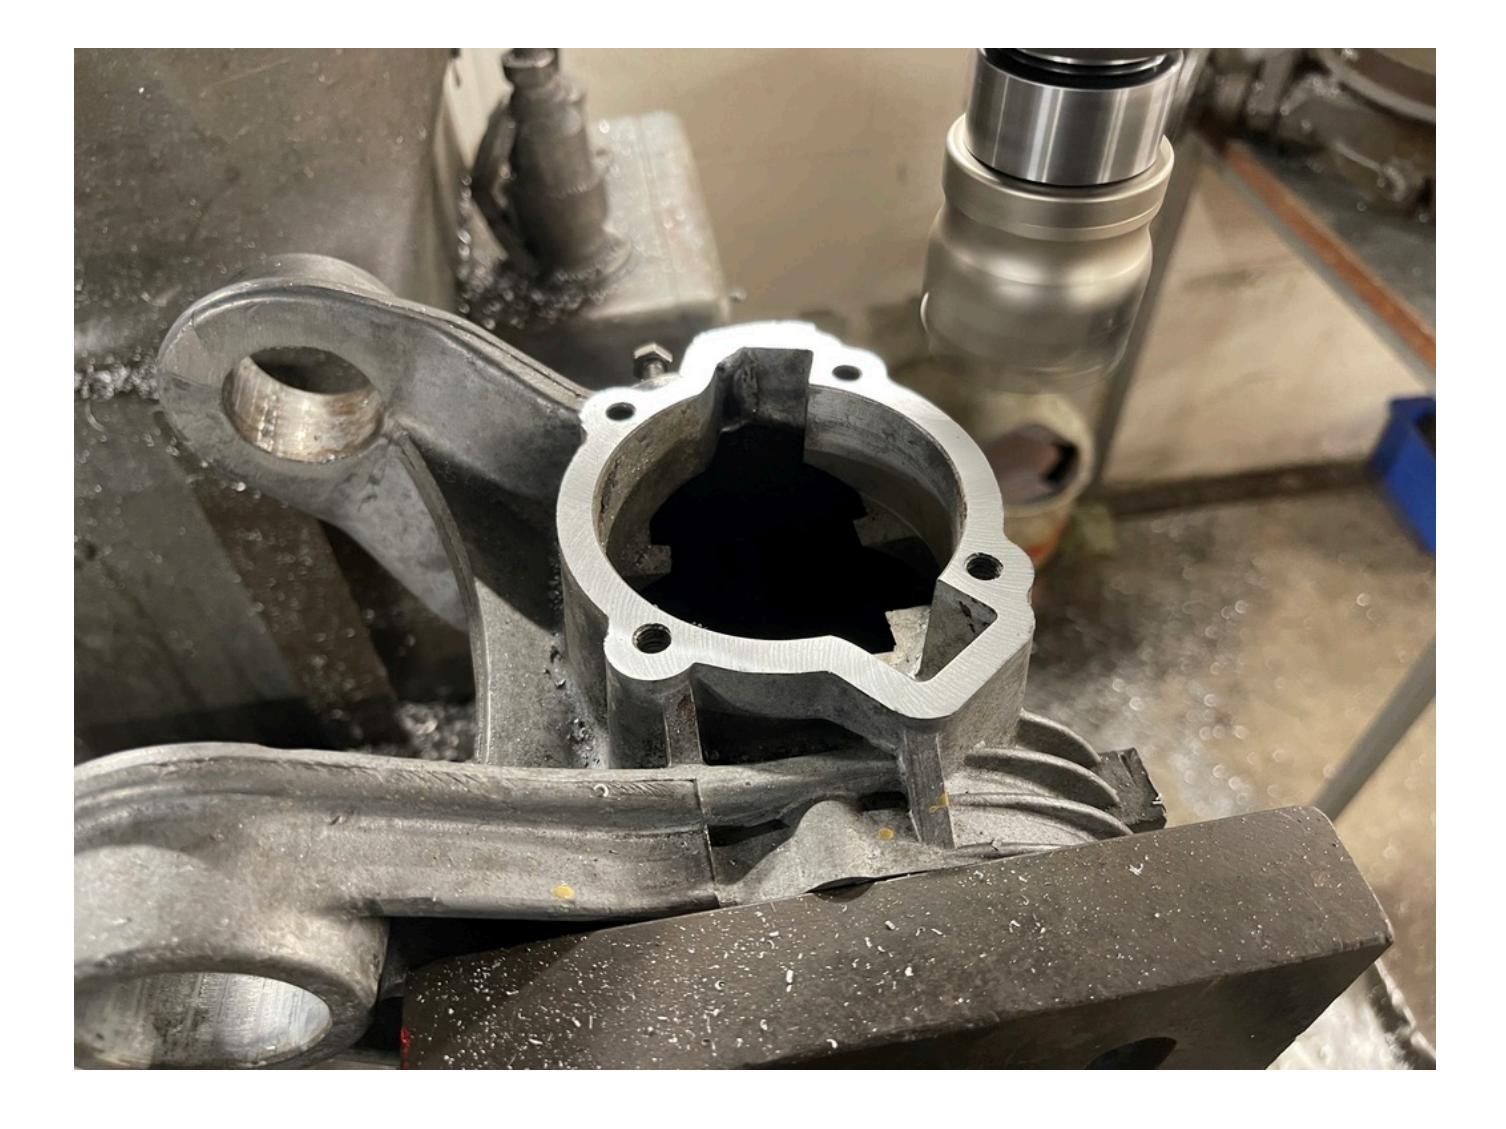
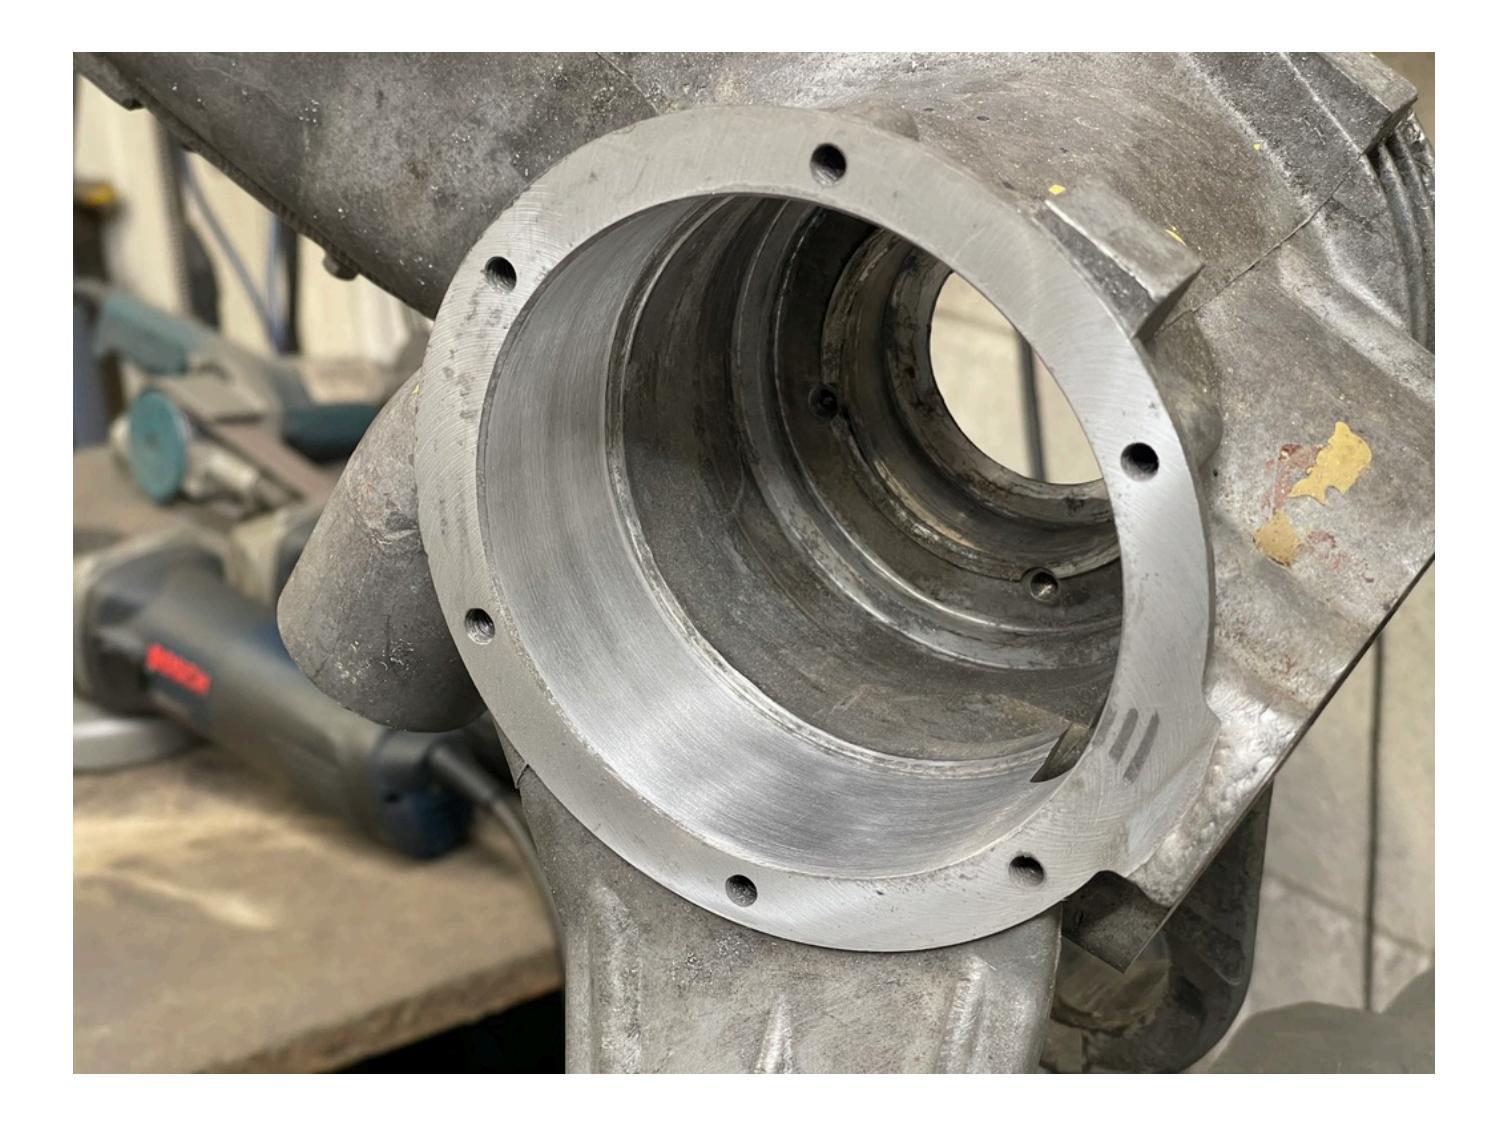
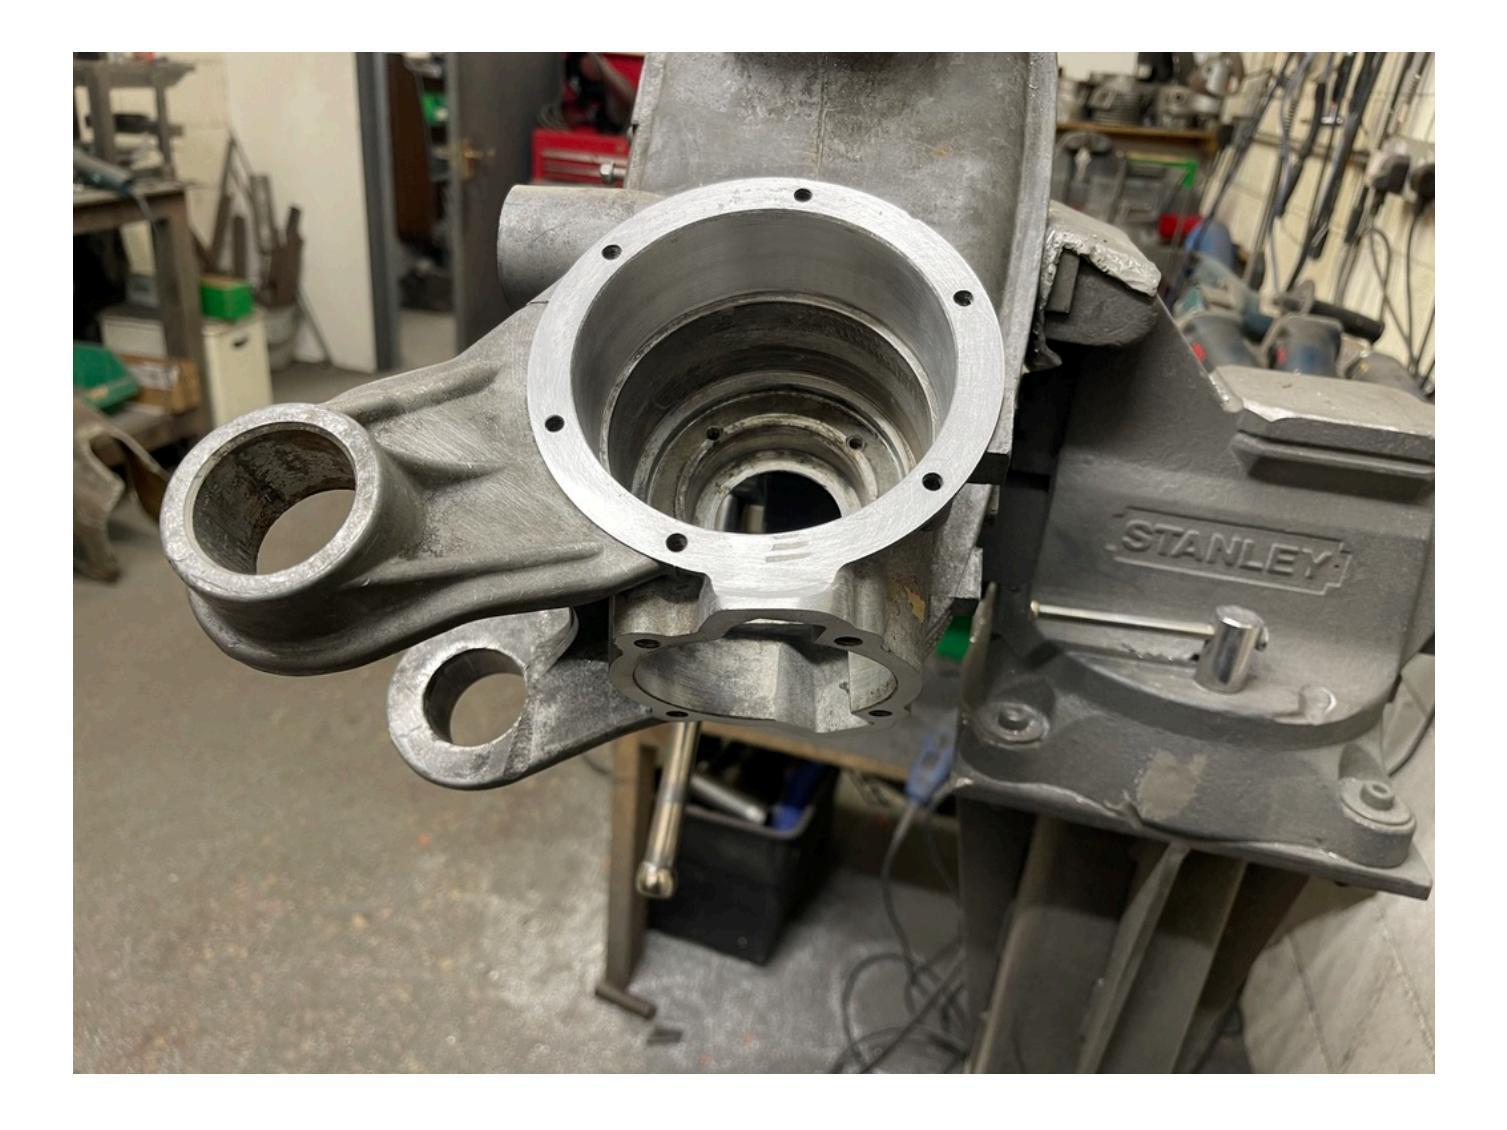
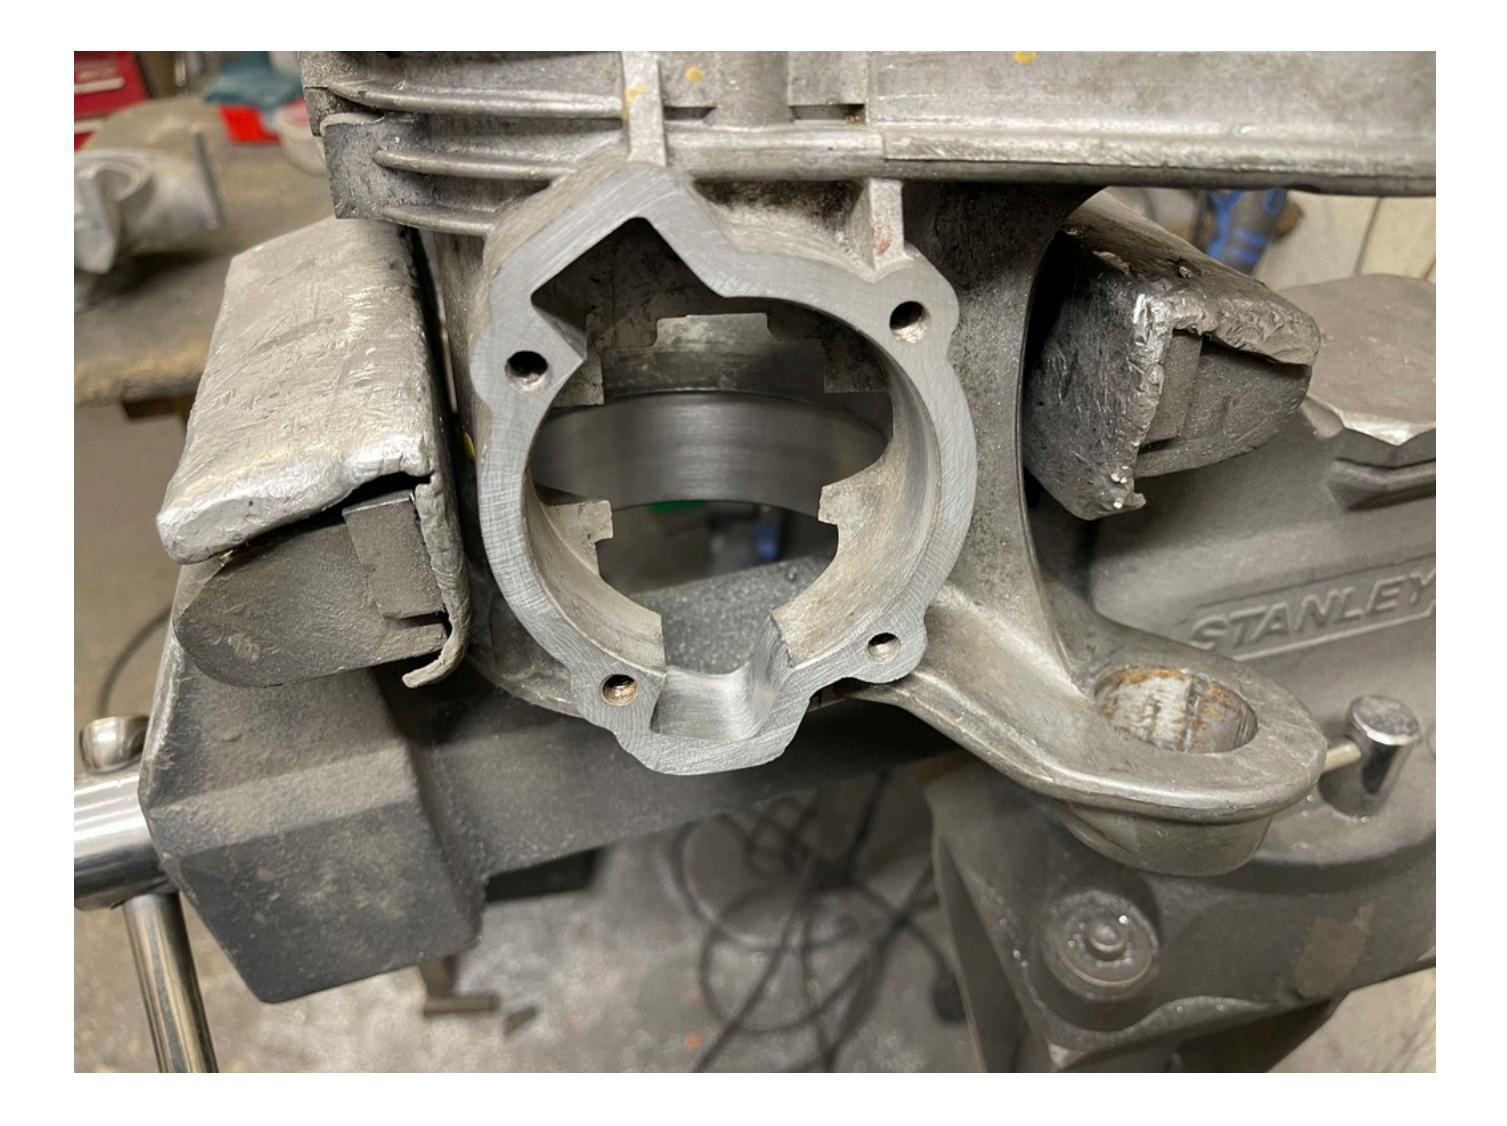
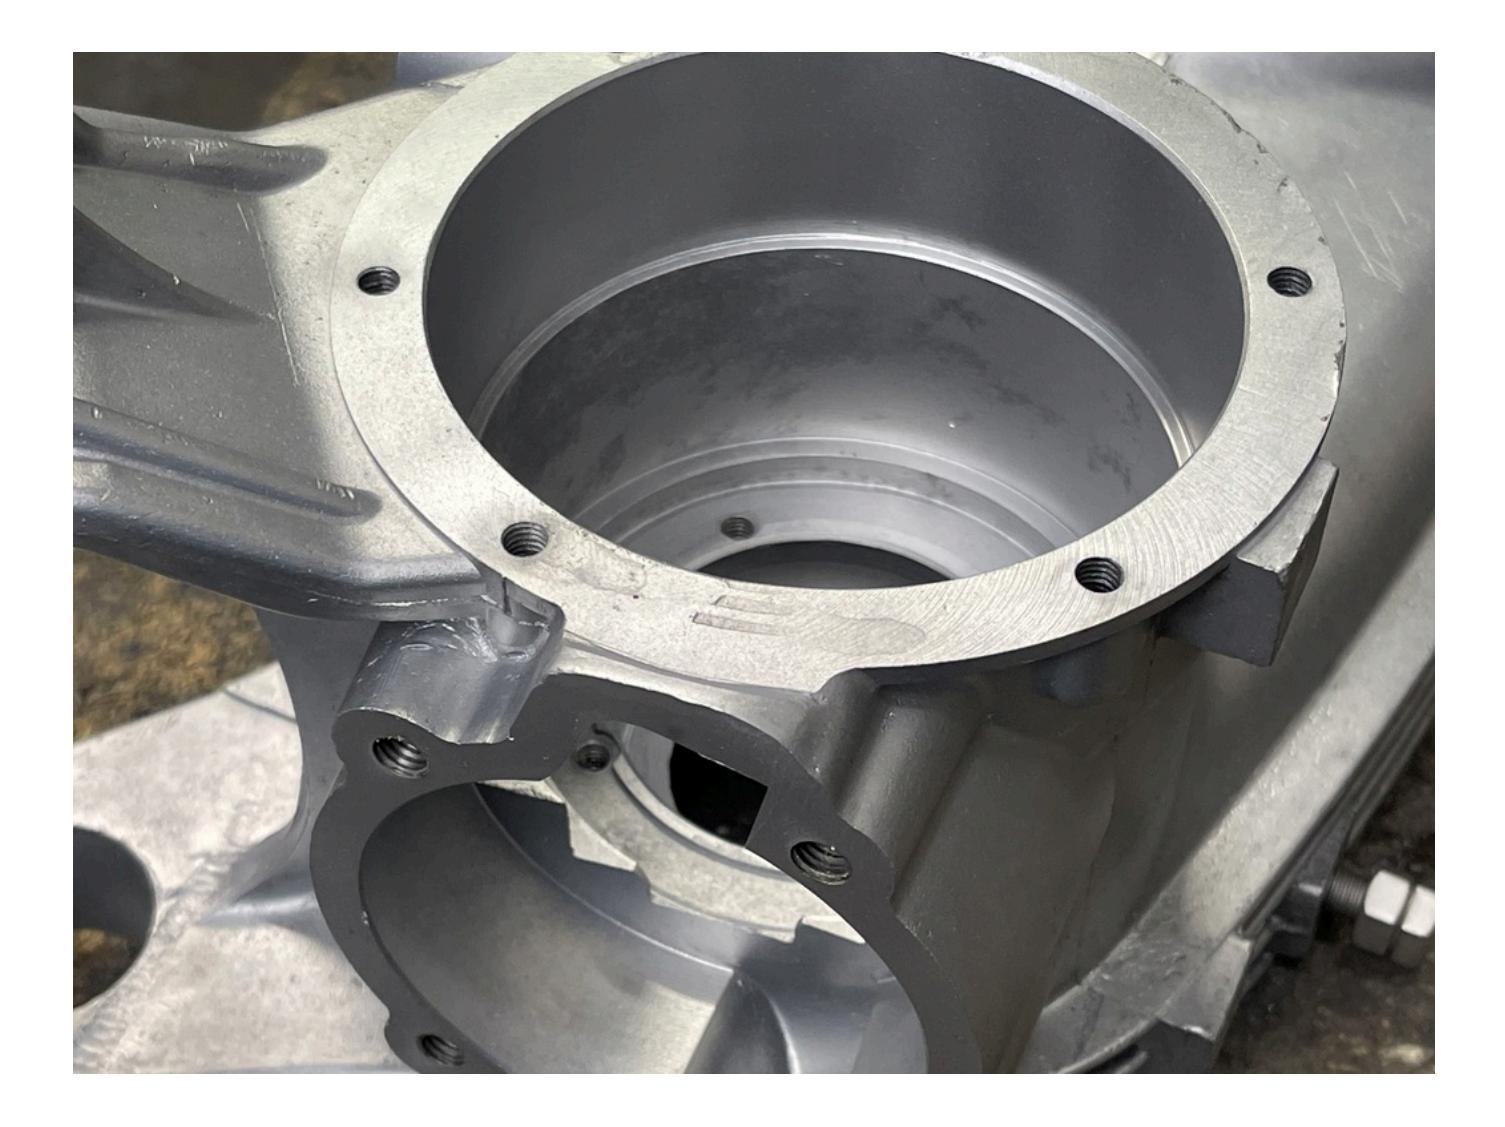
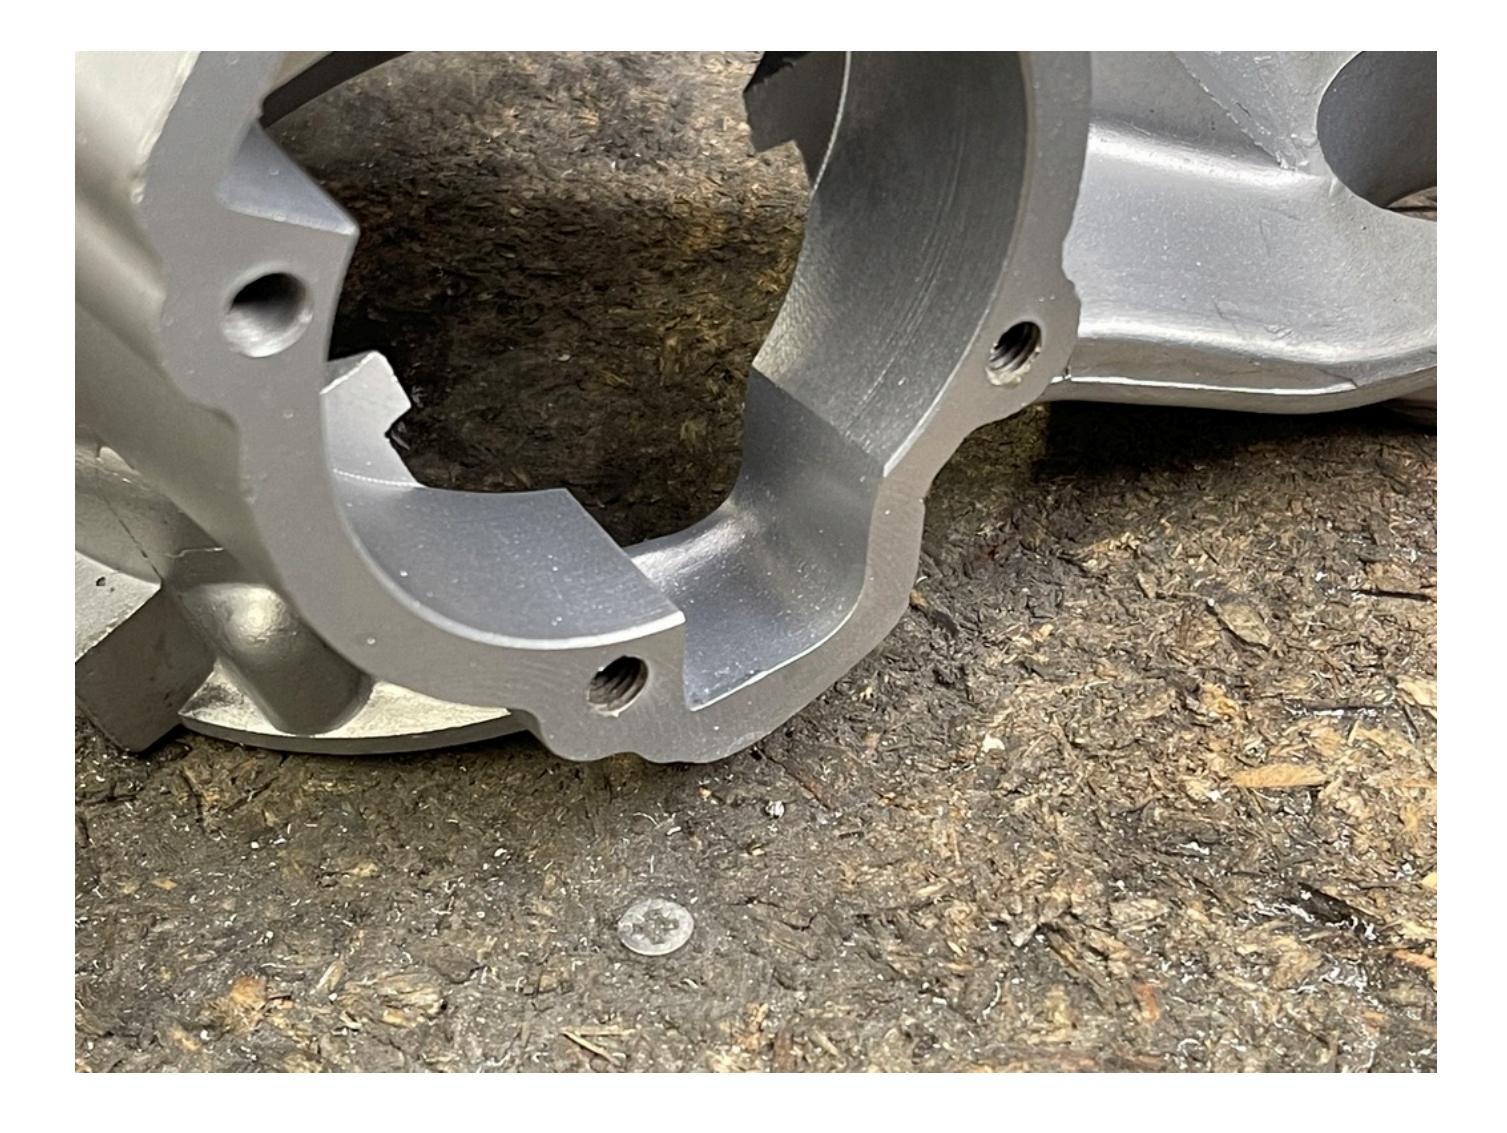
What ever — it weakens the casing. Especially on the mag face and it's very common to see a crack through into the transfer port — which is the weak link in all large block casings. This happens on Italian and SIL casings also but mainly the Spanish.

If you weld in this area everything distorts, some do it and only file the face. If you check the photos you can see high and low spots even though it's been machined. The idea is to machine as little off as you can and still get a seal on the gasket faces.

As with all welding jobs, the casing has to be totally stripped, all studs removed and the casing cleaned to remove as much oil as possible. But even with our ultra sonic cleaner oil has been soaked into the casing and only comes out when it's heated up, causing problems for the welder.

With a clean casing you need to grind into the crack and prepare it to break the surface and find clean metal. It's important to pre heat a big casing, this stops a casing cracking and distorting more than it should. Once welded it needs cooling to do the machining which needs doing on a milling machine where the casing is clamped tight to the crankcase side face keeping the mag face as true as you can.

Now if everything goes well and the alloy welds okay there should be very little distortion, but this area is weak and distorts quite a lot. It's not uncommon to machine 0.5mm off the face, this is quite a lot and why we supply thicker mag gaskets to take up the meat thats been removed. Also the cylinder base has to be machined which requires removing the casing and resetting it vertical in the miller. Usually not much meat needs machining from this face but it usually shows people have butchered this area so it does need a few runs over it. Do the job right and the casing is good to go – don't do it right and you're always going to have a problem, especially if you do a pressure leak down test.

Whenever you weld in this area the mag housing hole distorts, you would have to hammer a mag housing in place — of course you don't want this. I hand polish inside the big hole and keep trying a mag housing to fid the high spots. You would ever manage this on the miller as there is nothing to clock up to to find centre and when you do this the hole ends up too big. Ideally a mag housing just drops straight into the casing — this makes an engine assembly much easier.
