Engine – Repair too much sealer will kill it

HOW NOT TO BUILD AN ENGINE

Once upon a time, not too long ago, this Gp 200 engine casing was a perfectly good engine casing – until Billy Butcher got his Bloody hands on it.

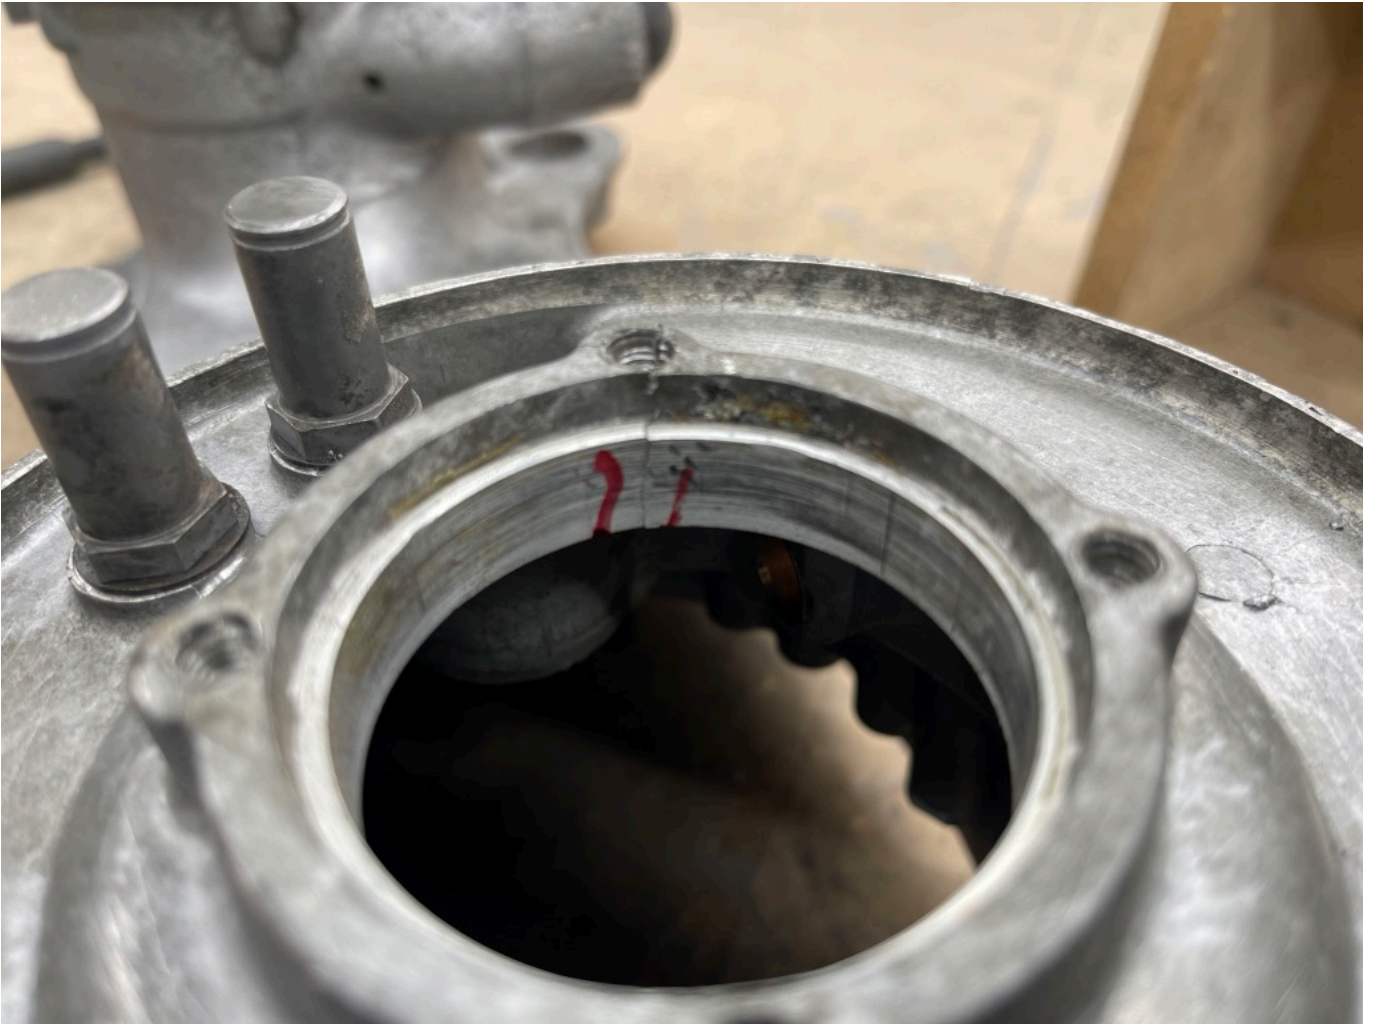
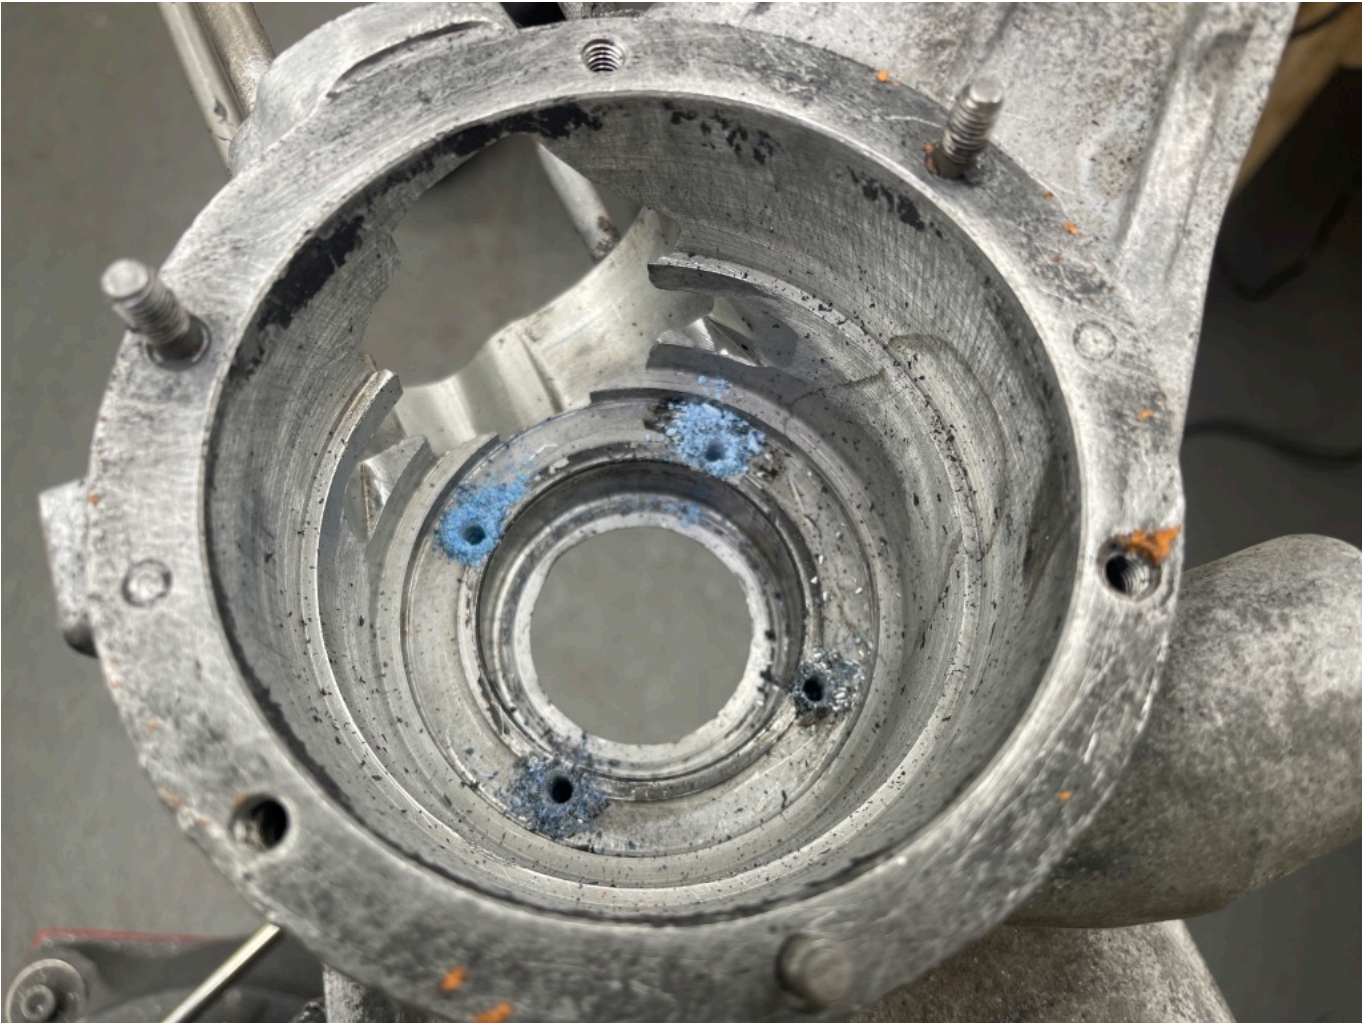
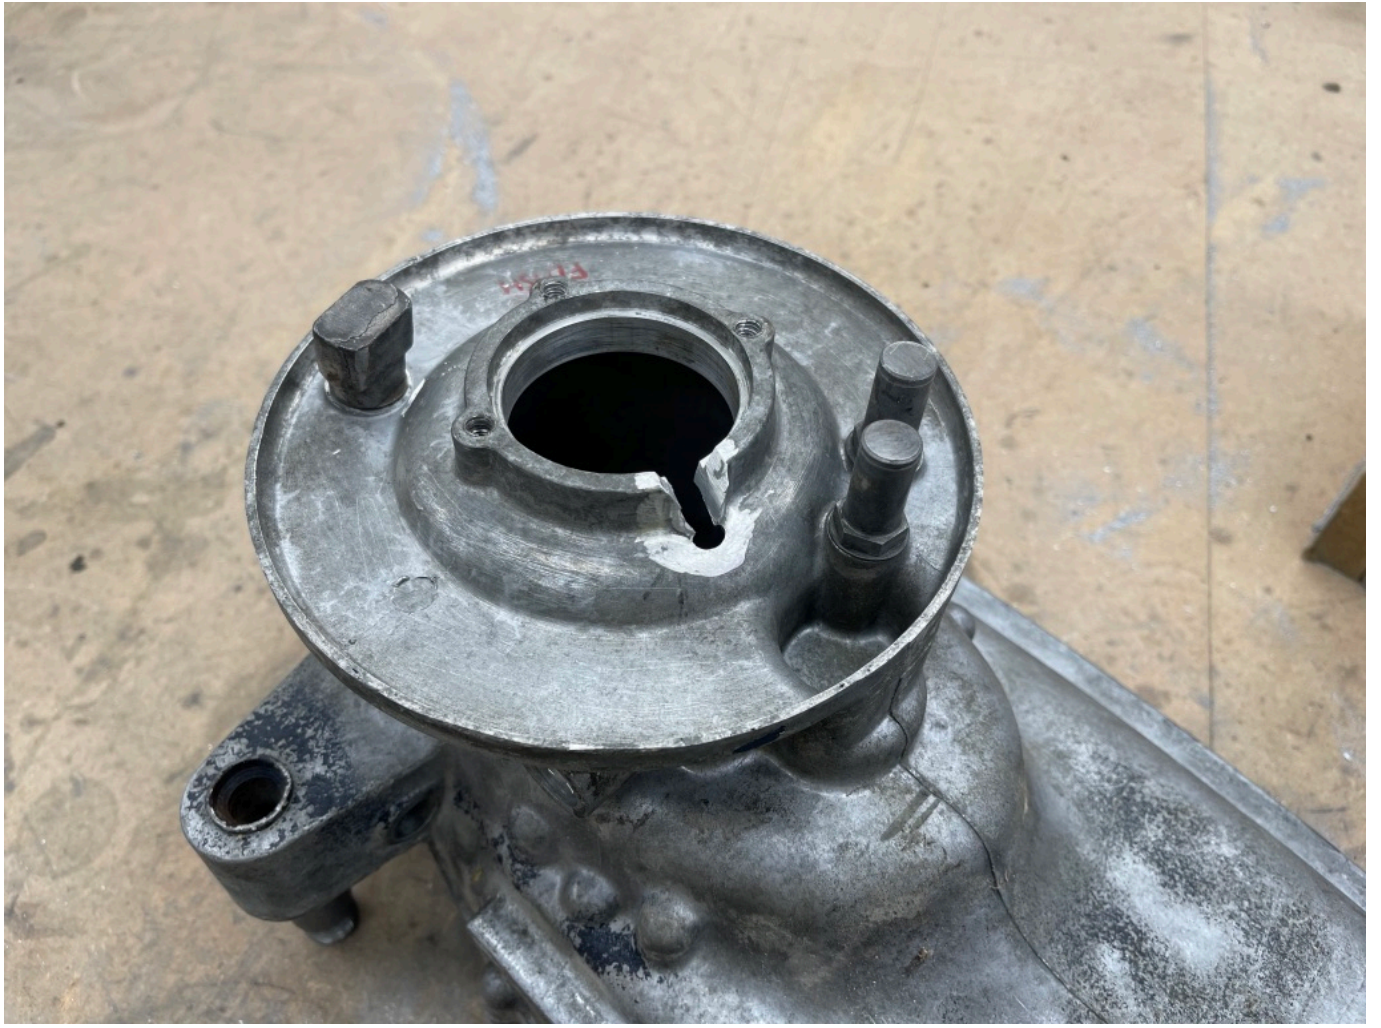
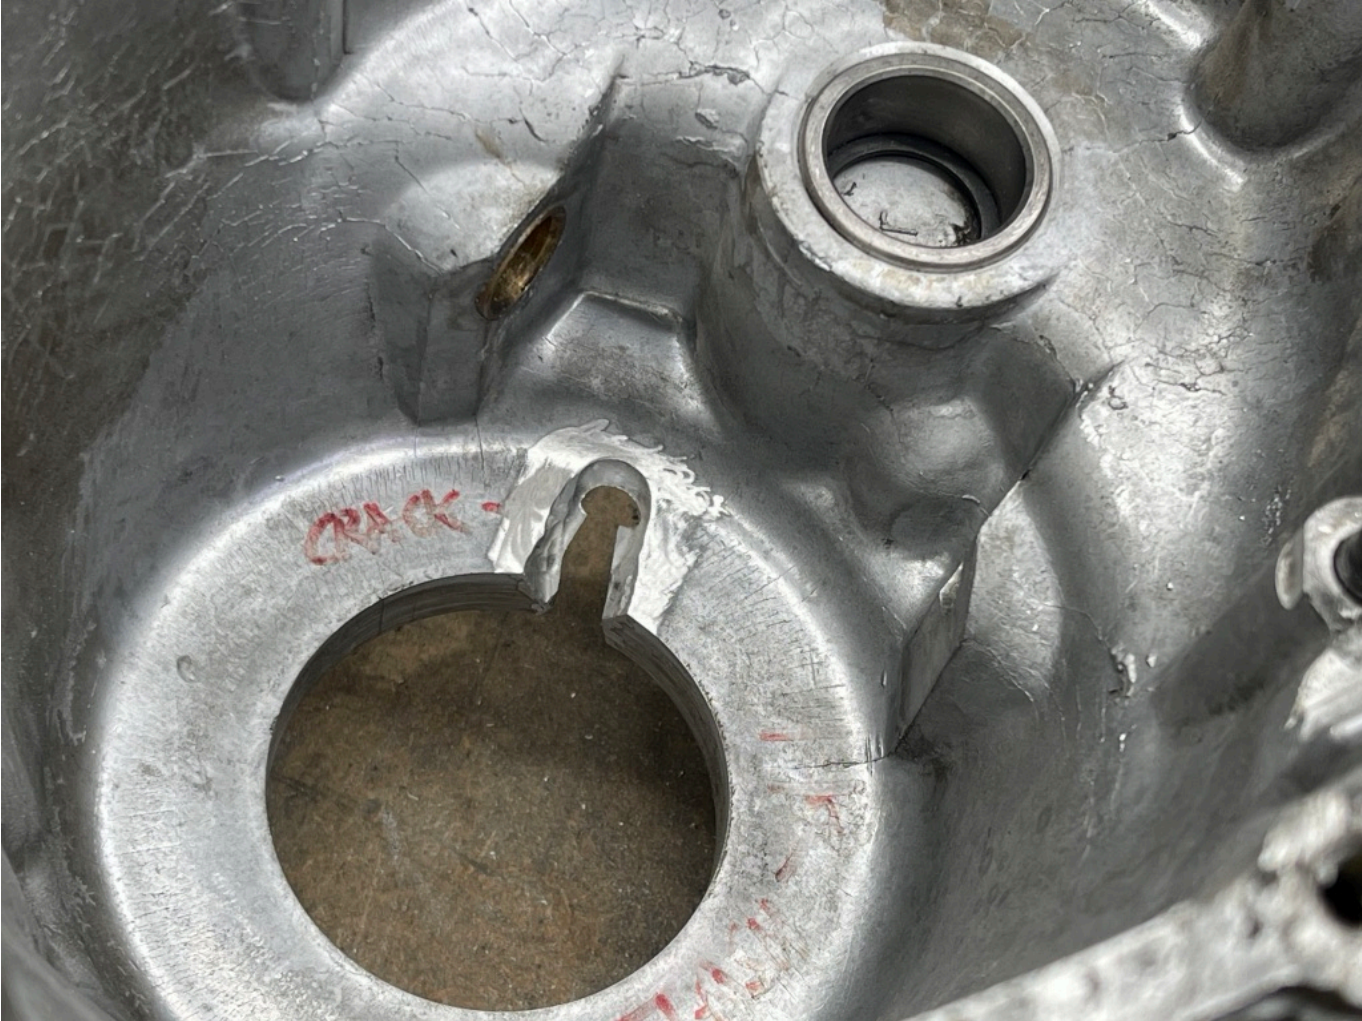
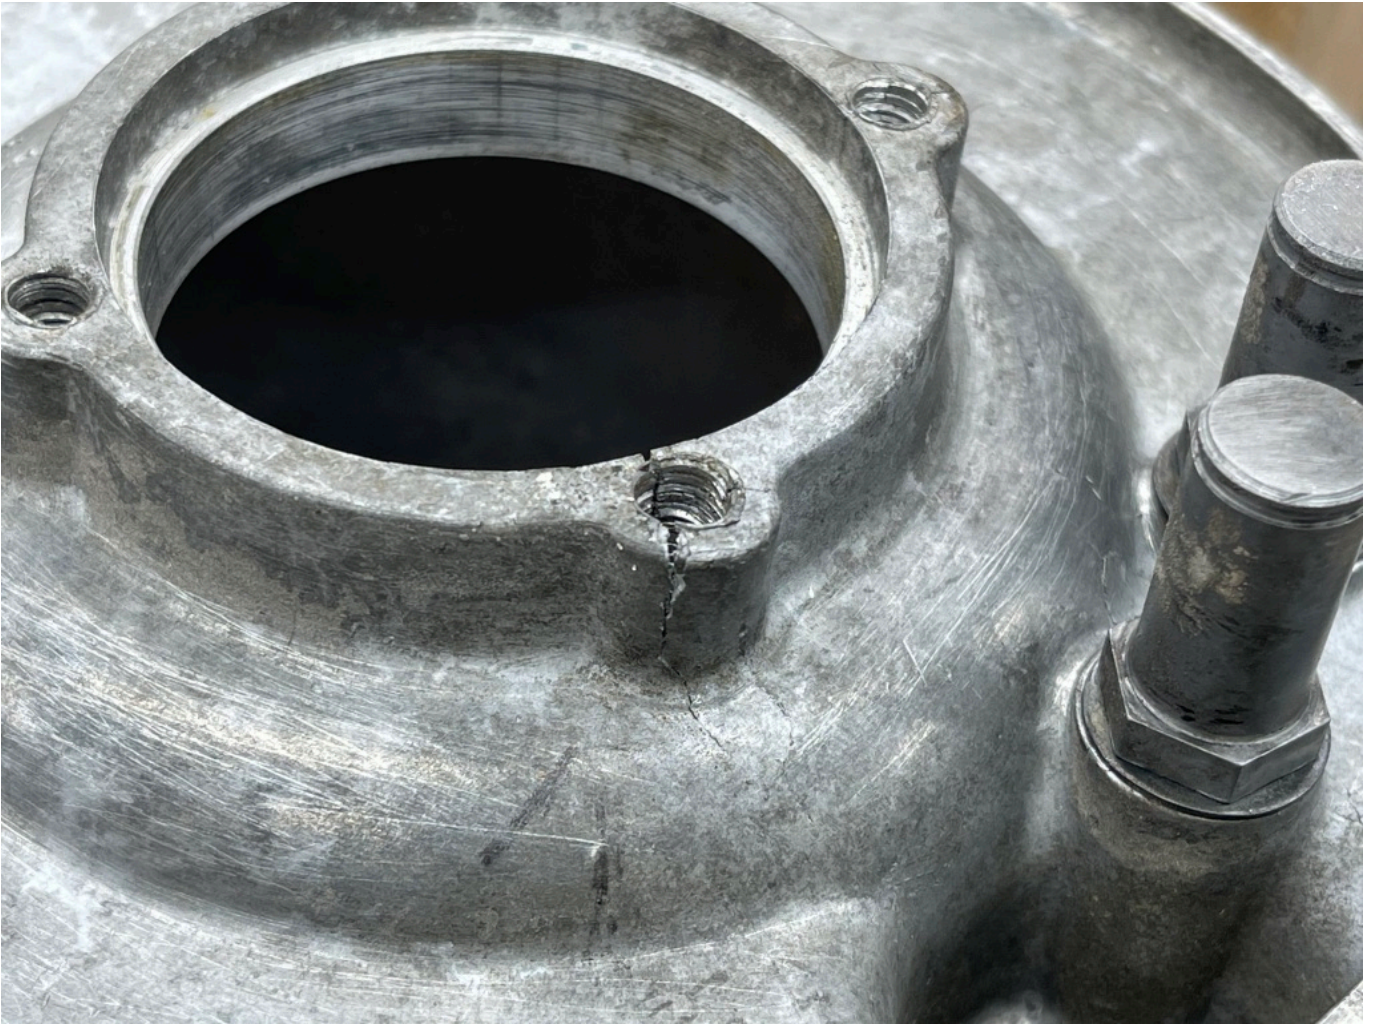
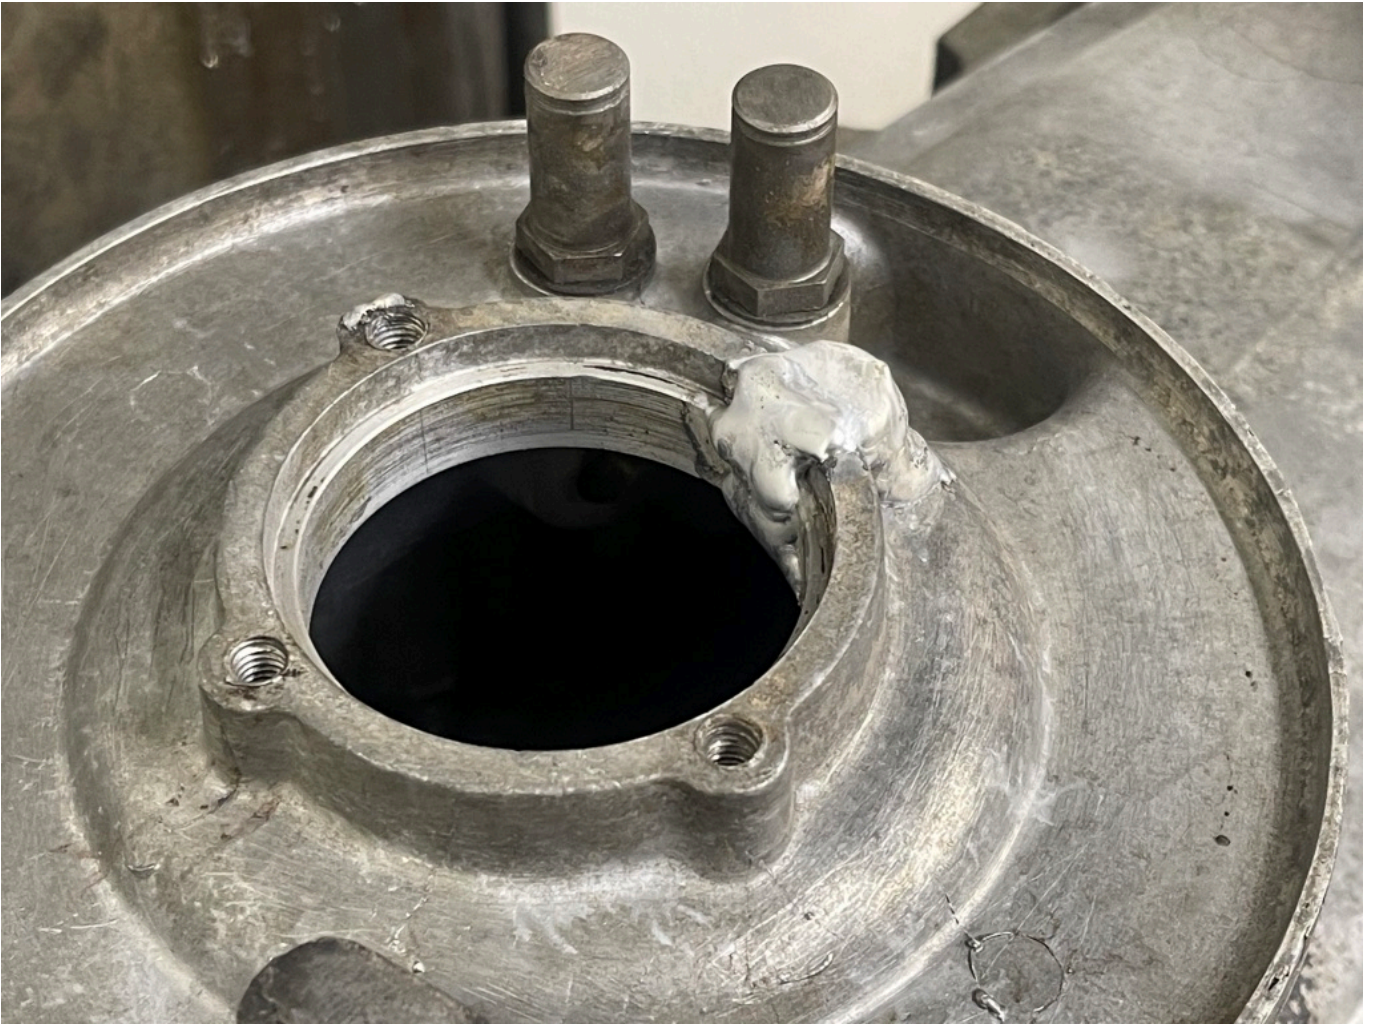
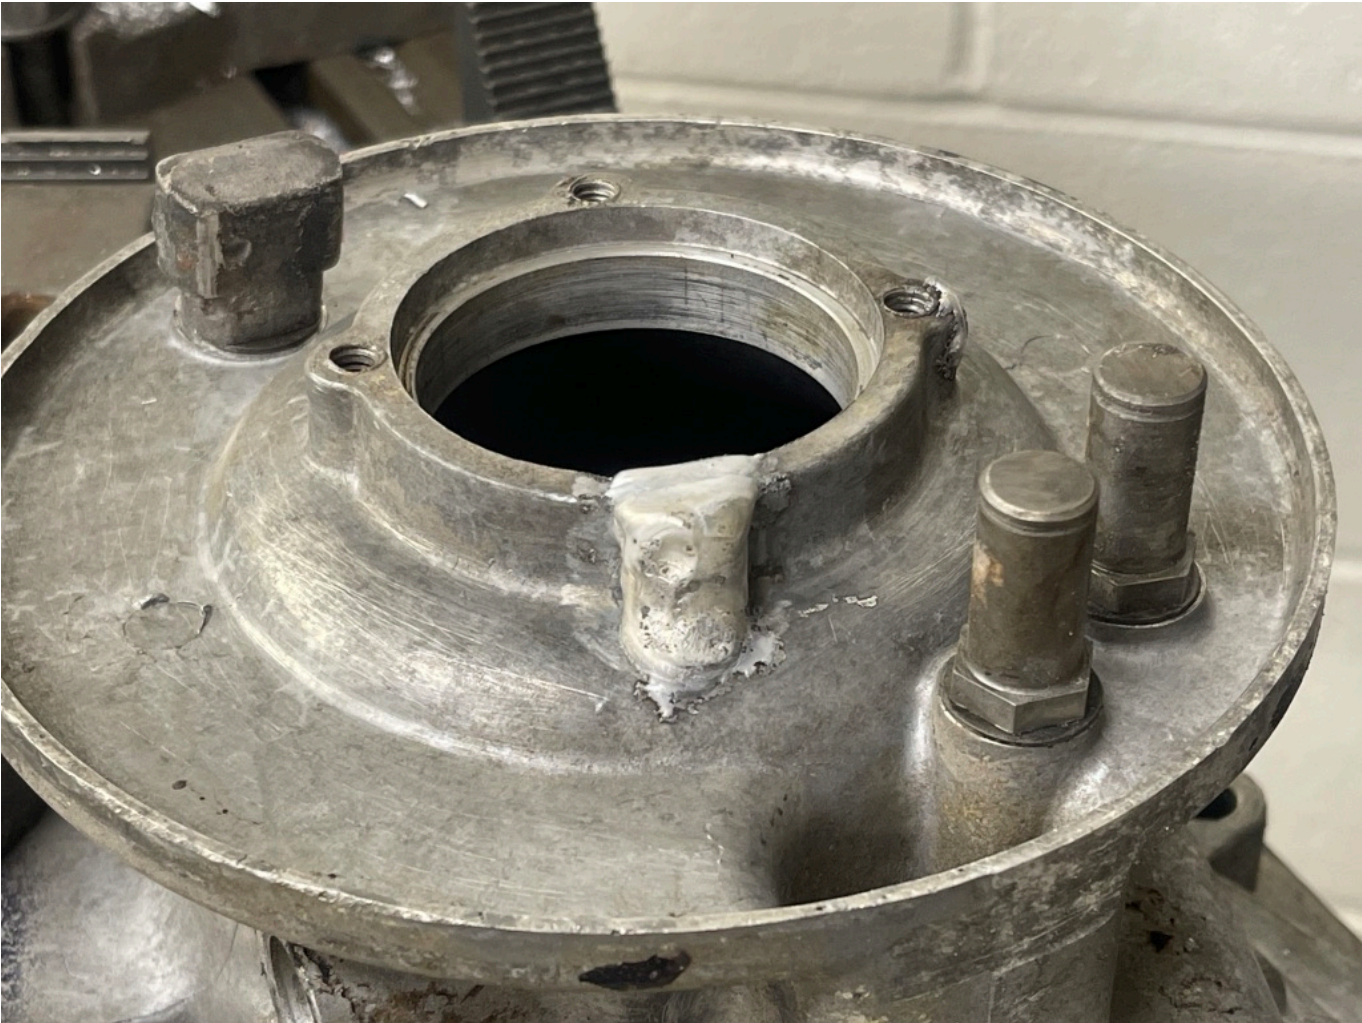
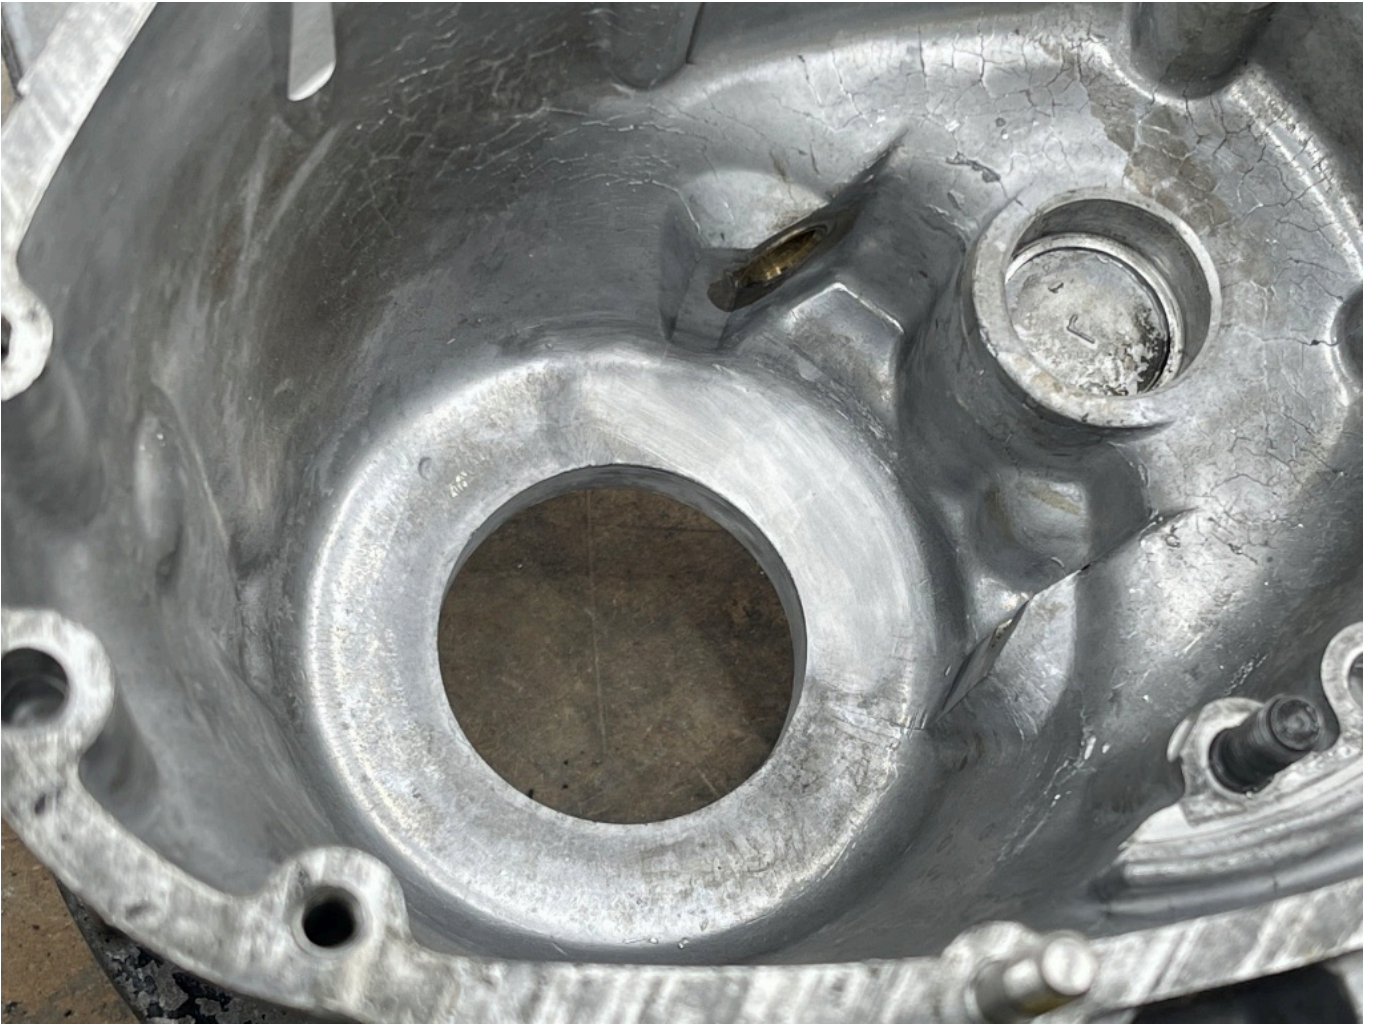
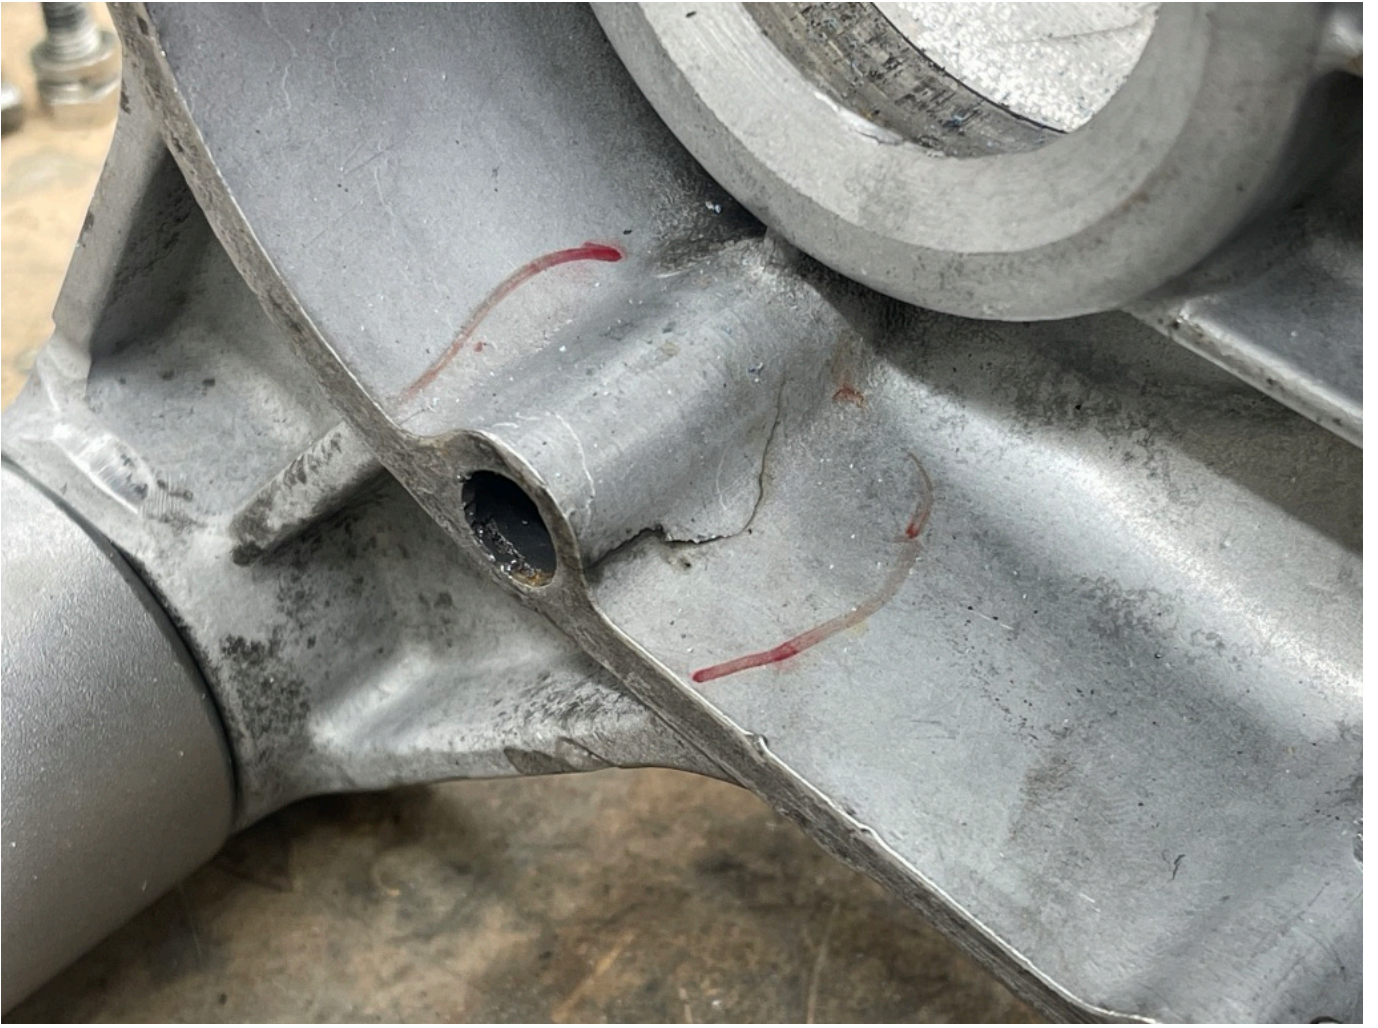
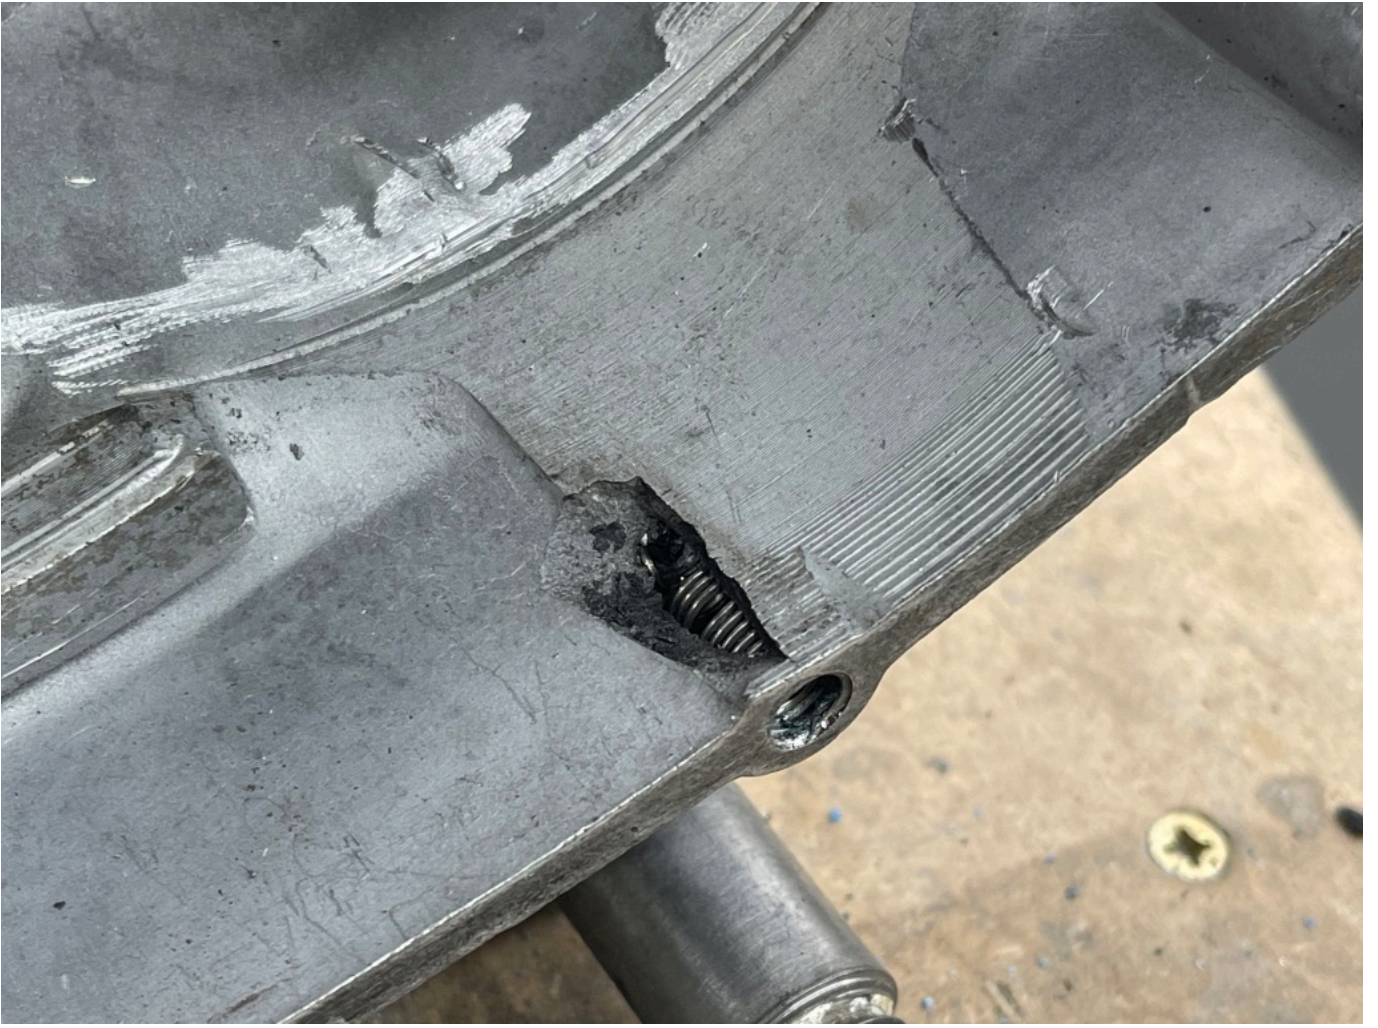
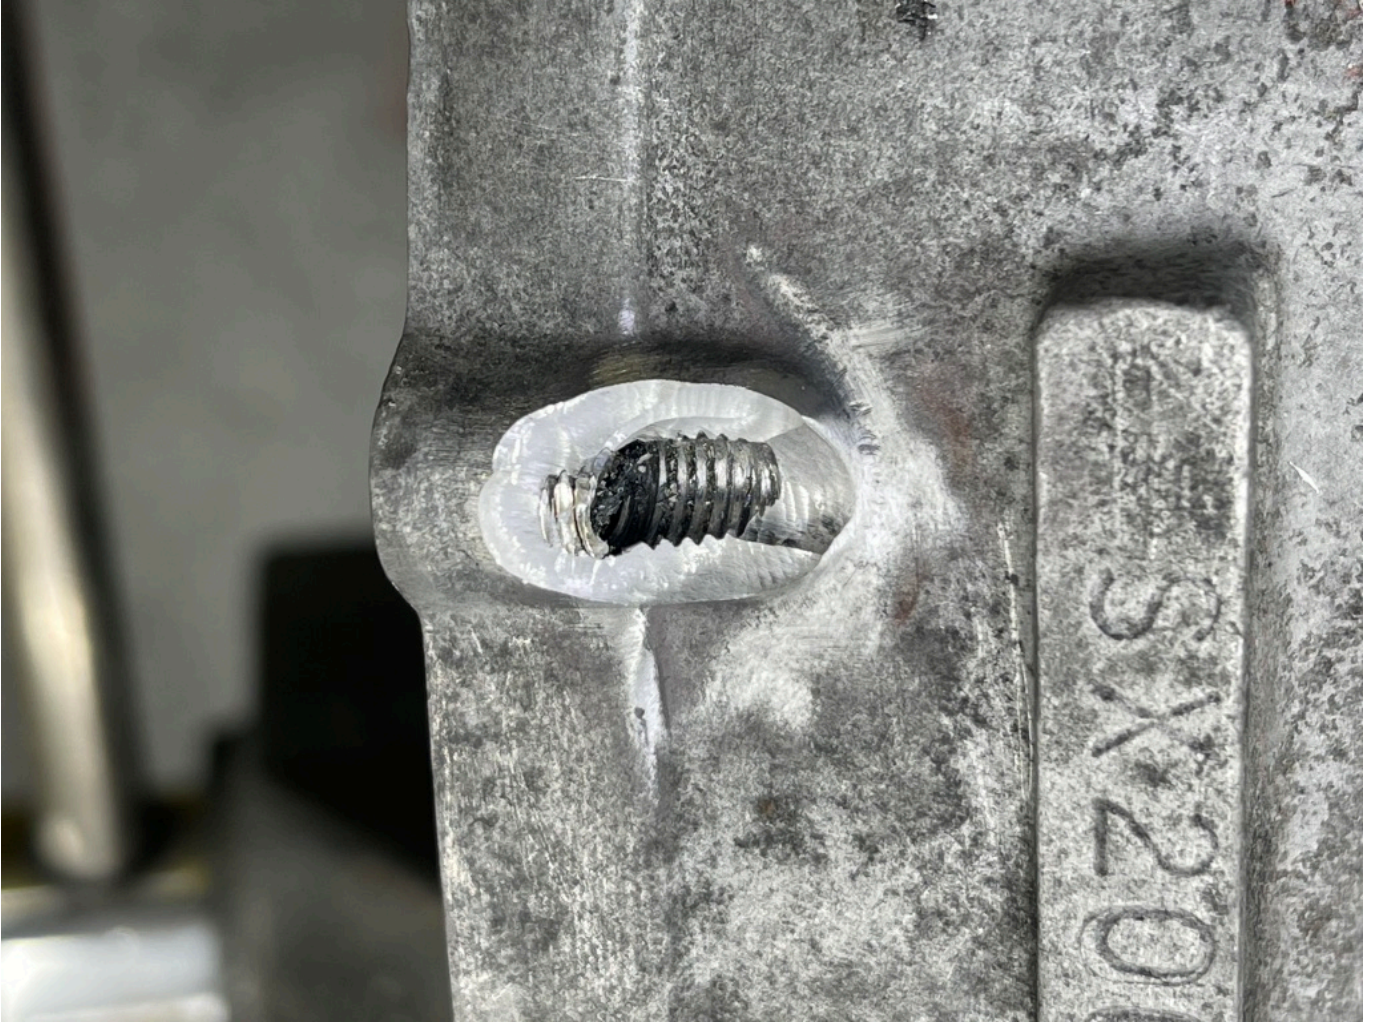
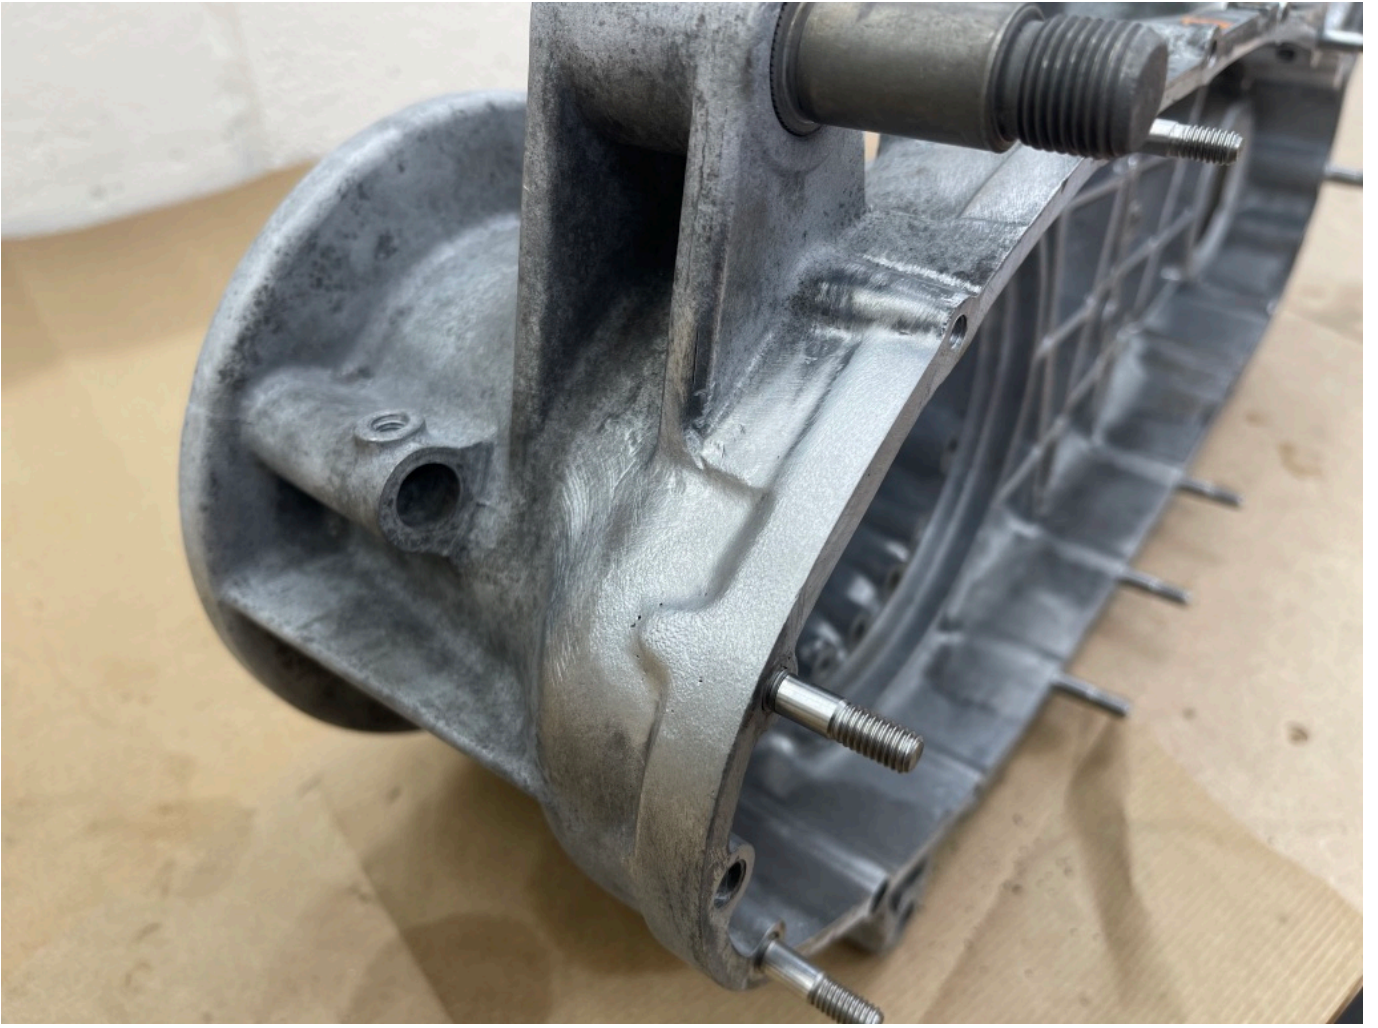
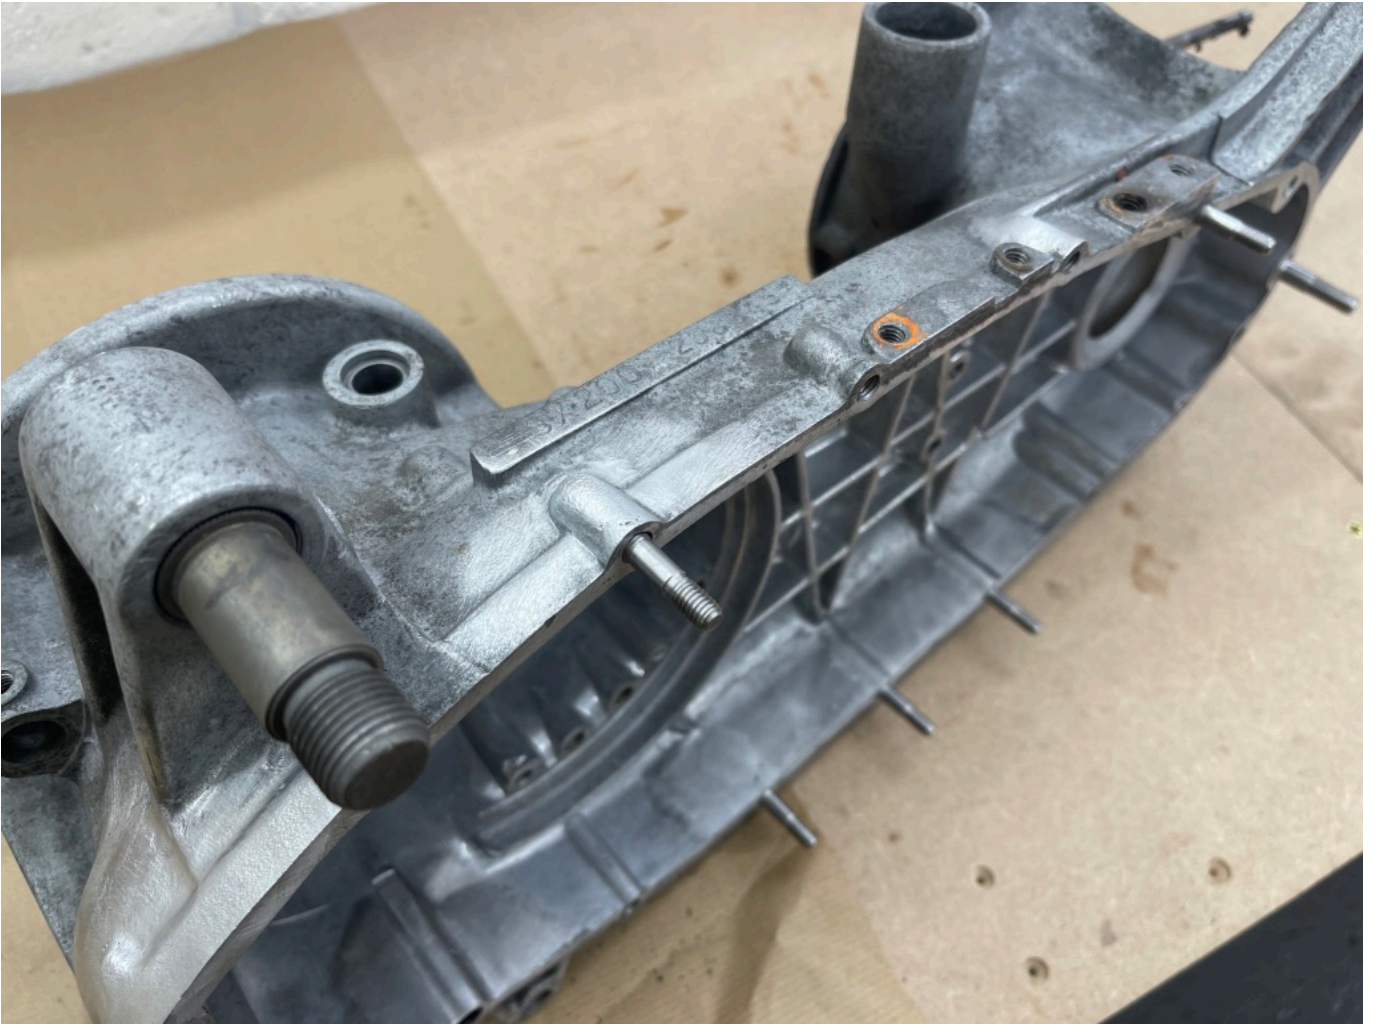
How much silicone sealer do you need? And how much loctite do you need? This is what happens – Too much Silicone sealer, grease or loctite fitted into the threads before studs and screws are fitted is a big NO NO.

Here we have a crack or two in the rear hub bearing area!

Here we have a few crankcase side stud holes that's hydra locked the casing and pushed out perfectly good metal!

The casing was scrap – until I got my little grubby hands on it.

Cracks ground away, helicoils removed, metal welded up, and then machined all in house – no subbing out to others.

The Rear hub bearing area is machined on our miller, but even when you're as anal as me, you can not control heat distortion – the hole had to become slightly larger to get a fully machined face to stop leaks – MB Scooters are the only people to make different slightly oversized rear hub bearings allowing for this!

If you do any amount of welding to a casing the mag face joint always needs a fine skim, the photo shows why.

Then the welding needs hand grinding to reshape the welds, then disguised so its not so obvious its had the welding done – both different inside and out, slightly rough on the outside and smooth on the inside.
