MB Services - Casing restoration

Another TV200 engine repaired and restored at MB Scooters. Seems I do get through a few TV motors!

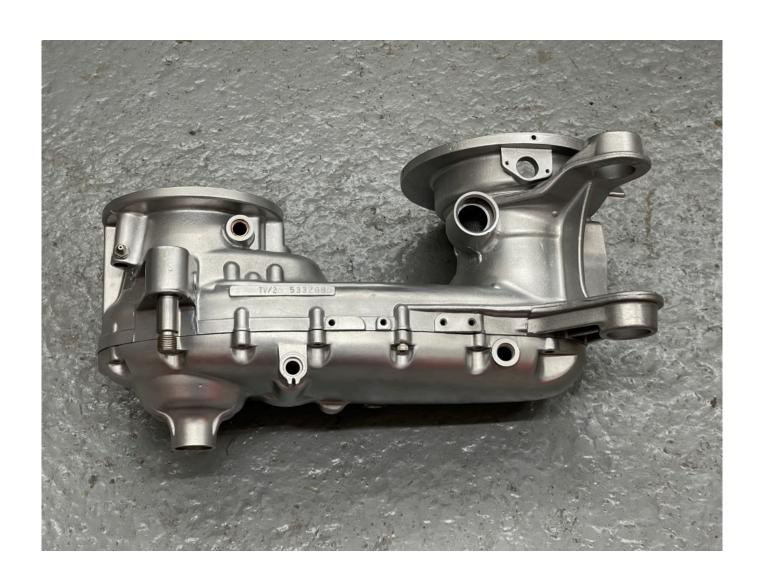
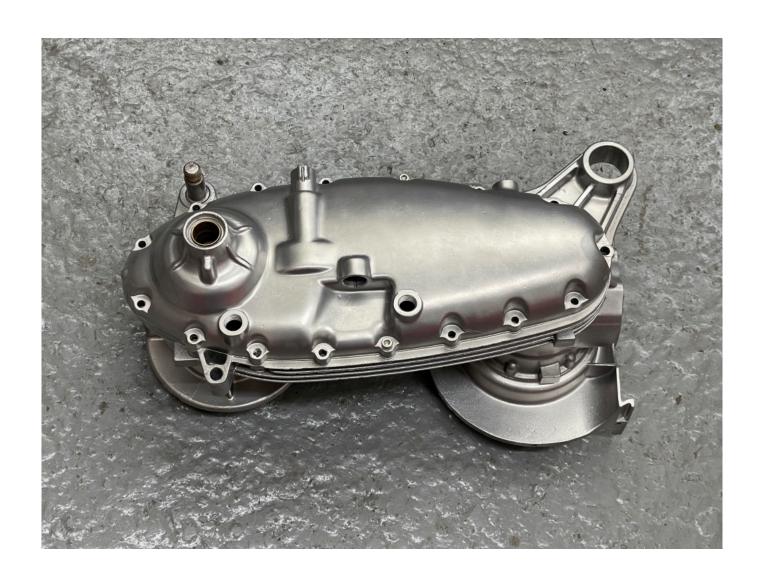
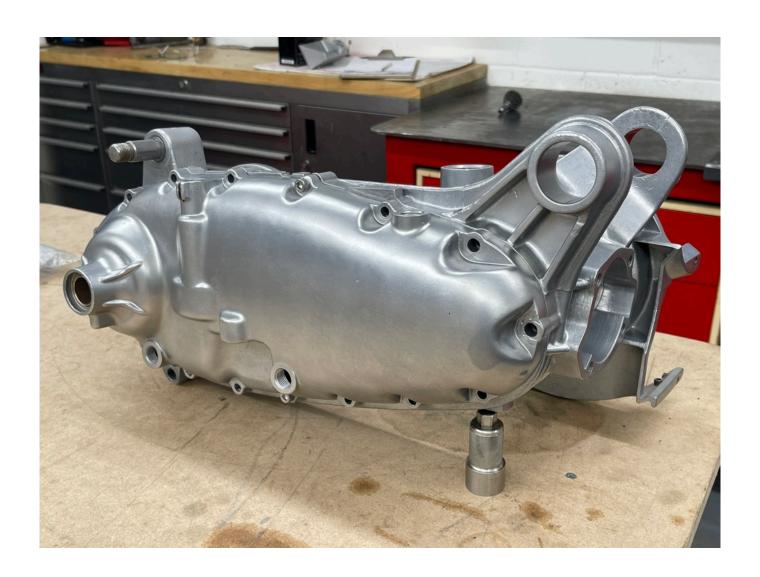
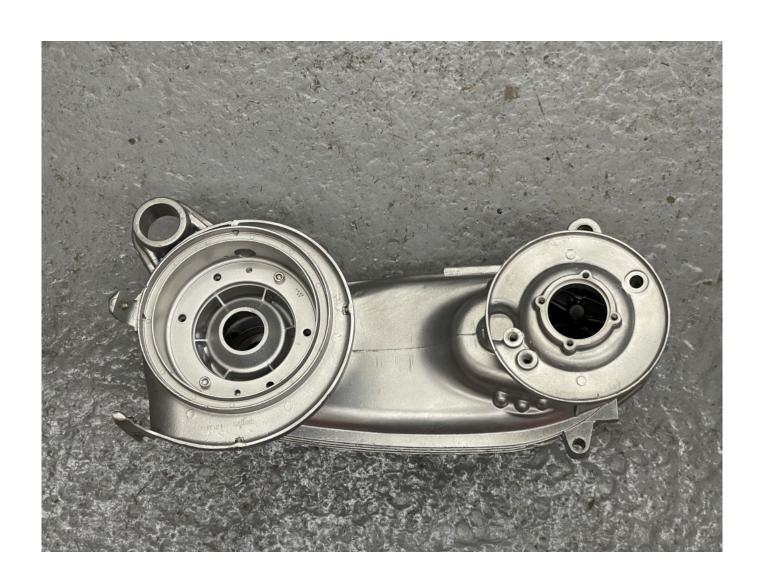
This casings had some grinding, welding, fettling and some threads repaired with MB inserts — then it's been restoration finished the MB way — all done in house!

This casing was no exception. After it was ultra sonic cleaned, there was marks and pitting to the 3 casing parts. Some areas were better than others, so decided to make it look similar all over to blend in the pitting and patina by using different media in our rumble machine. The side cover was so bad which is very common that I had to hand polished and grind out deep marks then run it over the polishing machine before it was bead blasted prior to the rumbling system.

On this one I've actually added more pitting to make it all look the same which has blended it in all over. I've then worked it down and given it a semi shine in the rumbler then finished it off with a shine and blend in the aqua blaster.

Note - Ive kept the original looks by leaving the casting flashes so its got that factory look.
