# Repair – Horncast Series 1

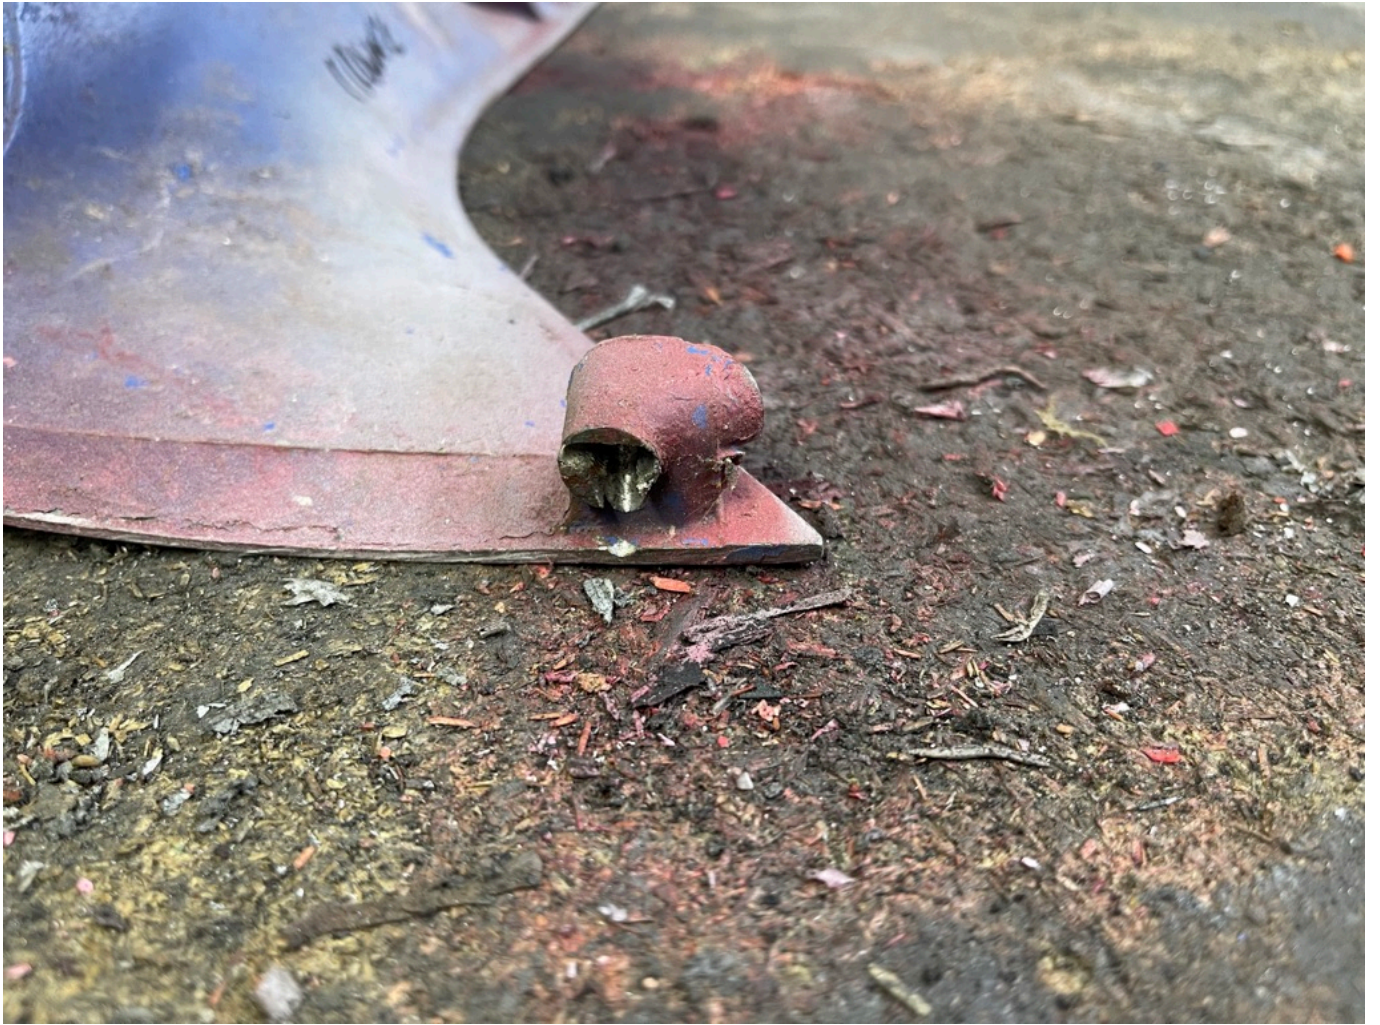
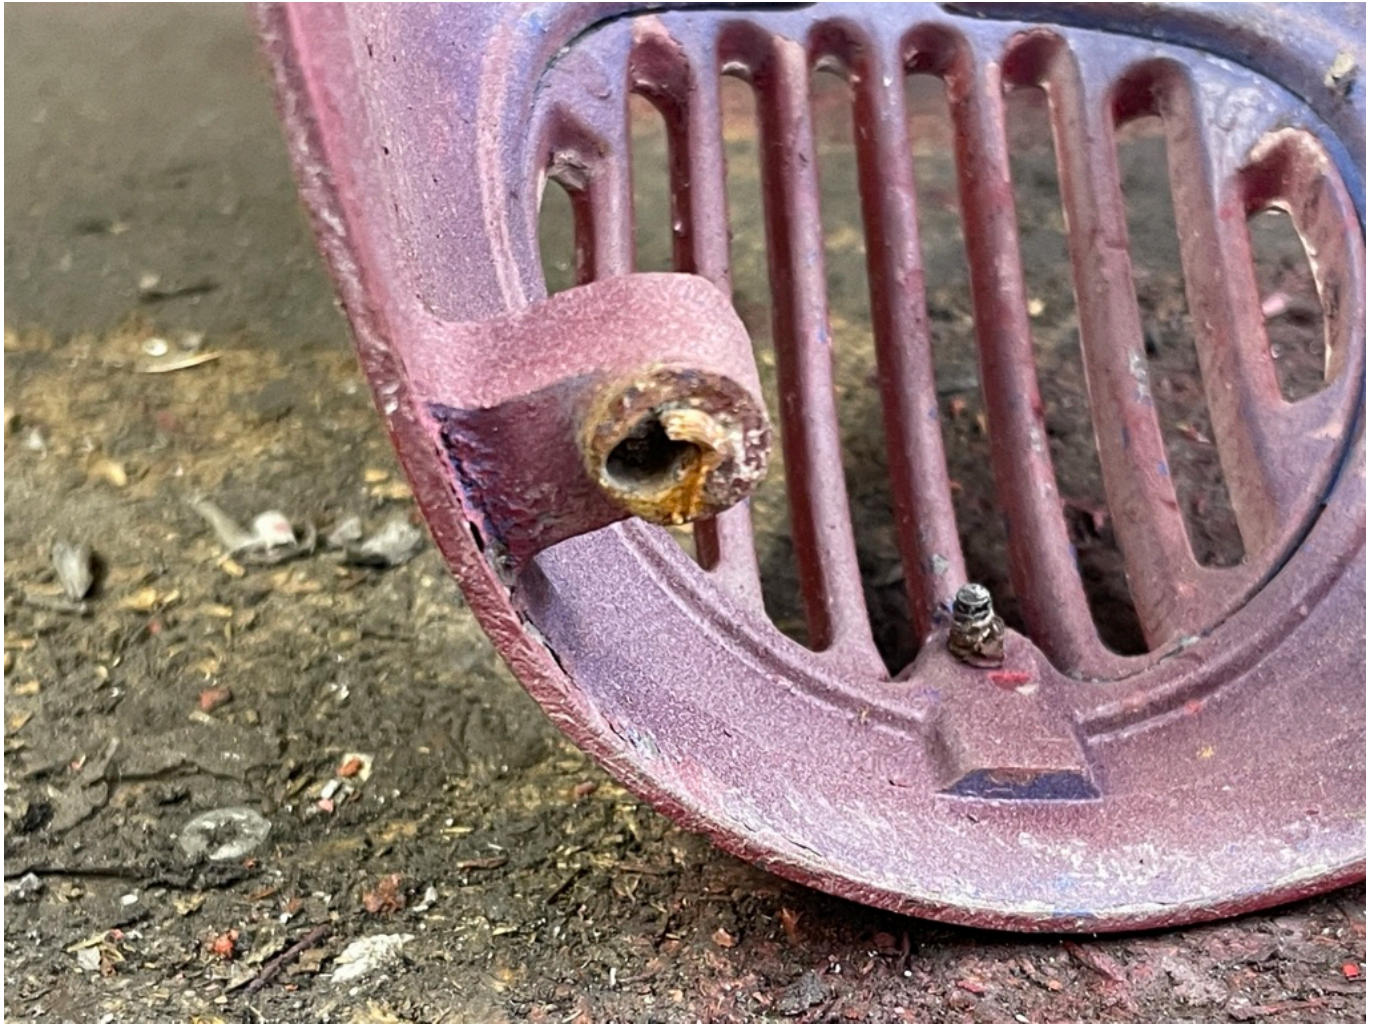
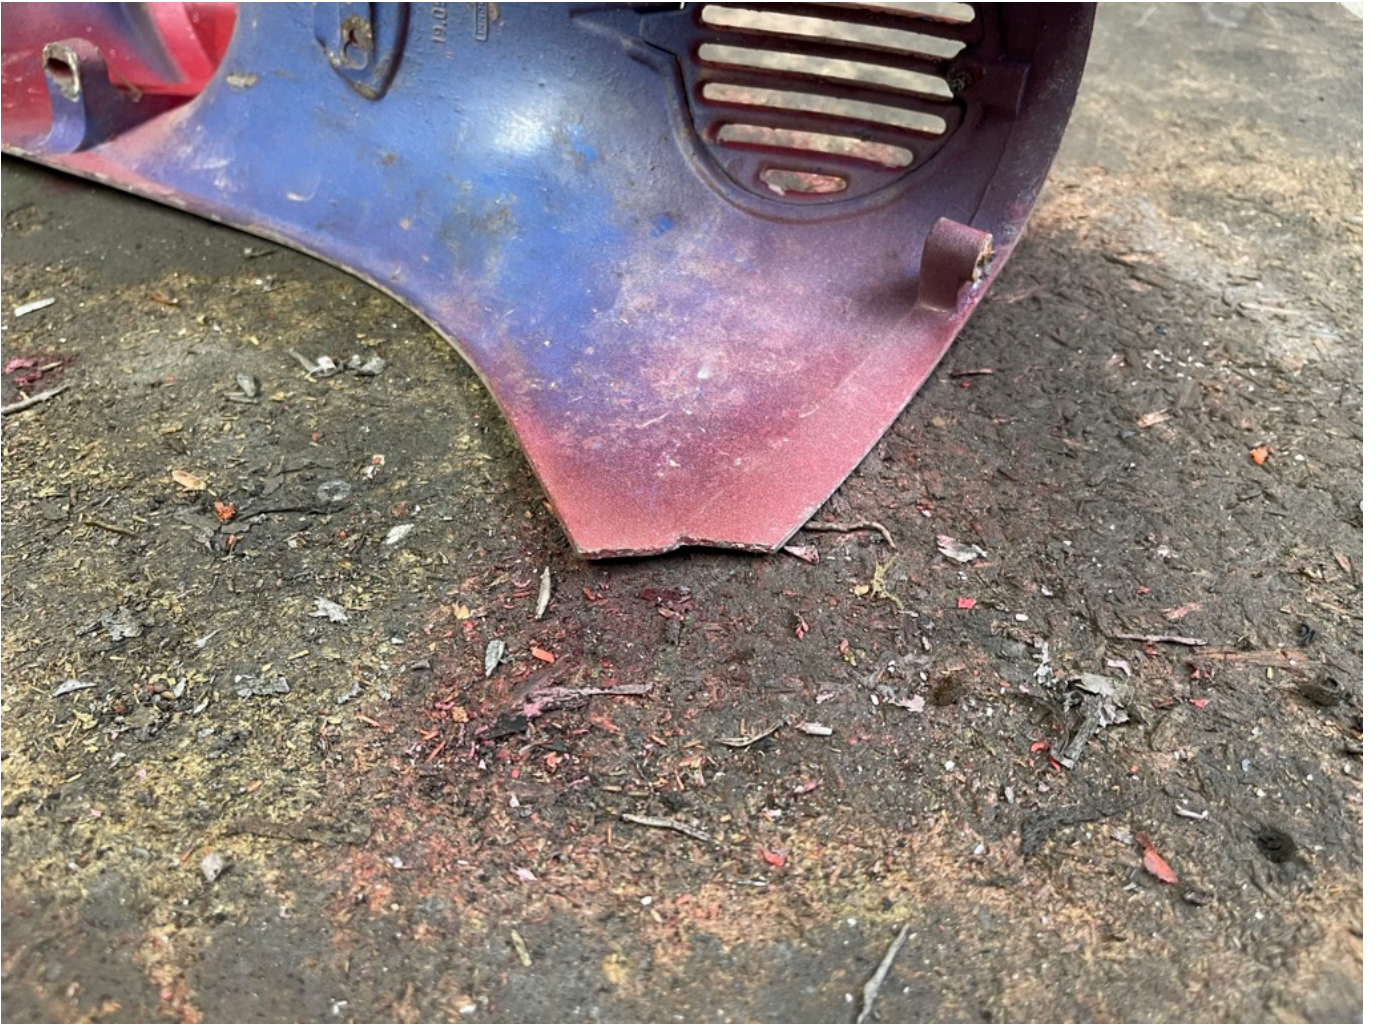
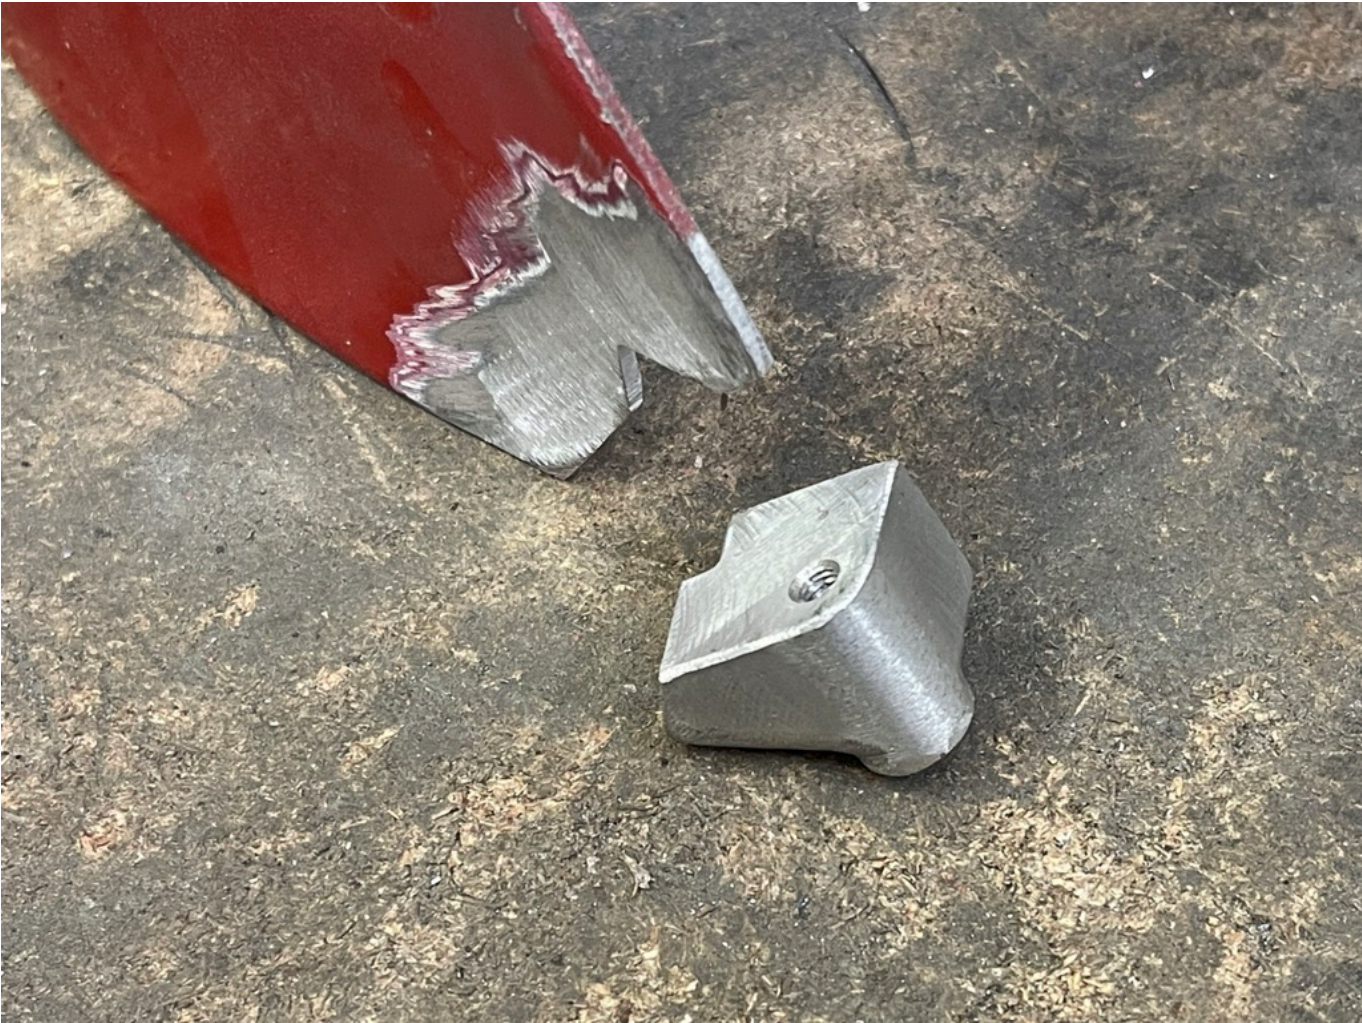
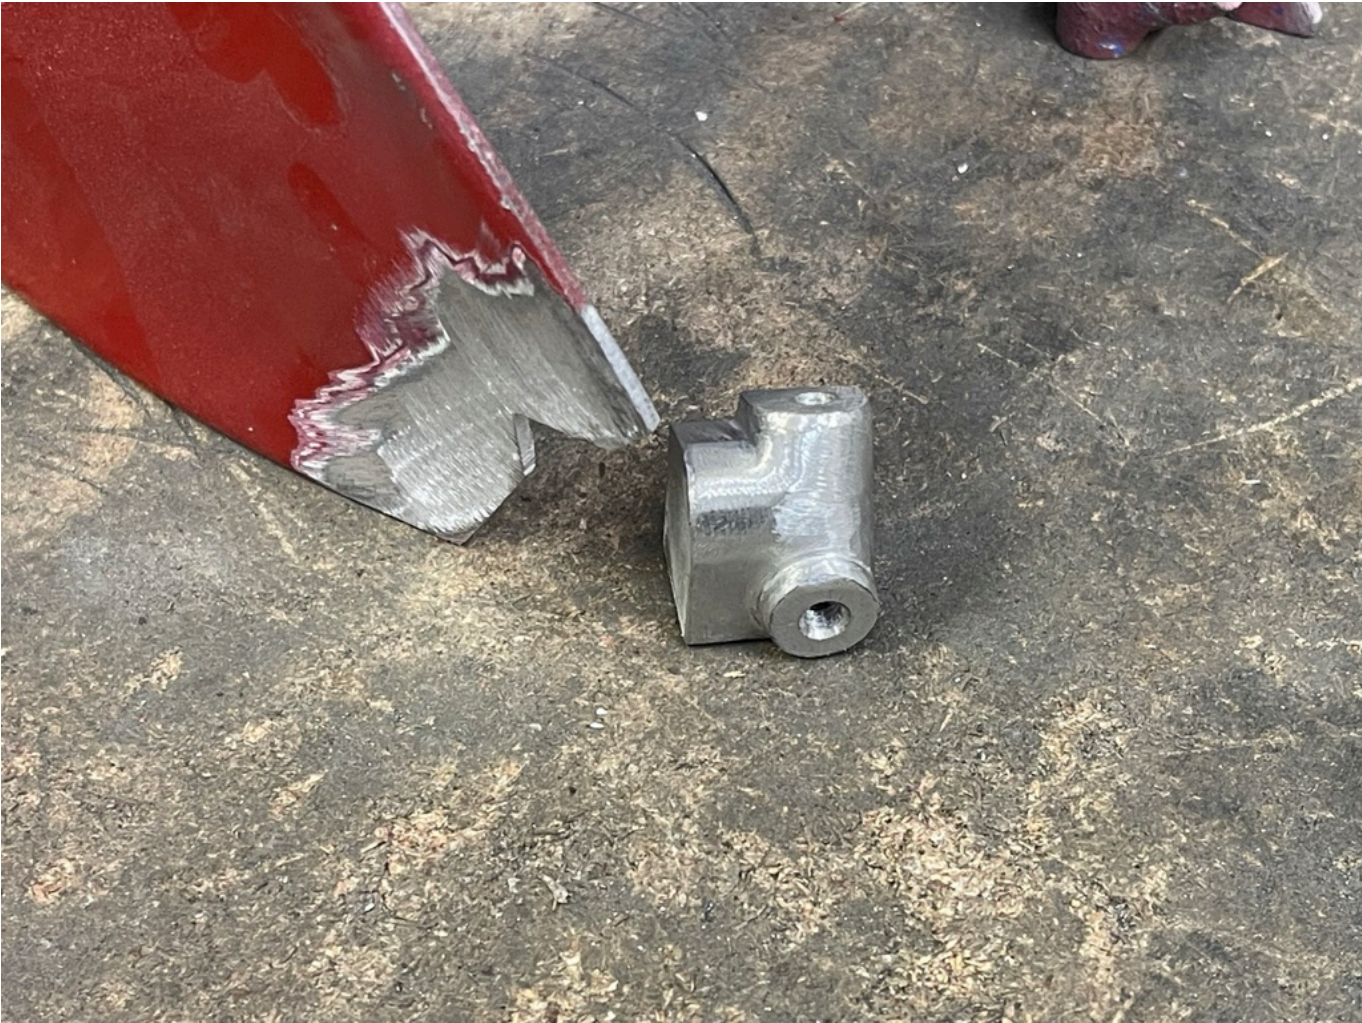
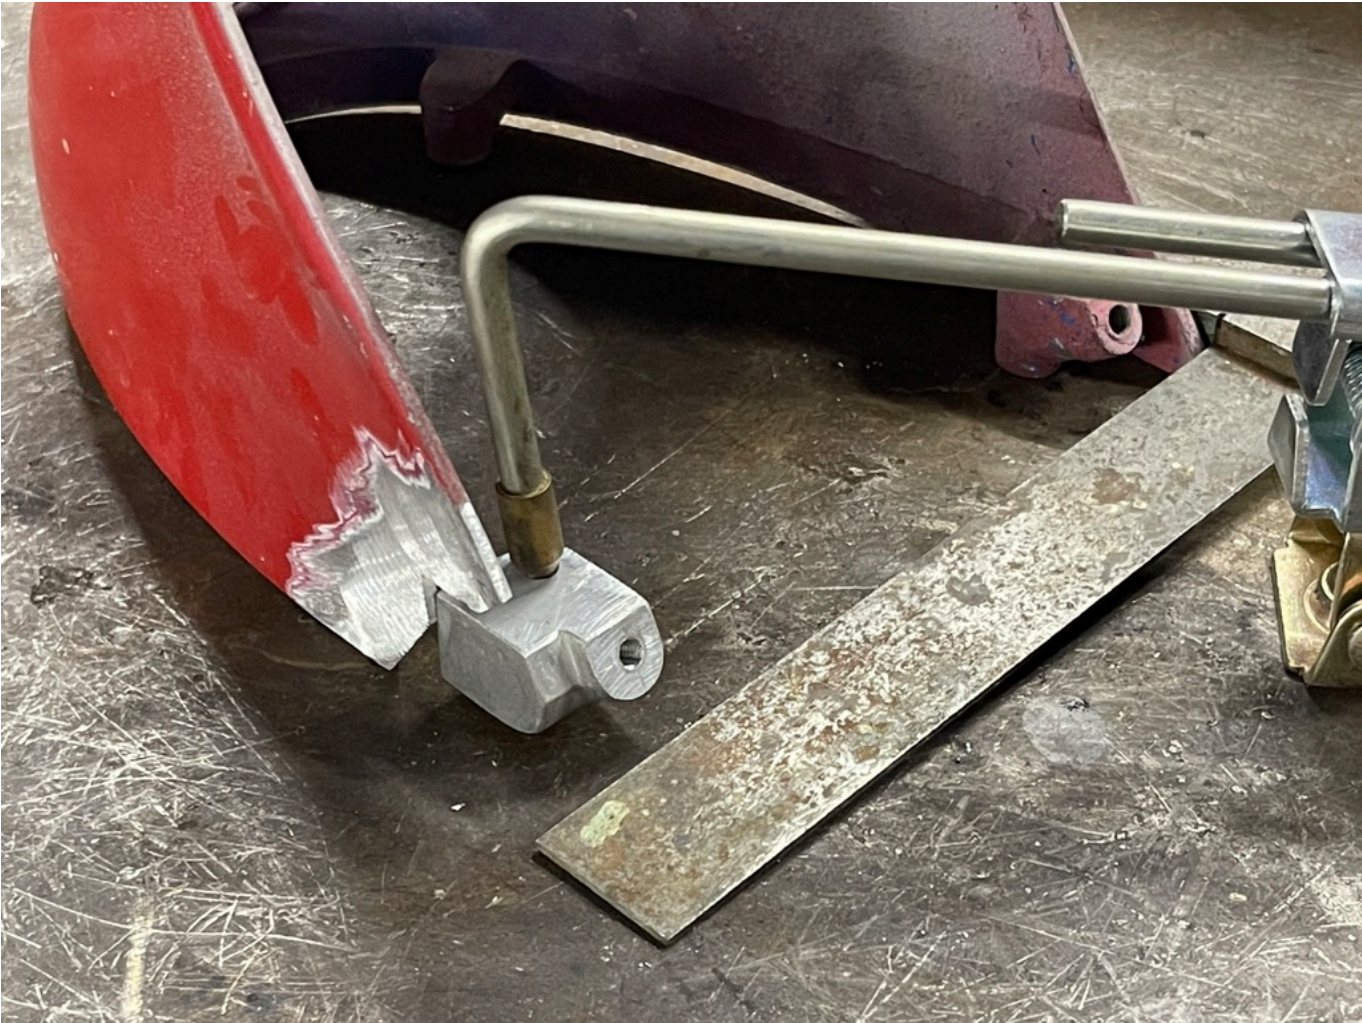
Here we have a horn casting that's had the lot – parts broken off – threads gone – threads drill off set and cracks!

This one had the lower part of the horncast missing. You can build it up with weld then grind it all to shape – or like this one you can make the part that is missing in the milling machine and weld it in place. As you can see from the photos, theres lots been done to this one.

When this happens some heavy fisted person usually tries to drill out the broken screw and then slips to one side creating a hole in the alloy where a professional can not drill out the screw and cure the problem. Usually theres a gap and the only thing a professional can do is grind out the alloy, reweld, fettle, drill and tap the best you can back to standard.

Now if they left it alone, a professional can drill and tap out a broken screw which takes no time at all. Even if the alloy has corroded around the threads it's no issue to drill bigger, tap out and fit any of the various inserts available.

Horn castings are nearly impossible to hold straight in a vice, you certainly can't hold them in a milling machine – its down to holding them with one hand and using the other to do the intricate work.

This one took nearly five hours! Now you could find another which is better but the chances are it needs as much doing to it.
