# Repair – Horncast Series 1

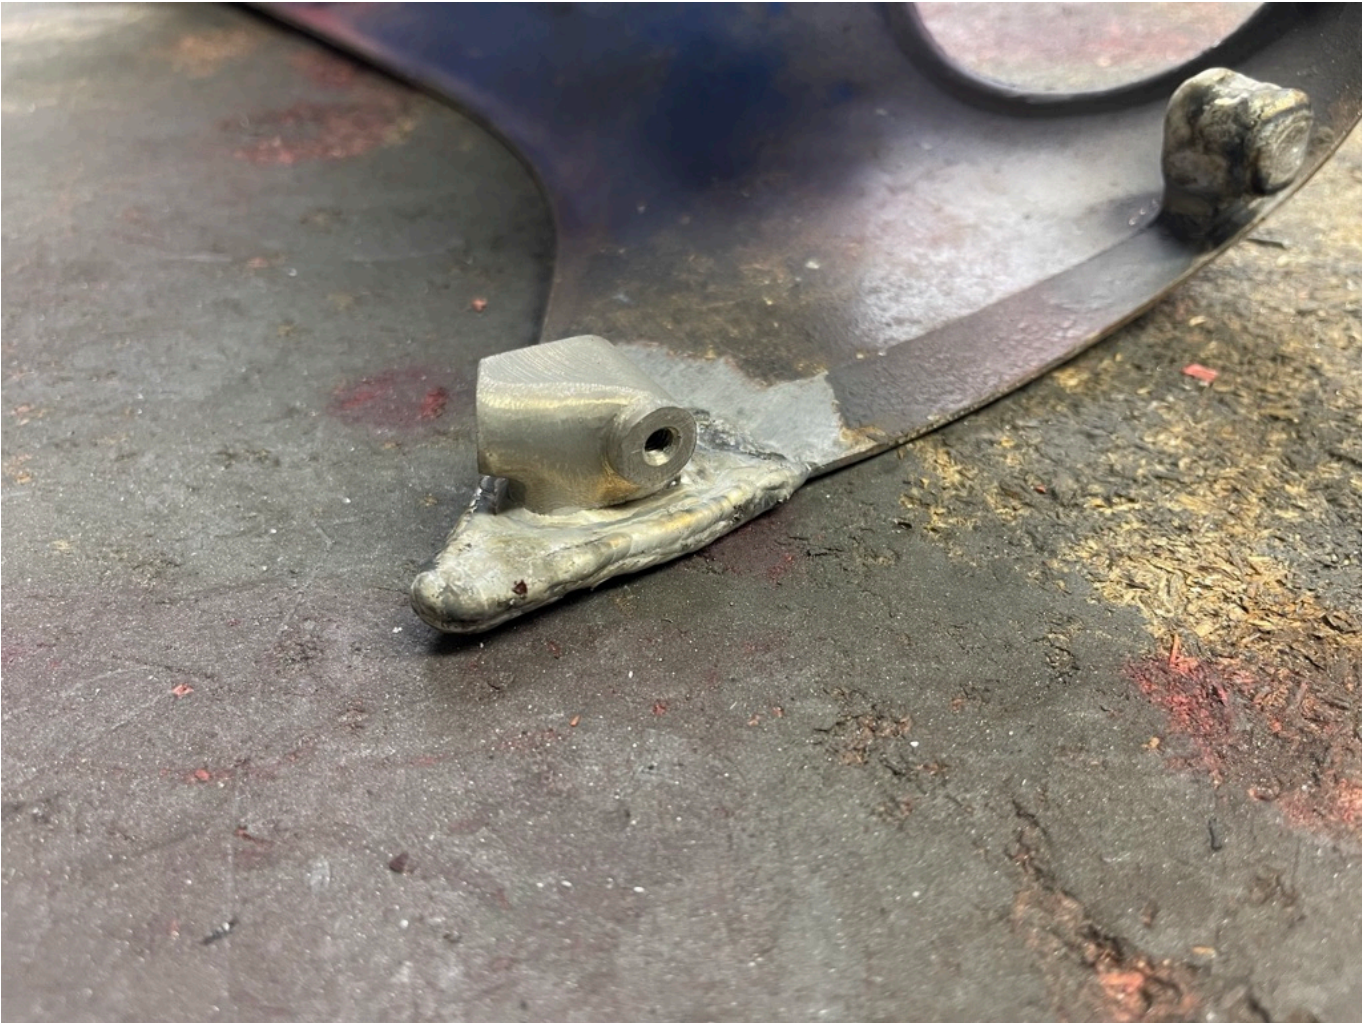
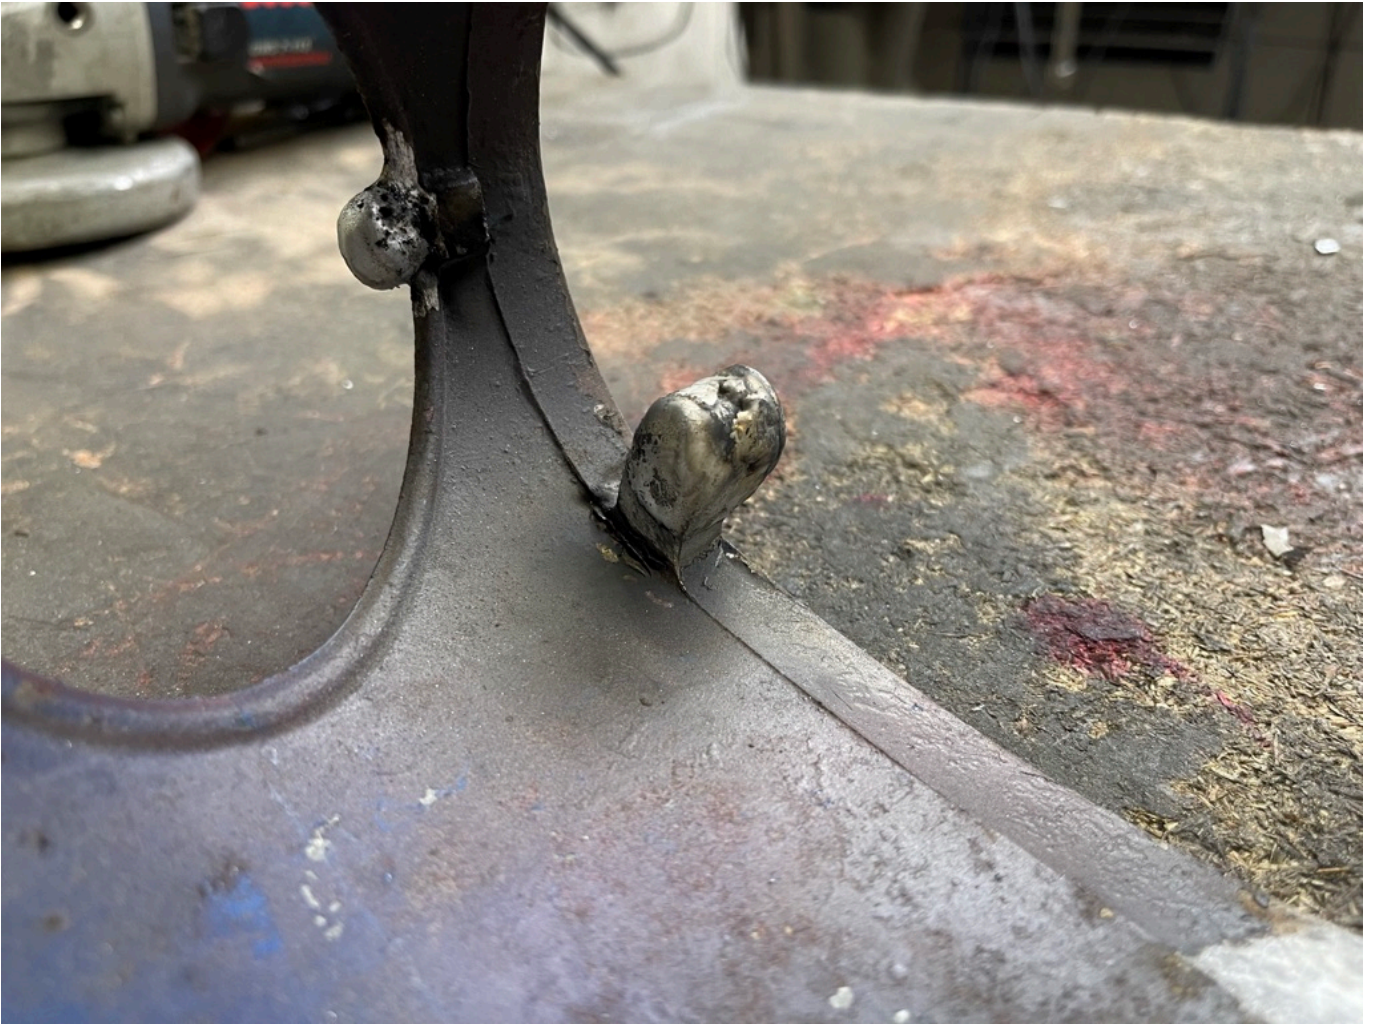
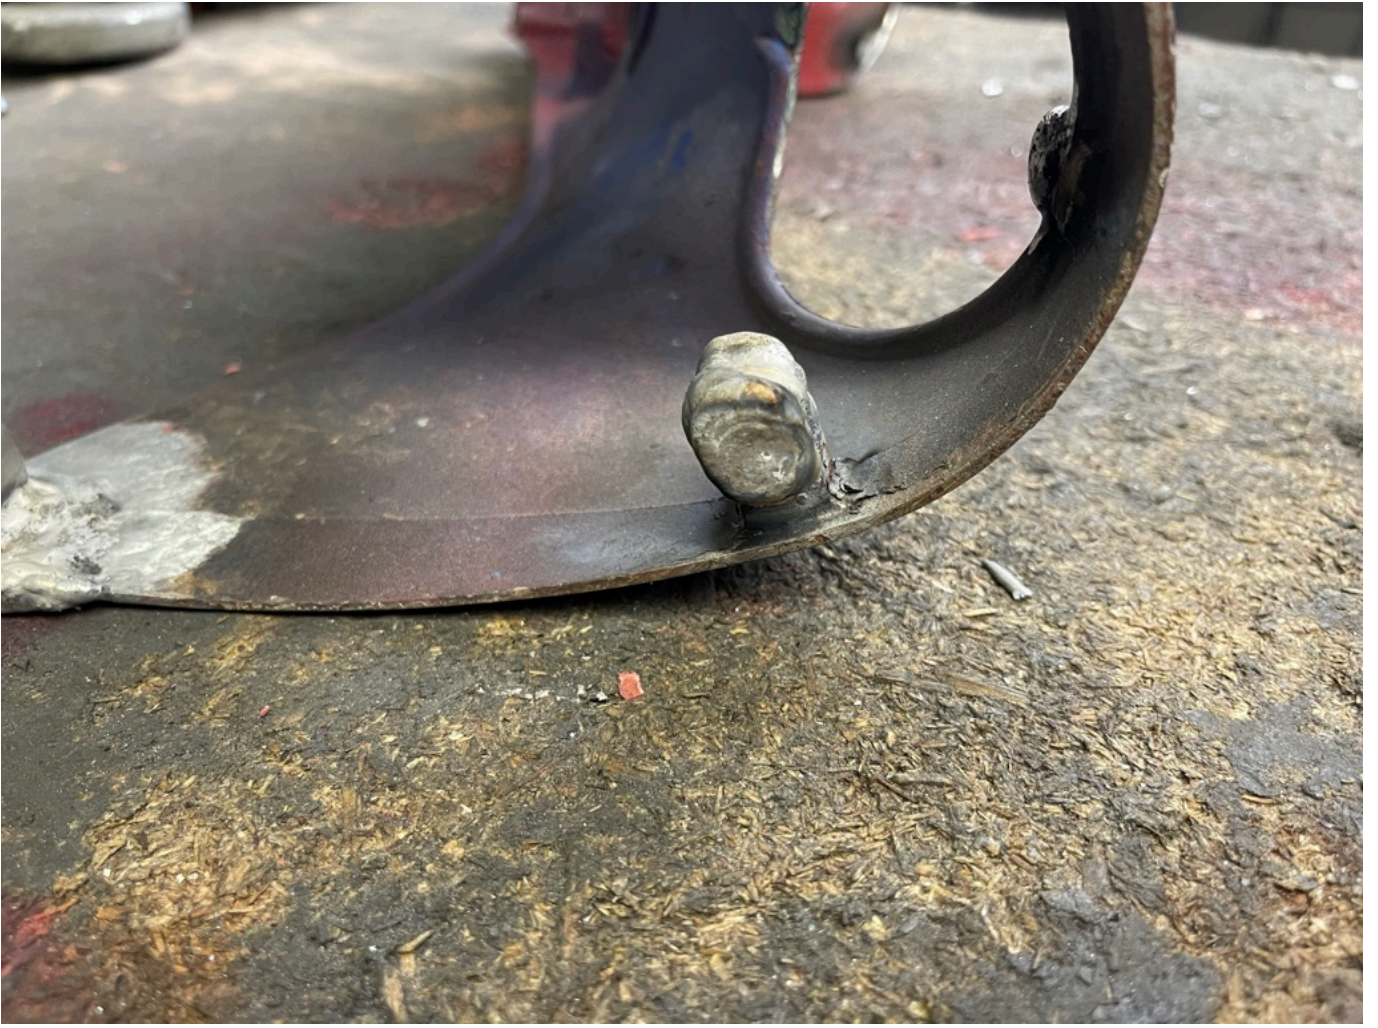
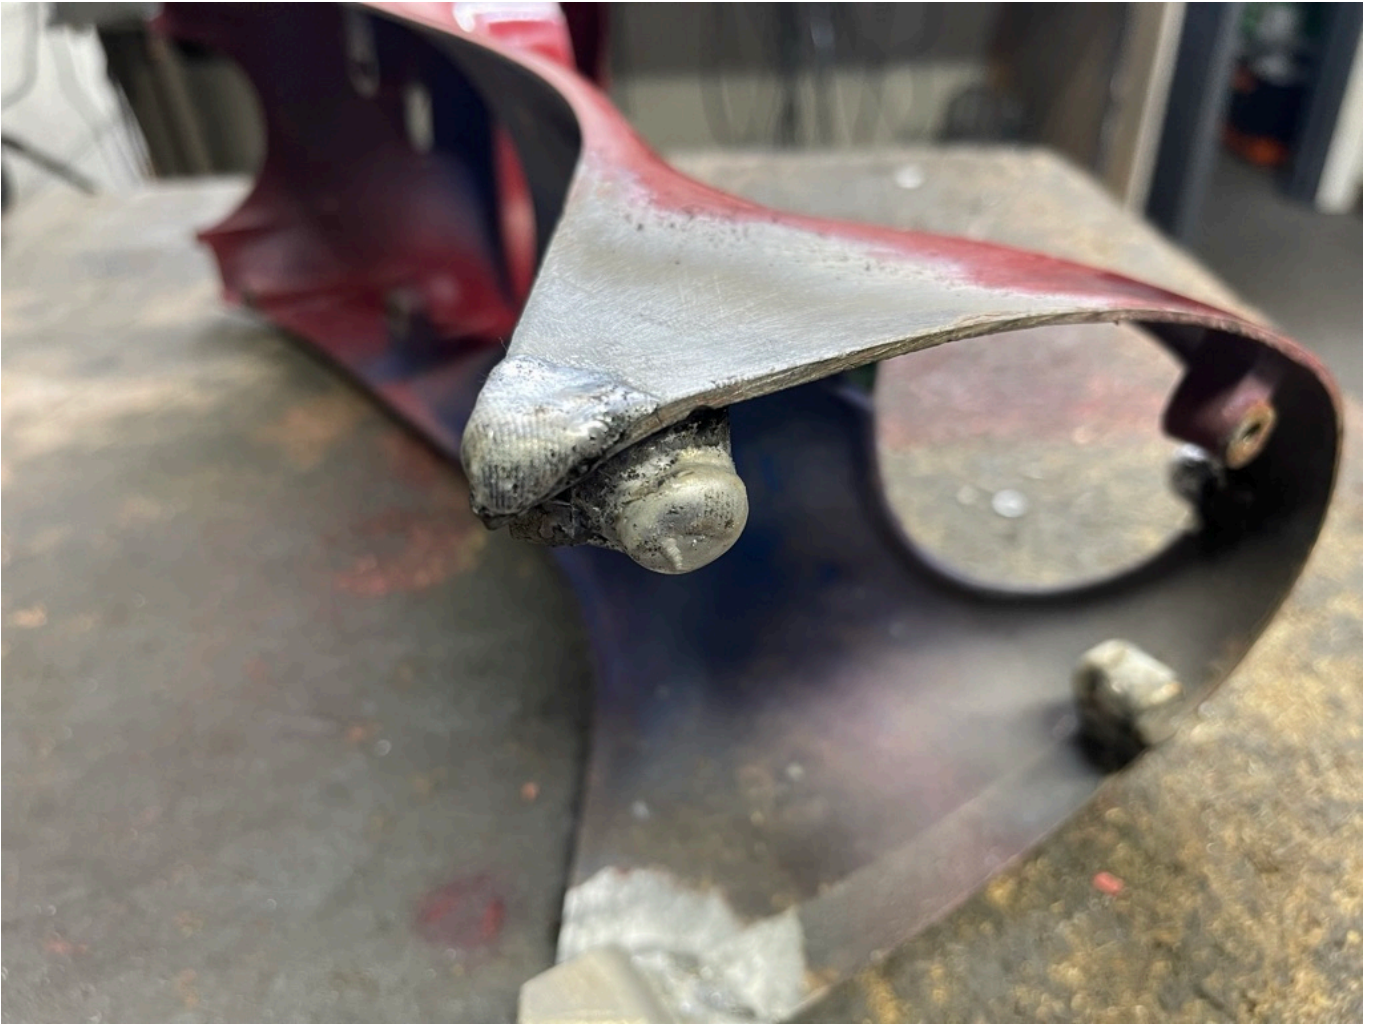
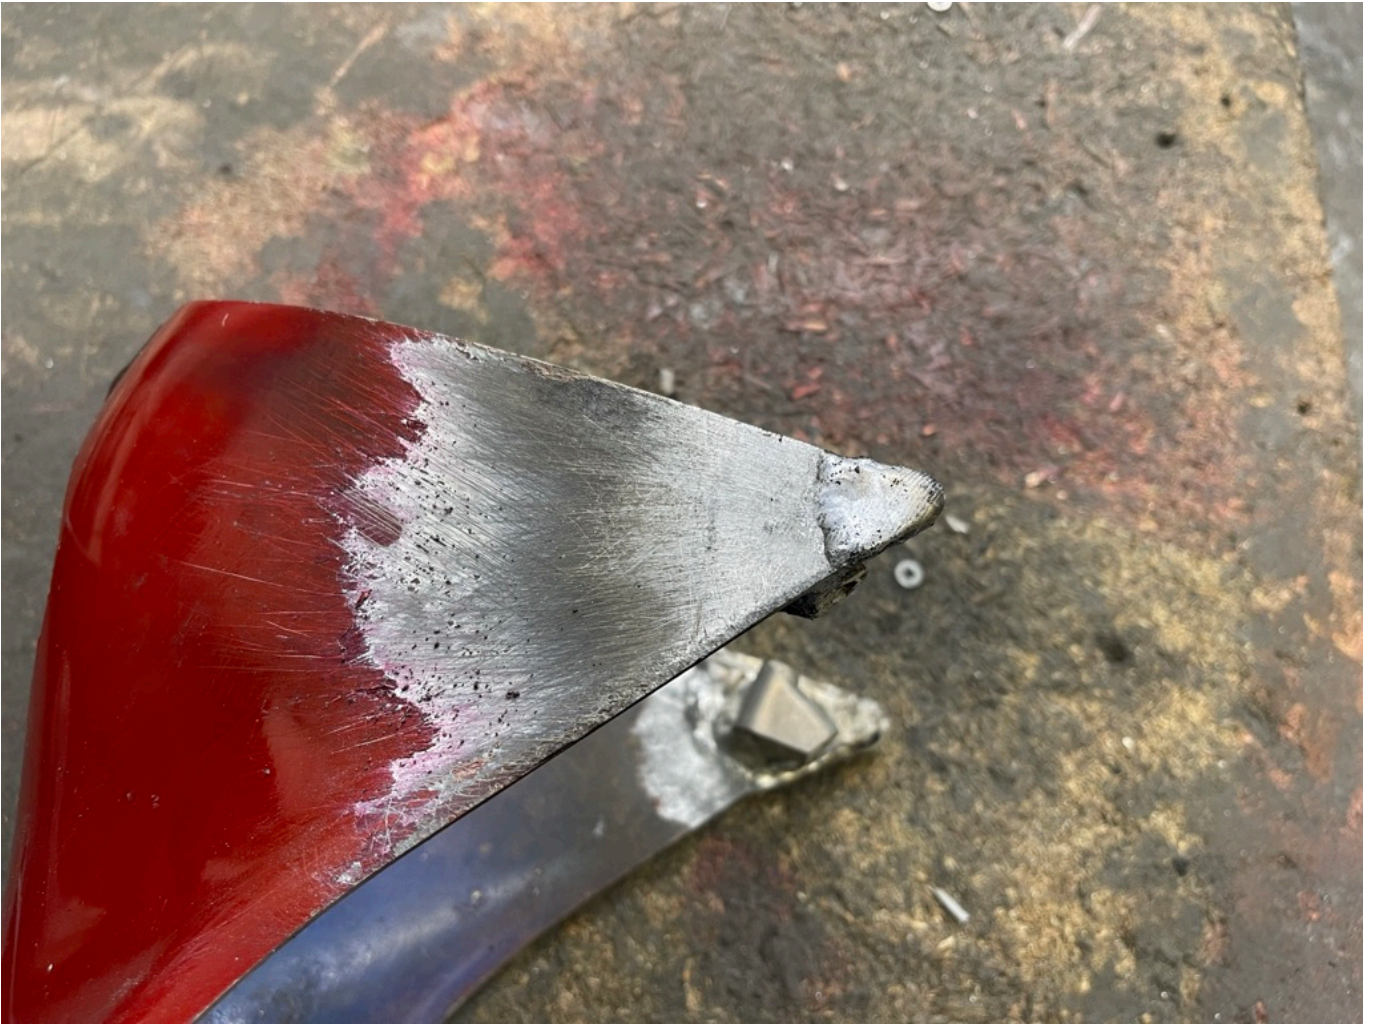
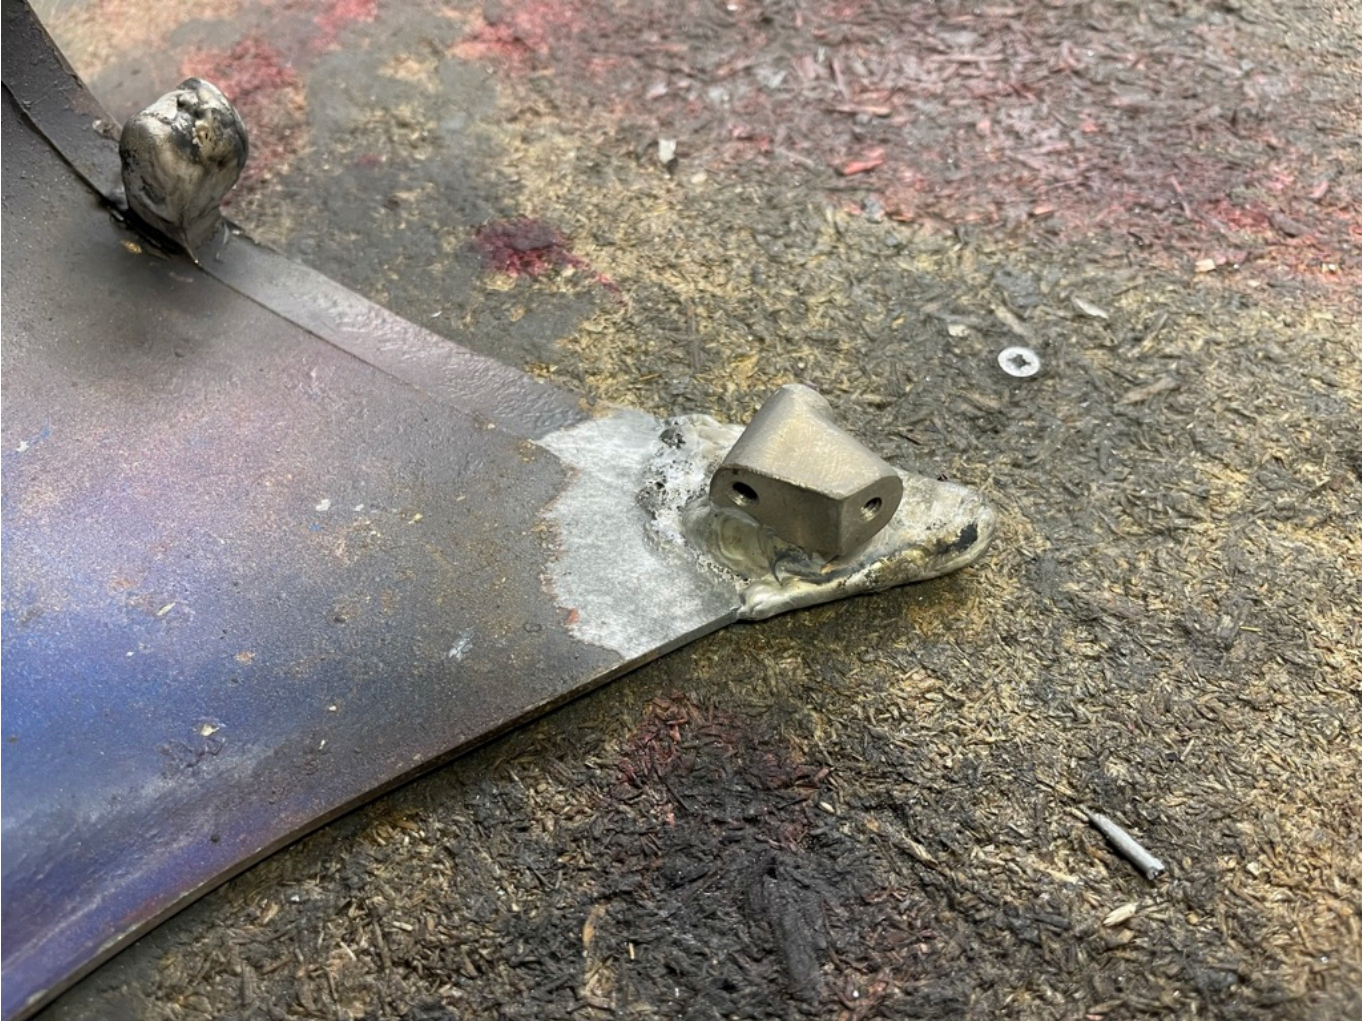
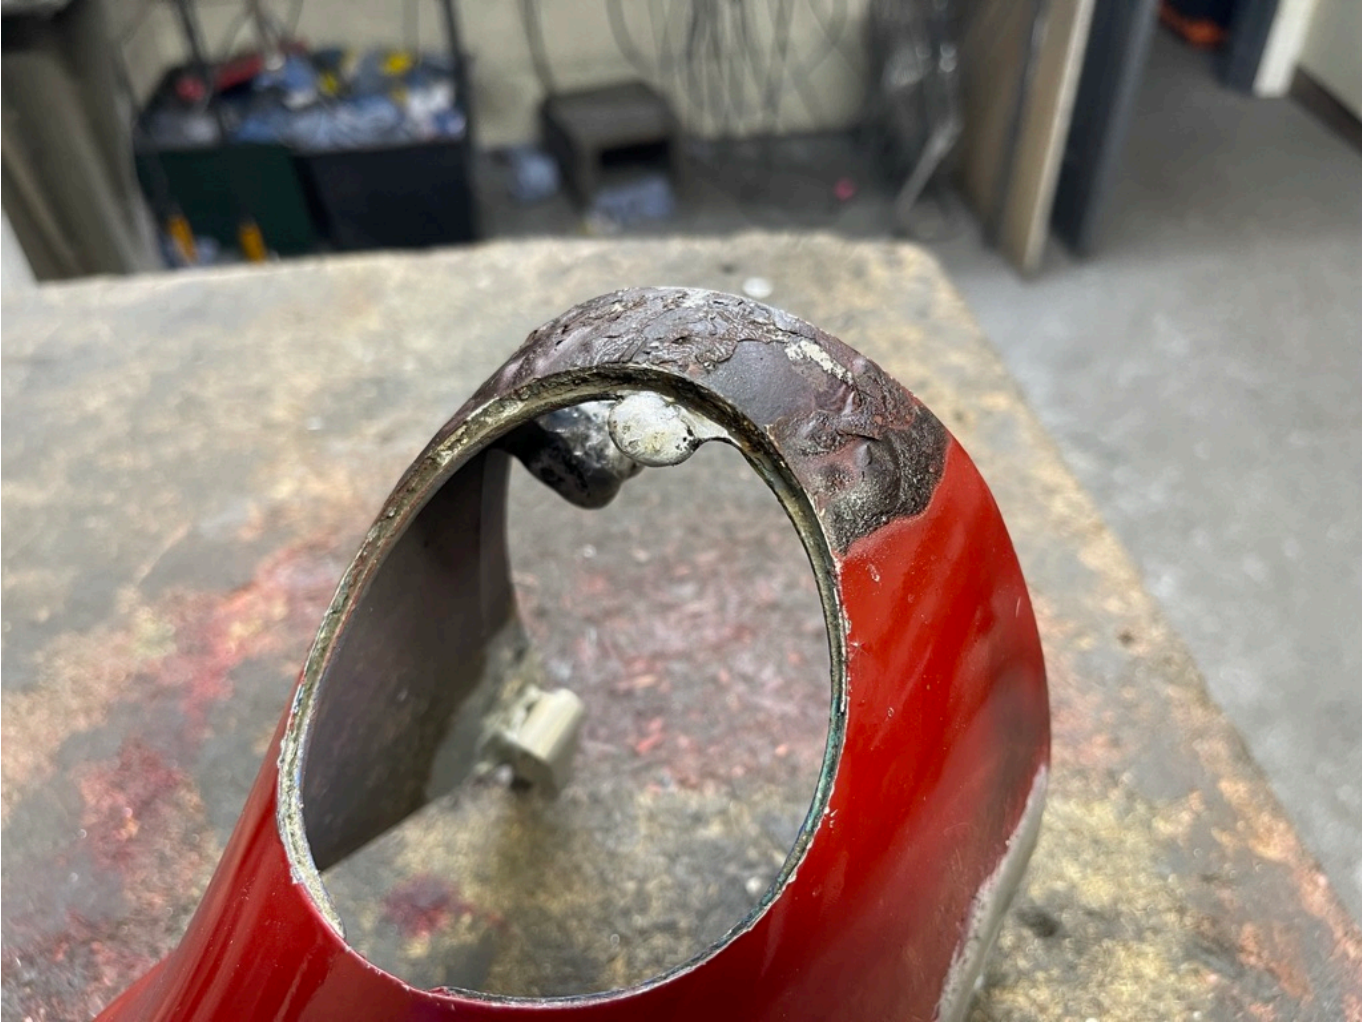
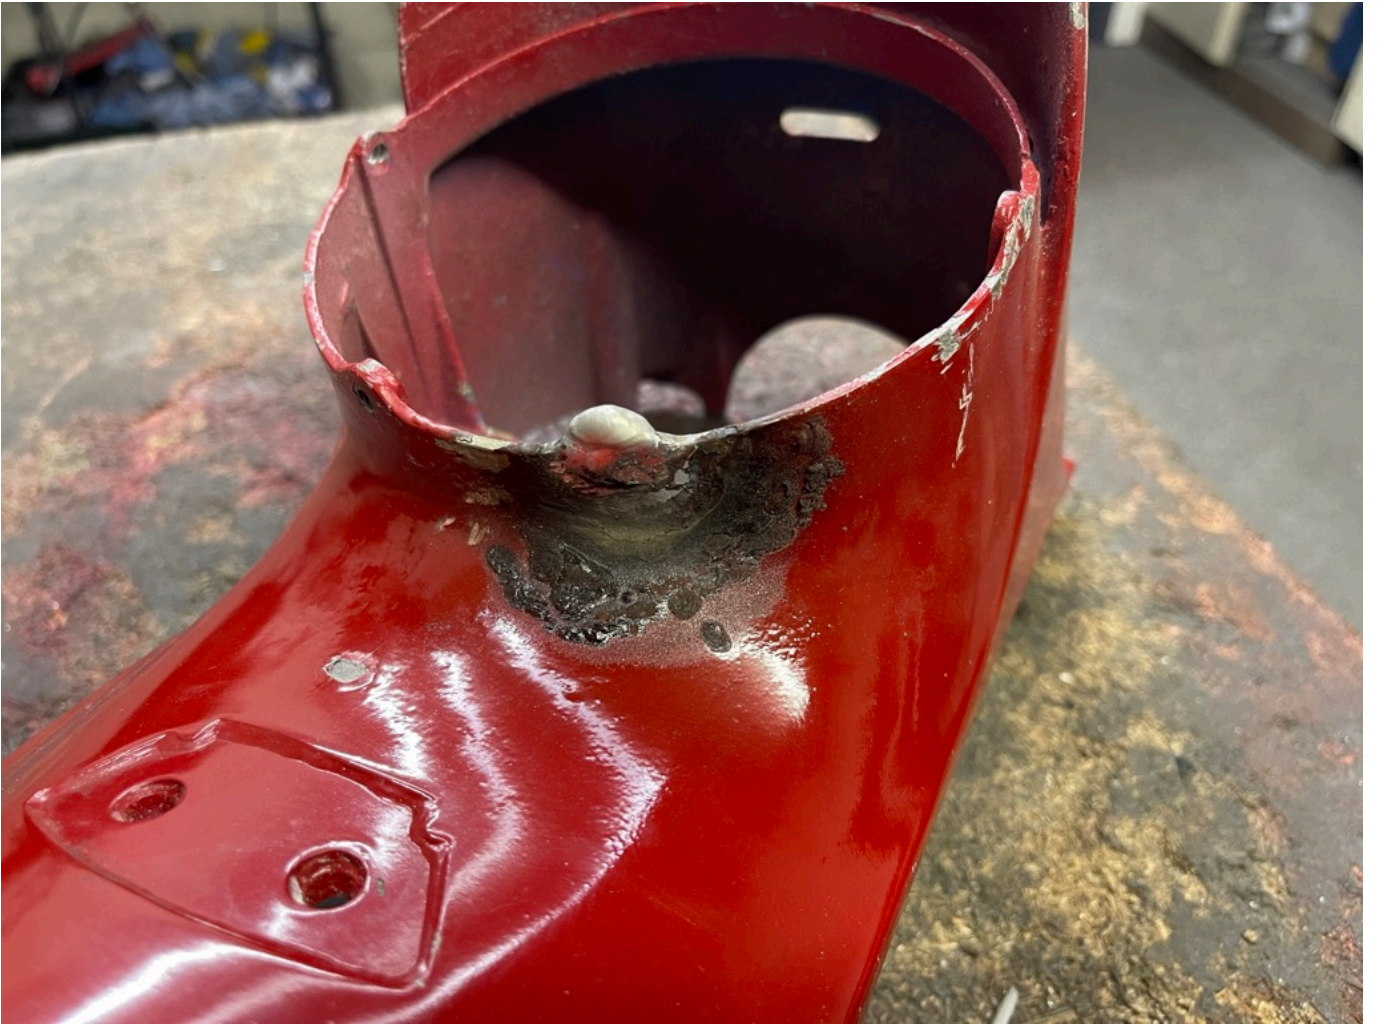
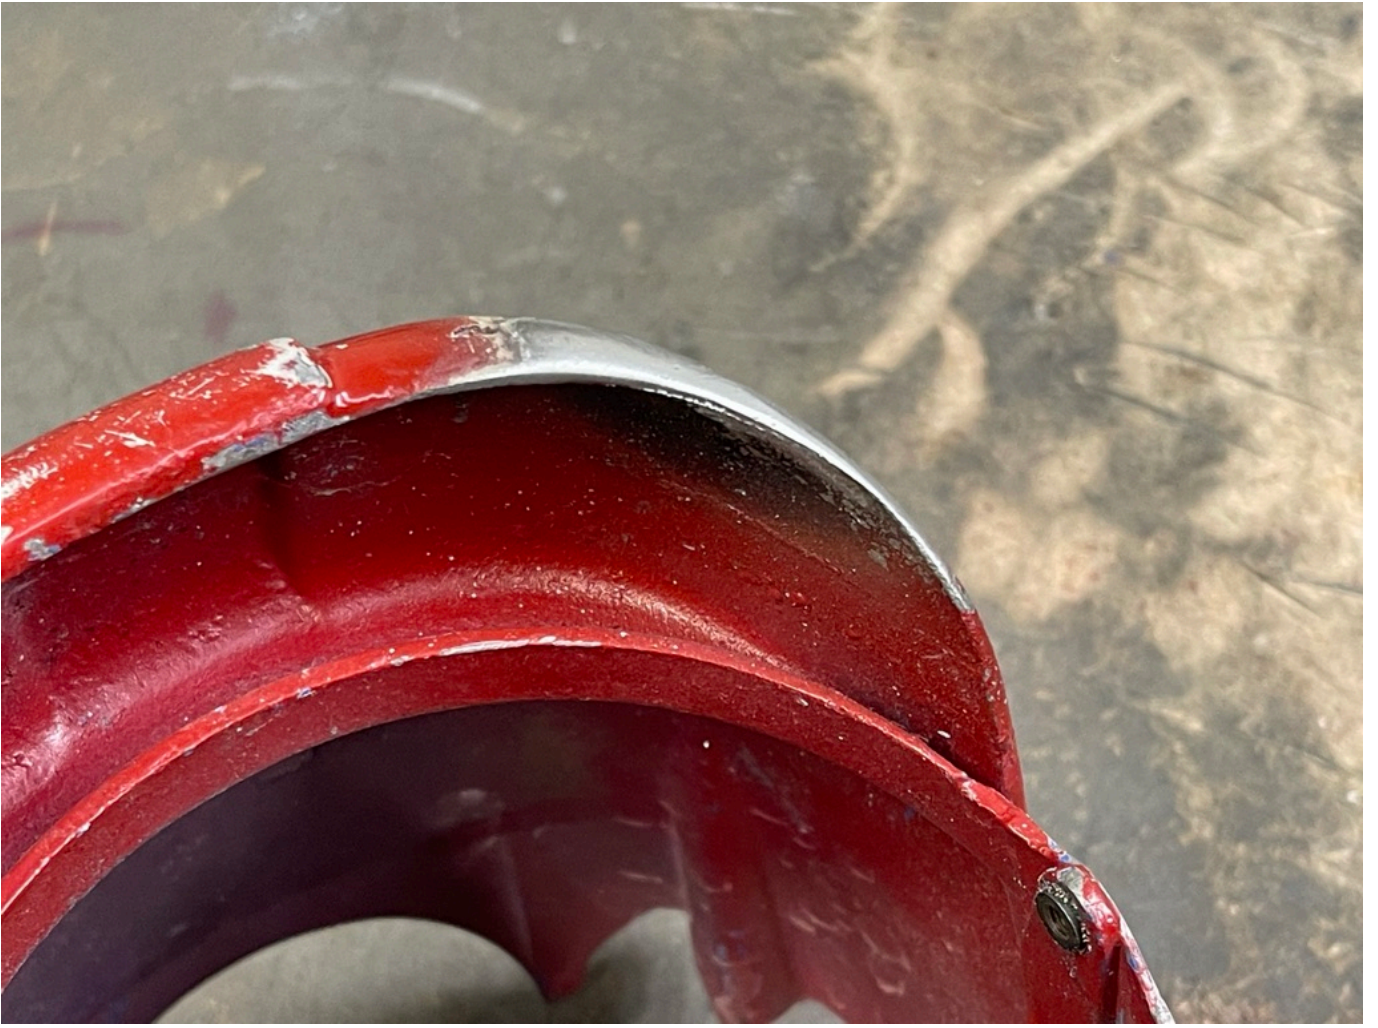
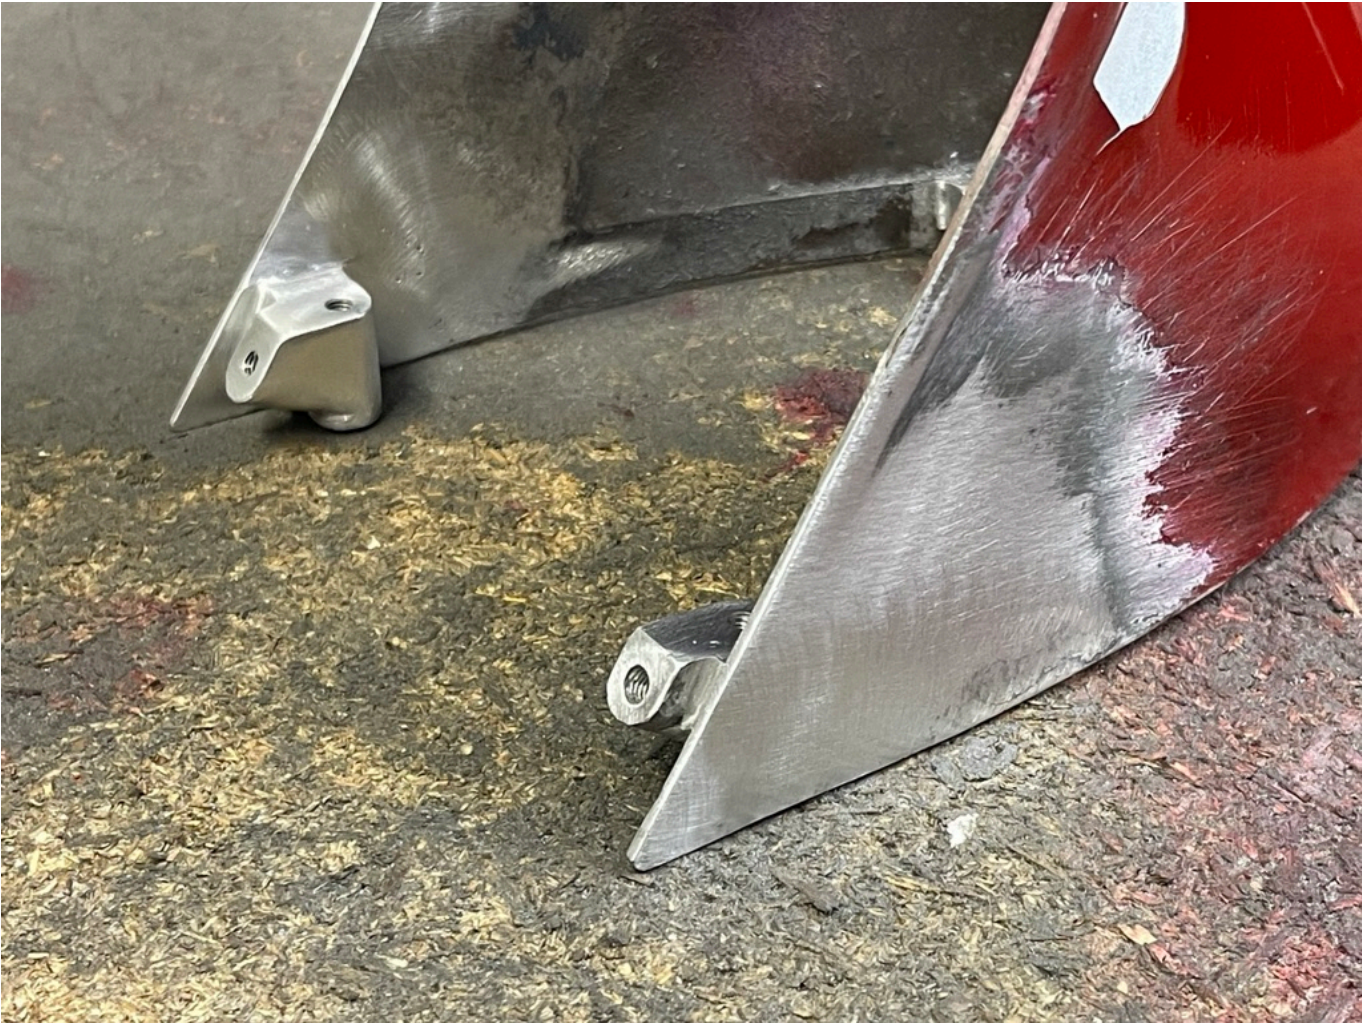
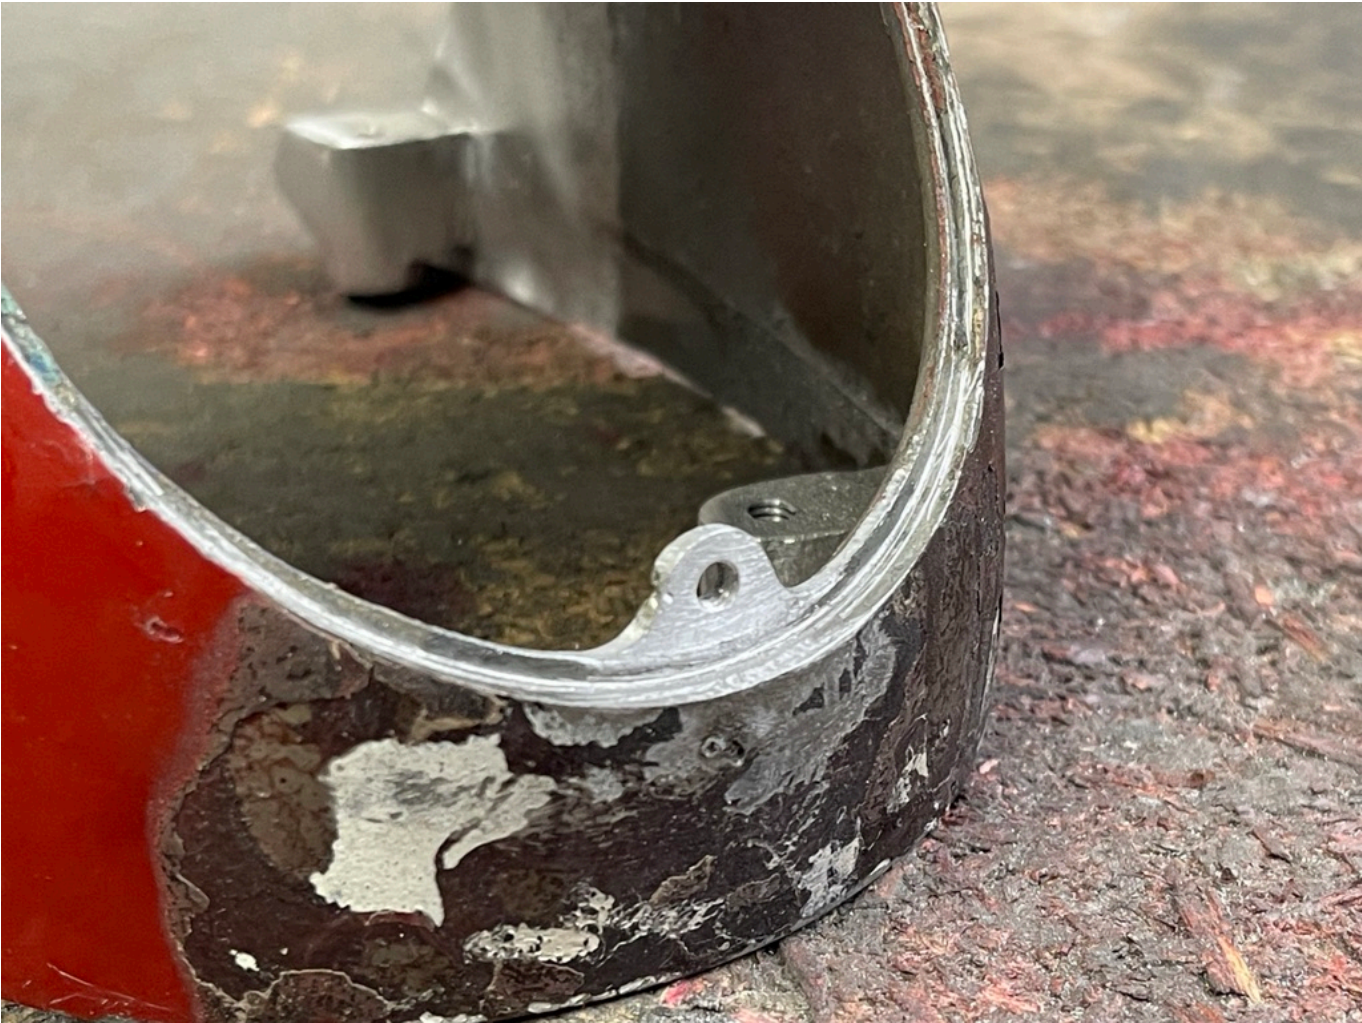
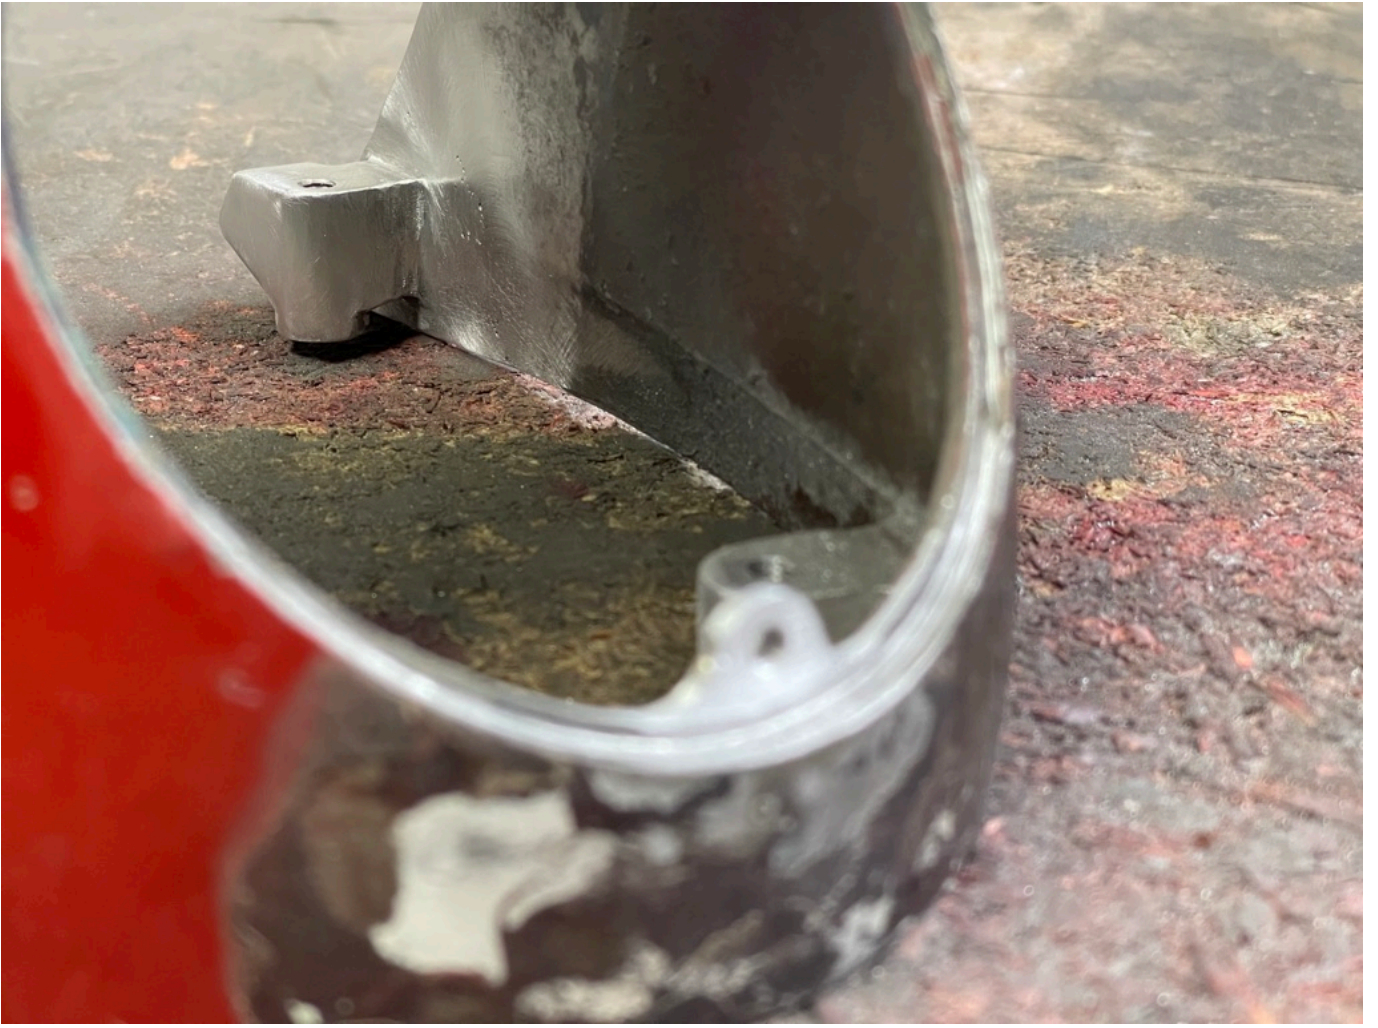
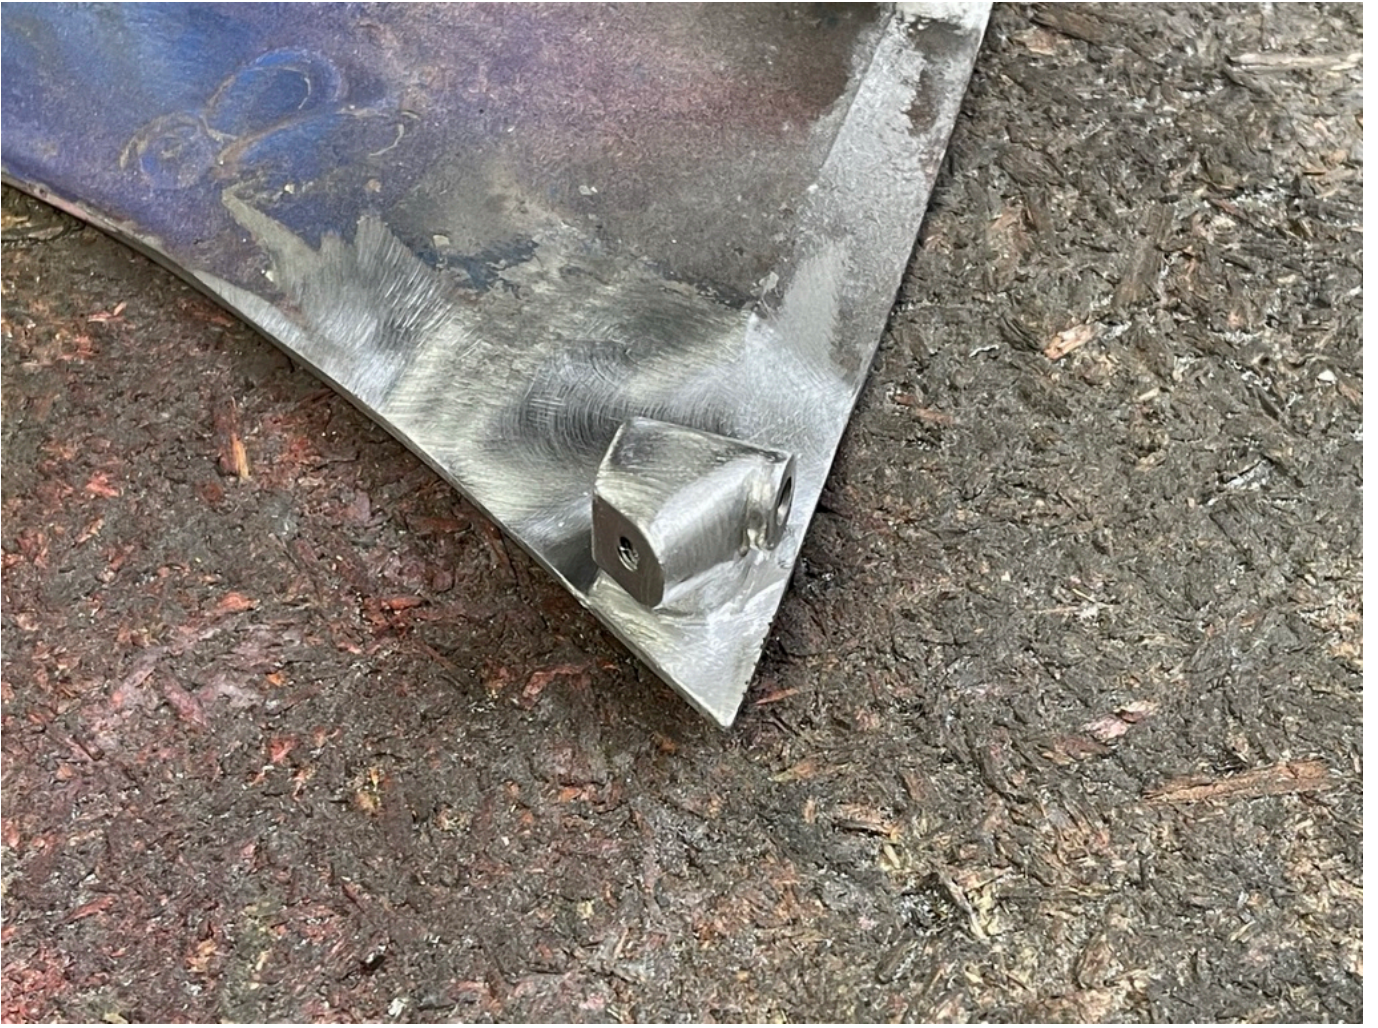
Here we have a horn casting that's had the lot – parts broken off – threads gone – threads drill off set and cracks!

This one had the lower part of the horncast missing. You can build it up with weld then grind it all to shape – or like this one you can make the part that is missing in the milling machine and weld it in place. As you can see from the photos, theres lots been done to this one.
